BASELINE REPORT

NAFCC PROJECT

INTEGRATED SURFACE WATER MANAGEMENT THROUGH CLIMATE CHANGE ADAPTATION IN U.T. OF PUDUCHERRY

Government of Puducherry

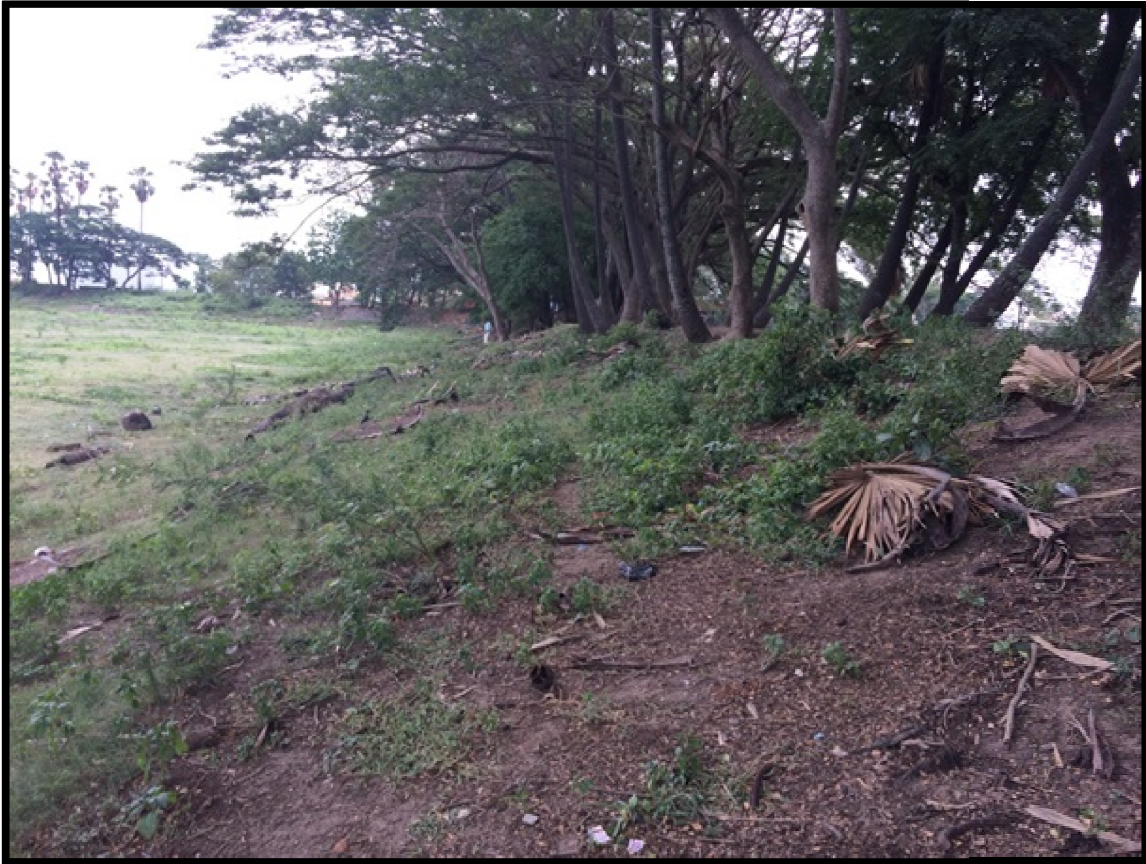
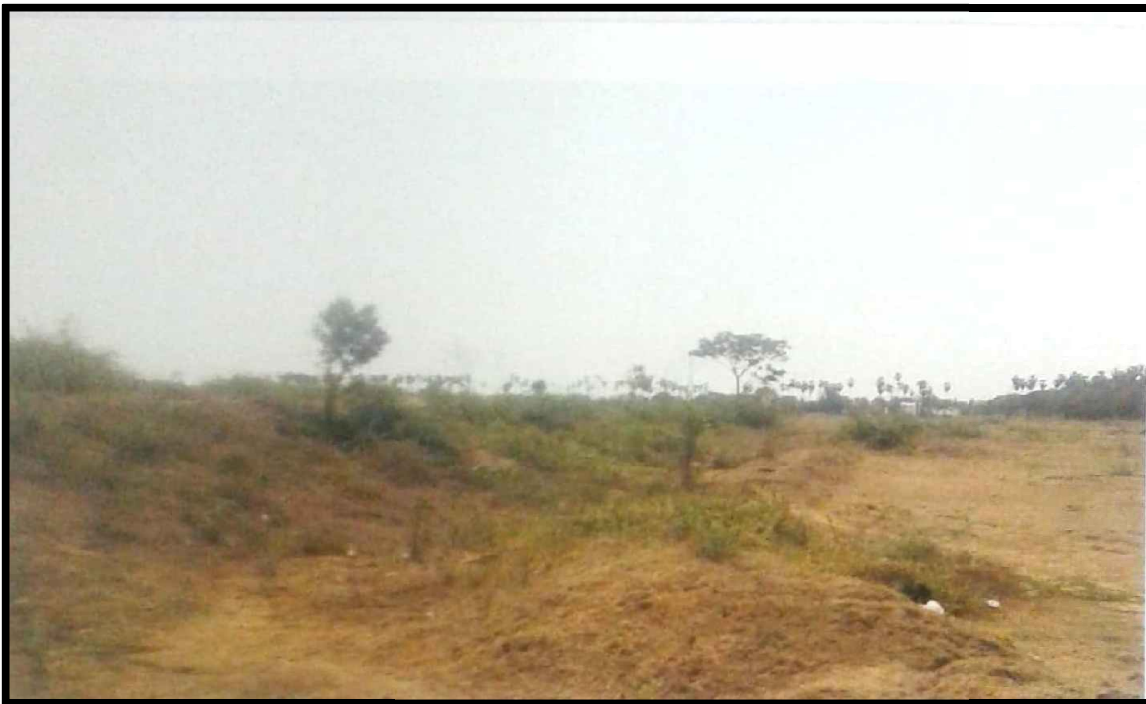
Tank photos before execution of the work:

Components	Condition	Remarks
Tank bund	Good	
Tank bed	Good	
Sluices	1	Poor
	2	Poor
	3	Poor
Field channels	1	Poor
	2	Poor
	3	Poor
Weir	1	Poor
	2	Average
Feeder canals	1	Good
Surplus courses	1	Poor

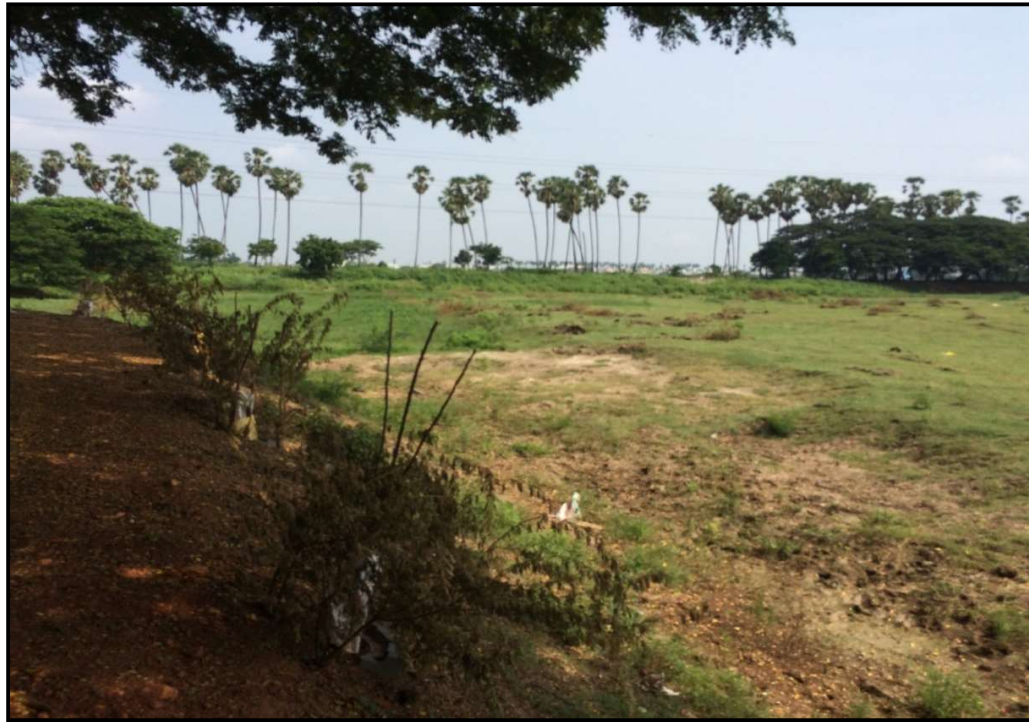
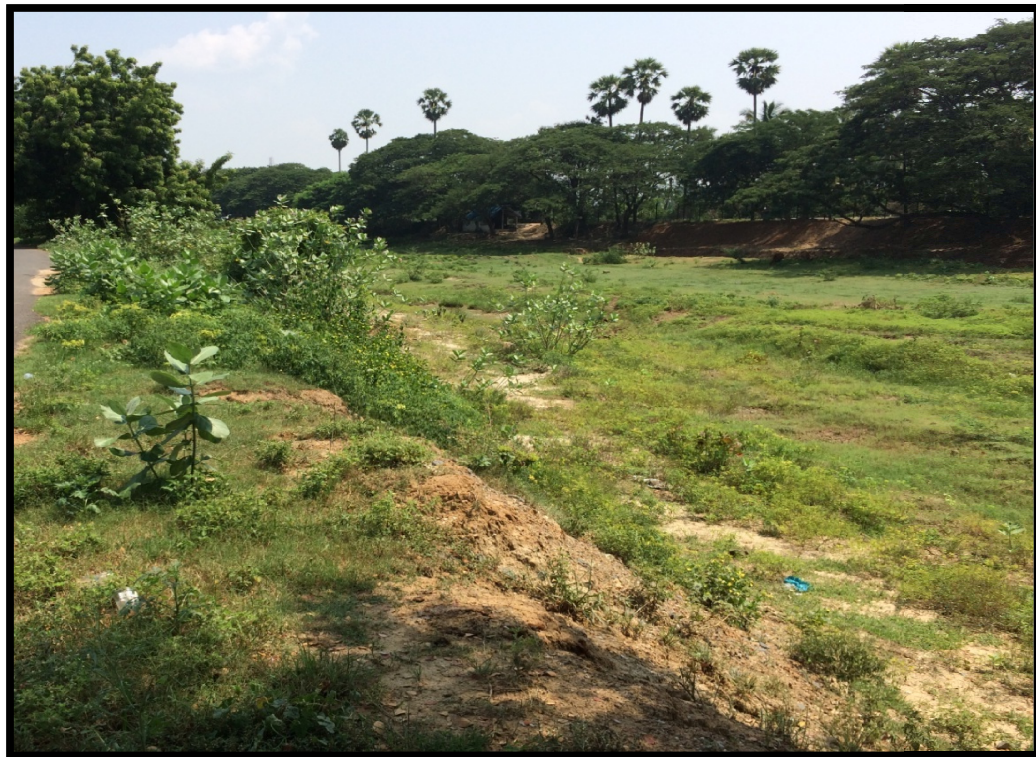
Tank photos before execution of the work:

Components	Condition	Remarks
Tank bund	Good	Road for full length at top;
Tank bed	Good	
Sluices 1	Good	Head wall – high level sluices; shutter exists; completely closed
2	Average	Head and wing wall – deepest sluice; no shutter; currently in use for irrigation
3	Average	Head and wing wall – no shutter ; pipe blockage 20%; currently not used for irrigation; rear cistern used for domestic purposes
4	Poor	Head wall – no shutter; piping problem; more damages; currently not used for irrigation;
Field channels 1	Poor	Earthen channel – more vegetation; silted not in use and falls into surplus course
2	Poor	Earthen channel – more vegetation; silted; encroached
3	Urbanised	
4	Urbanised	
Weir 1	Good	Culvert – minor damages
Feeder canals 1	Good	
Surplus courses 1	Average	Falls into Ariankuppam river – defined but more vegetation

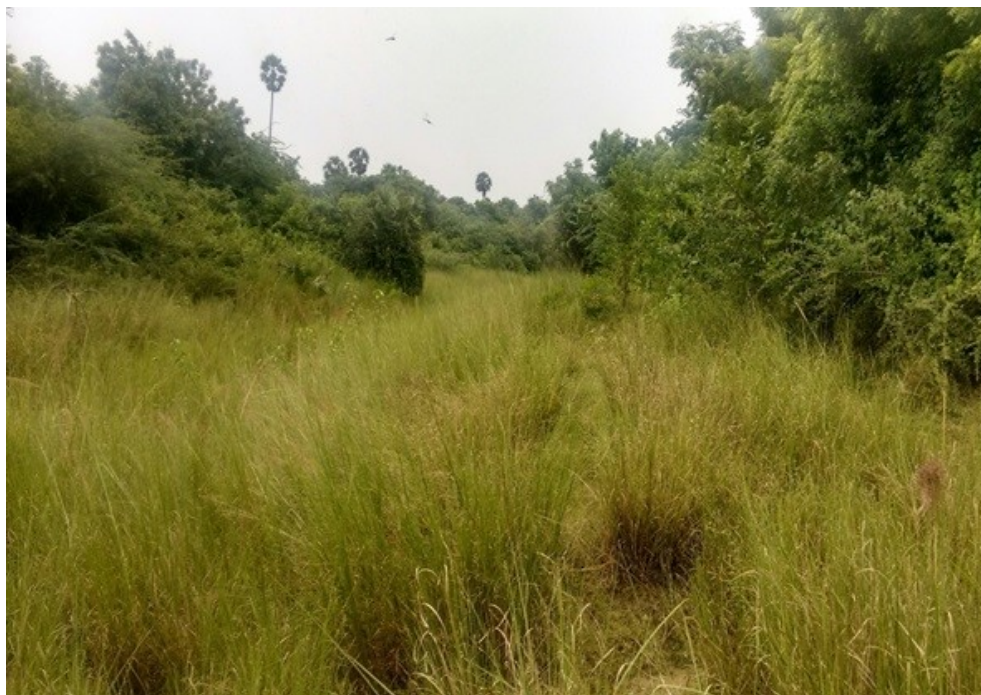
Tank photos before execution of the work:

Components	Condition	Remarks	
Tank bund	Average	Metalled road for full length at toe and it has few weak points as per farmers' view	
Tank bed	Poor	Heavily silted and insignificant encroachment; partly infested with ipomea	
Sluices	1	Average	Weir vent – Weak. to be repaired
	2	Good	Head and wing wall – leaky; shutter exists; pipe blockage 50%
	3	Good	Head and wing wall – leaky; shutter exists; pipe blockage 50%
	4	Good	Head wall – shutter exists; pipe blockage 10%
	5	Good	Head wall – leaky; shutter exists; pipe blockage 50%; minor damages

6	Average	Head wall – no shutter; leaky; minor damages; pipe blockage 90%
Field channels	1	Average	Line channel – more vegetation; silted
	2	Average	Line channel – less vegetation; silted
	3	Average	Line channel – less vegetation; silted
	4	Good	Earthen channel – less vegetation; less encroachment
	5	Good	Lined channel – less vegetation
	6	Poor	Earthen channel – more encroachment; more vegetation; silted
Weir	1	Average	BC – leaky; minor damages
Feeder canals	1	Average	Suttukeni vaykkal – less encroachment
Surplus courses	1	Average	Sluice 1 field channels acts as surplus channel’ which is not sufficient during the surplus periods due to its present width of 0.3m

Works (on priority)	What is required?
Tank bed	Removal of weeds and desiltation
Tank bund	Widening and strengthening
Field channels	Clearing and repairing the lined channels and lining for the remaining portion; it will help reducing the drainage problem
Feeder canals	Clearing
Community well	Small farmers opt for community well and they are willing to contribute

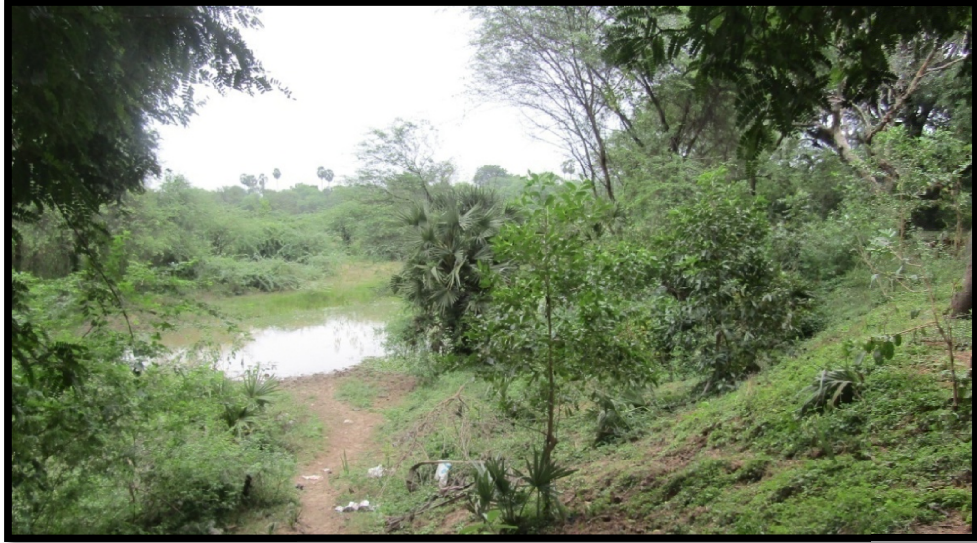
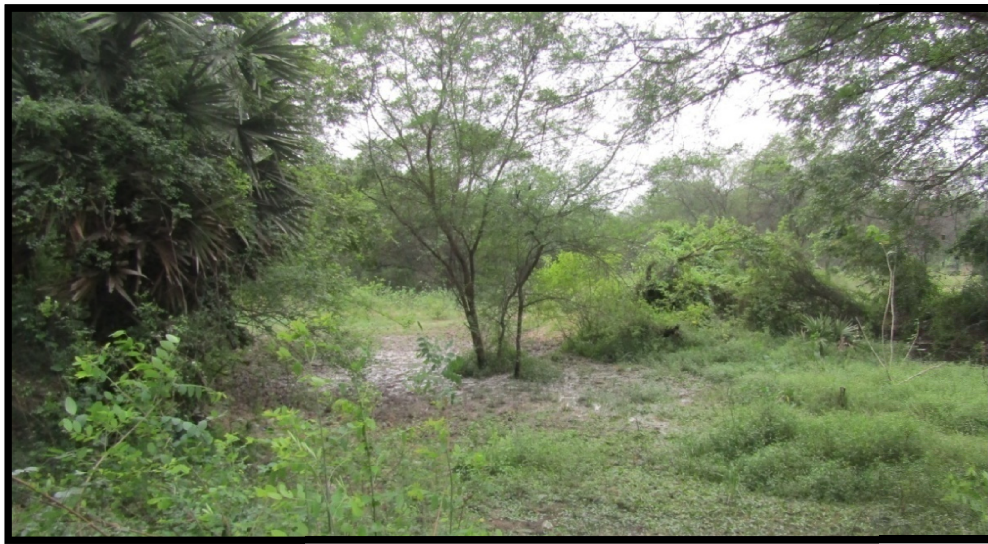
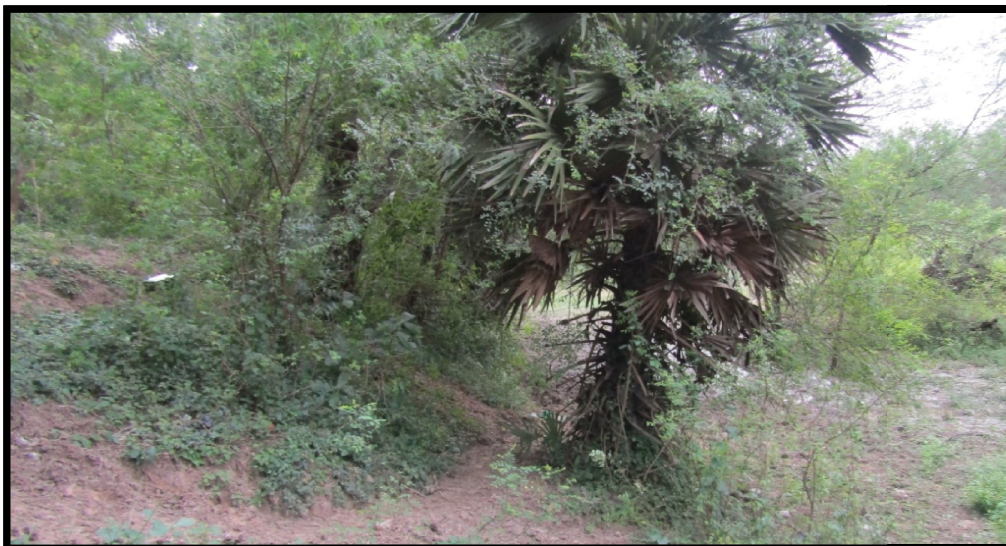
Tank photos before execution of the work:

Components		Condition	Remarks
Tank bund		Average	BT road formed during 14-15
Tank bed		Average	Heavily Silted and covered with bushes
Sluices	1	Poor	Entirely damaged
	2	Poor	Entirely damaged
	3	Poor	Entirely damaged
Field channels	1	Poor	Earthen channel with more vegetation and obstruction; more encroachment; heavily silted
	2	Poor	Earthen channel with more vegetation and obstruction; more encroachment; silted
	3	Average	Earthen channel with less vegetation; less encroachment
Feeder canals	1	Good	Kunichampattu pazhaya eri feeder channel from the Vikravandi channel – recently cleared
Surplus courses	1	Poor	Leads to Vikkravandy Main Channel and partly encroached and vegetation

Works (on priority)	What is required?
Tank bed	Desiltation
Tank bund	Standardisation, widening to enable cart movement and new bund between the foreshore and tank
Field channel	Clearing and lining
Sluice	Repairs and shutter provision
Injection wells	Bore holes in the tank to recharge the groundwater

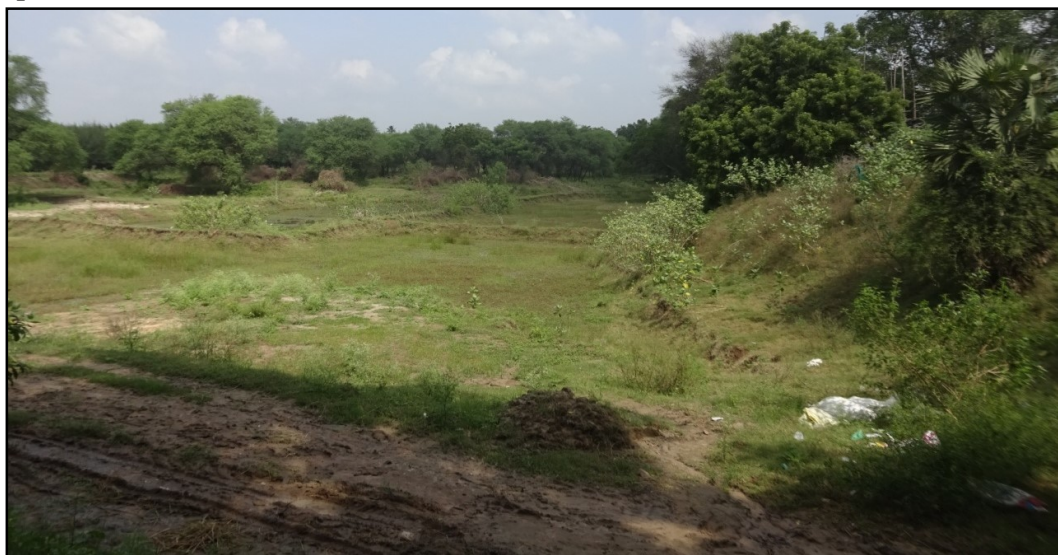
Tank photos before execution of the work:

Components	Condition	Remarks
Tank bund	Average	BT road formed in the offshore bund
Tank bed	Average	Moderately silted and less encroachment
Sluices 1	Average	Sluice under repair
Field channels 1	Poor	Earthen channel with less vegetation and obstruction; more encroachment; silted
Weir 1	No	No weir, cut opening bund to release water in practice
Feeder canals 1	Good	Branch channel from Tirukkanur peria eri feeder channel from vikravandy main channel- recently desilted
Surplus courses 1	No	No surplus channel

Works (on priority)	What is required?
Tank bed	Desiltation
Tank bund	Standardisation and needs a cart track
Field channels	Clearing and lining
Diversion structure	Inlet shutter is damaged and needs to be repaired.
Community well	New community well to supply water to small farmers. These are more than 30 farmers having less than 1 ha of land.
Sluice	Sluice arrangement needs to be replaced

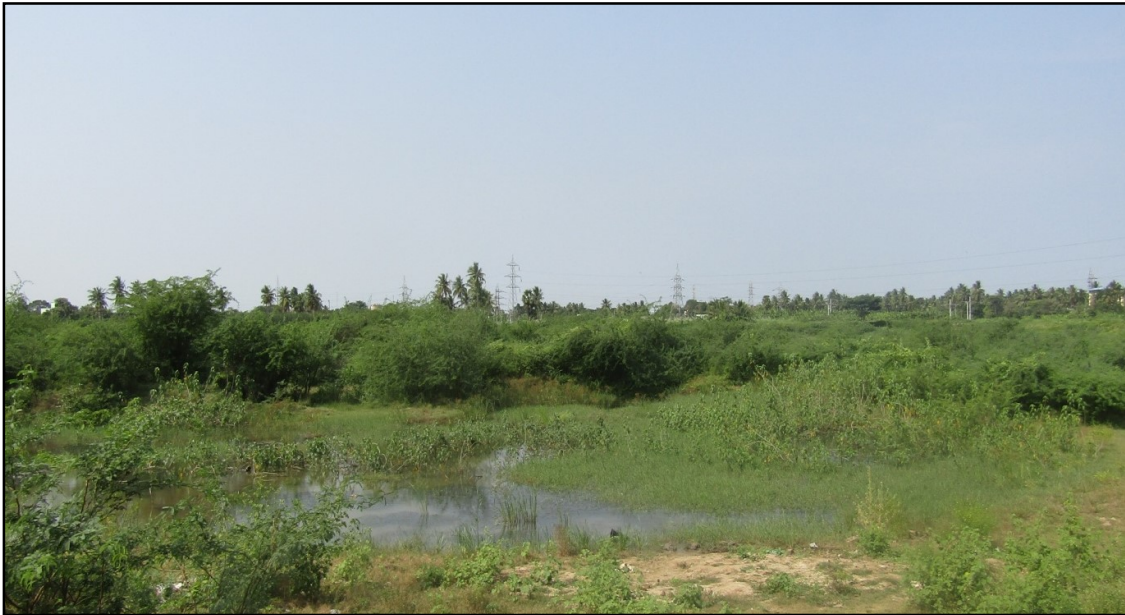
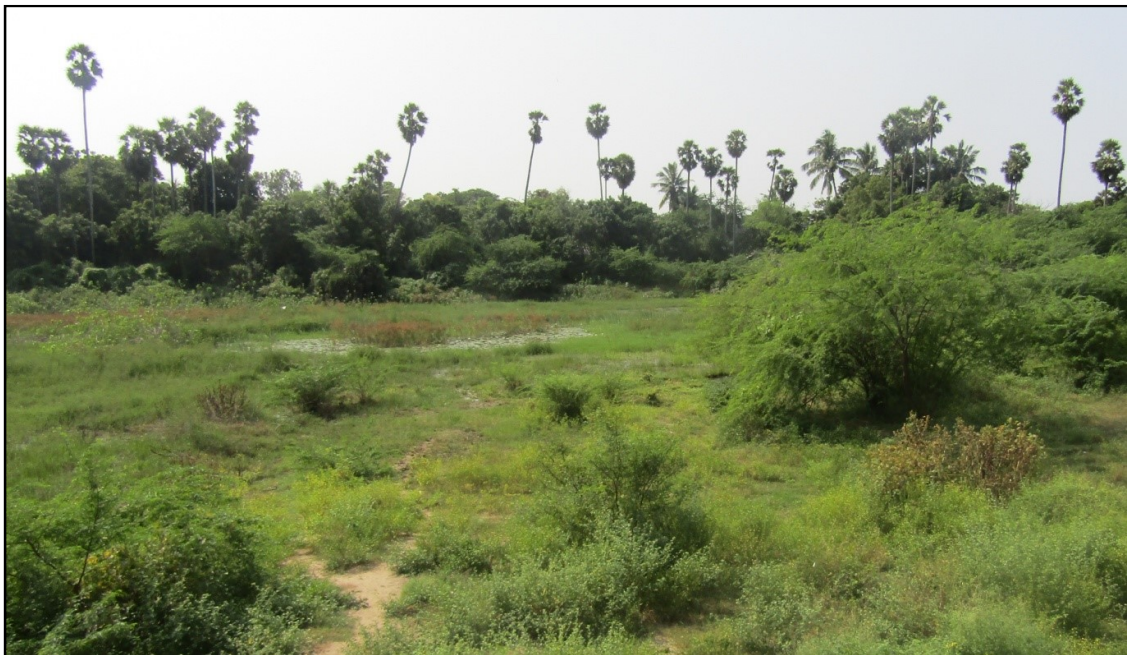
Tank photos before execution of the work:

Components		Condition	Remarks
Tank bund		Poor	Cart track at toe (partly); Not to the standard with two vulnerable points.
Tank bed		Poor	Heavily silted;
Sluices	1	Average	Head and wing wall – shutter exists; less leaky pipe blockage 70%; and minor repair
	2	Average	Head and wing wall – shutter exists; less leaky pipe blockage 50%; and minor repair
Field channels	1	Average	Earthen channel with less vegetation and obstructions; less encroachment; silted
	2	Average	Earthen channel with less vegetation and obstructions; less encroachment; silted
Weir	1	Poor	BC - Caligulah – located far away on the u/s side of the inflow channel; Dam stone is fully damaged by the village people (Tirubhuvanai peria pettai) since their houses are located just above the weir.
Feeder canals	1	Poor	It receives surplus from the Tirubhuvanai tank after filling the Ural kuttai, which is located in Kalilthirhalkuppam village – partly lined however damaged; encroached and less vegetation

Works (on priority)	What is required?
Feeder canals	Clearing
Tank bed	Removal of weeds, eviction of encroachment and desiltation
Tank bund	Strengthening and standardisation
Sluice	Minor repairs
Surplus courses	Clearing the Mandagapattu channel which also feeds the Kovilkulam
Field channels	Clearing and lining

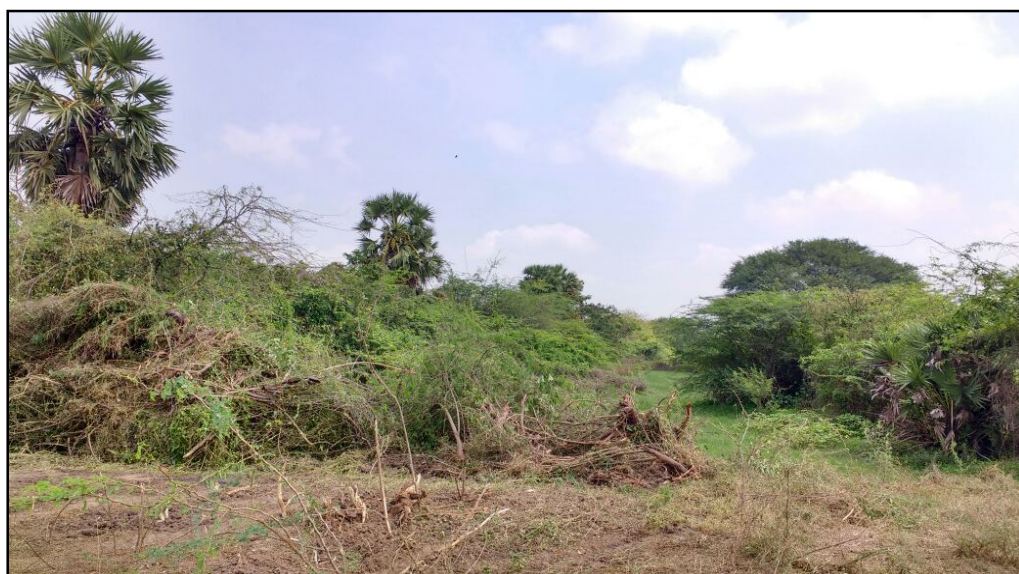
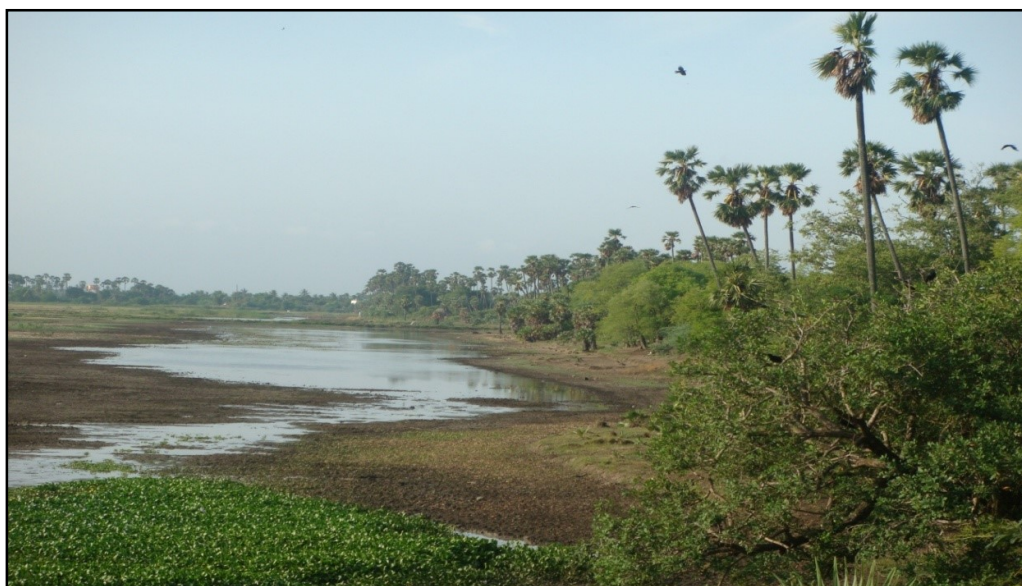
Tank photos before execution of the work:

Components		Condition	Remarks
Tank bund		Poor	Half of the tank bund in TN Palayam side in good condition; Whereas in Abhishekapakkam side the bund is not to the standard and twice the tank bund breached in the last 30 years.
Tank bed		Poor	Heavily silted; Infested with Ipomea and water hyacinth; Medium encroachment
Sluices	1	Poor	Reconstruction is required.
	2	Poor	Reconstruction is required.
	3	Average	Reconstruction is required.
	4	Average	Reconstruction is required.
	5	Average	Reconstruction is required.
Field channels	1	Poor	Earthen channel – more vegetation and obstructions; heavy encroachment;
	2	Average	Earthen channel – less vegetation and more encroachment
	3	Average	Earthen channel – less vegetation and more encroachment
	4	Average	Earthen channel – less vegetation and more encroachment
	5	Average	Earthen channel – less vegetation and more encroachment
Weir	1	Average	In good condition. Shutter only to be newly provided.

Works (on priority)	What is required?
Sluice	Major repairs and shutter provision
Tank bed	Encroachment removal, clearing and weeds desiltation
Feeder canals	Clearing and desiltation
Field channels	Removal of encroachment, clearing; The clearance of Nallavadu vaikkal would assist in drainage problem
Tank bund	Strengthening and Standardisation
Surplus courses	Lining and Strenthening

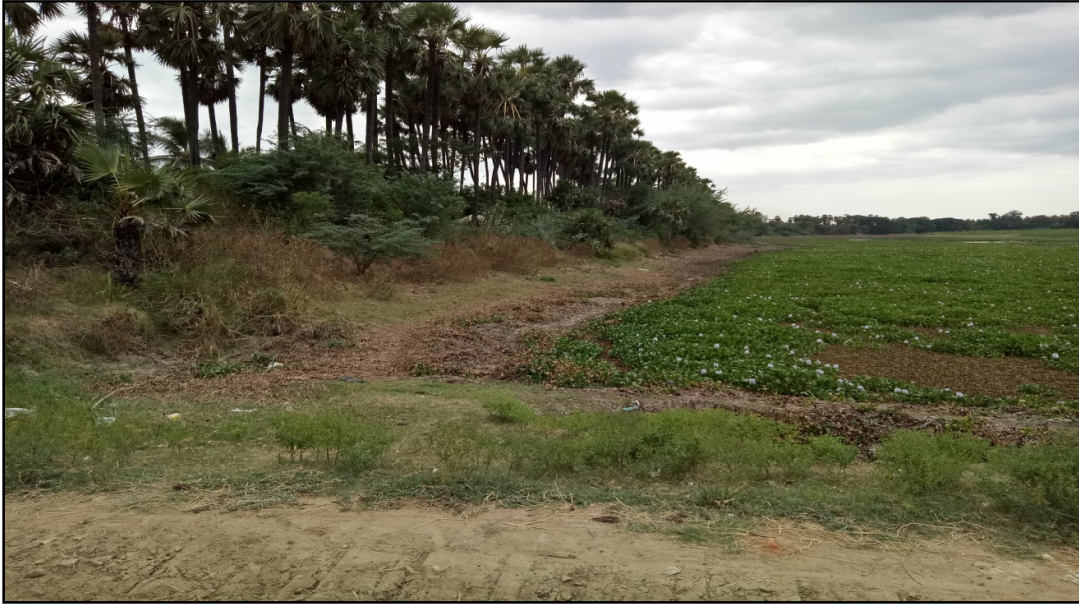
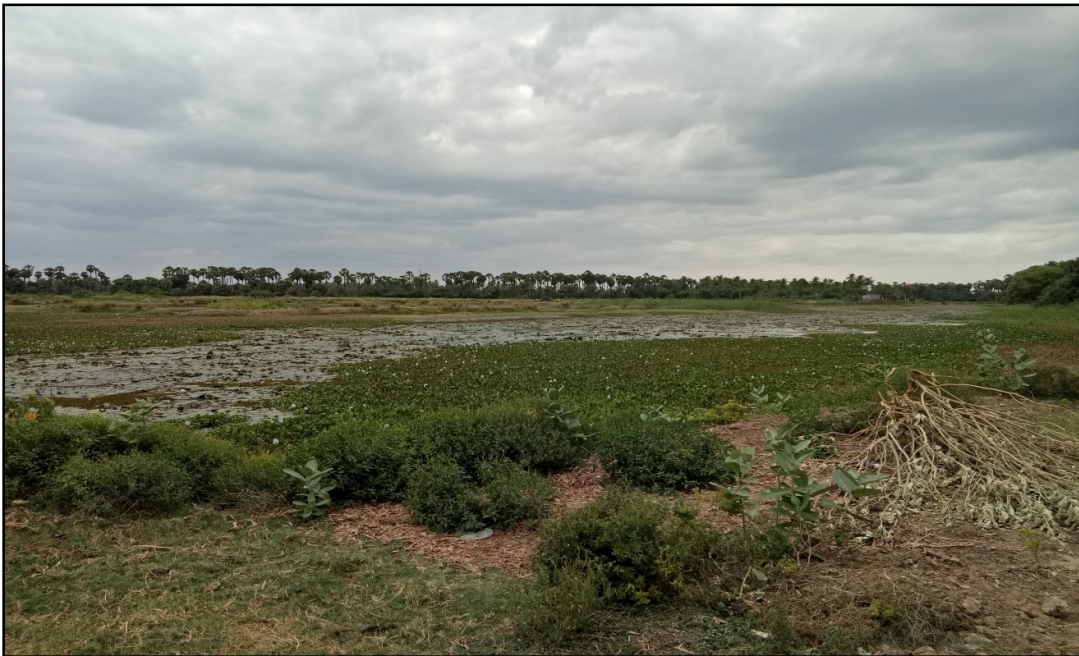
Tank photos before execution of the work:

Components		Condition	Remarks
Tank bund		Average	Metalled road (partly) at toe; a cart track cuts across the bund at one location to transport the harvests from the foreshore lands; the side slope and thickness are not as per standards.
Tank bed		Average	Moderately silted; Infested with weeds (Ipomea and acacia); encroachment; evicted;
Sluices	1	Average	Head and wing wall – no shutters; leaky; minor damages; pipe blockages more than 50%
	2	Average	Head and wing wall – no shutters; minor damages; pipe blockages more than 25%
	3	Average	Head wall; shutters exists but damaged; pipe blockages more than 50%
Field channels	1	Average	Partly lined channel with more vegetation and obstructions; less encroachment; silted; drainage problem at middle and tail reaches
	2	Average	Partly lined channel with more vegetation and obstructions; less encroachment; silted; drainage problem at middle and tail reaches
	3	Average	Earthen channel with less vegetation and obstructions, heavy encroachment, silted drainage problem at middle and tail reaches; very close to the sluice industry exists

Weir	1	Good	Regulator cum weir (2 shutters) – located at the end of the right flank.
	2	Poor	BC calingulah - Below the regulator across the surplus course - dilapidated condition
Feeder canals	1	Average	From Kilur anicut; dense vegetation; silted
Surplus courses	1	Average	Directly flow into Kuduvaayar odai - less than 500 m

Works (on priority)	What is required?
Tank bed	Removal of patta land (SRDL) from water spread area or construction of foreshore bunds around these patta lands
Sluices	Repairs and provision of shutters
Field channel	Clearing and lining; it would also reduce the drainage problem

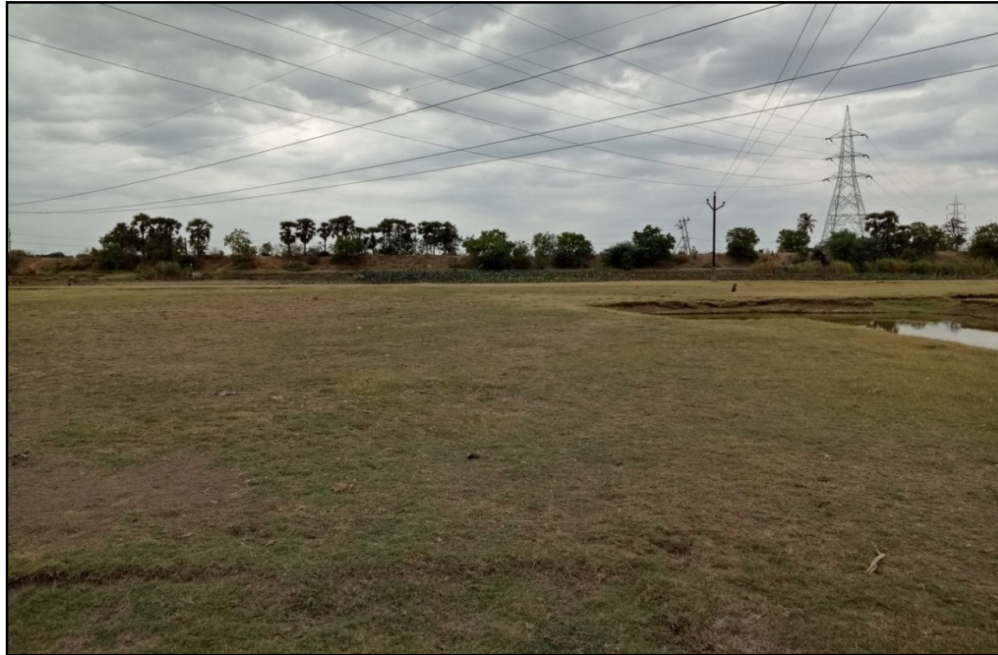
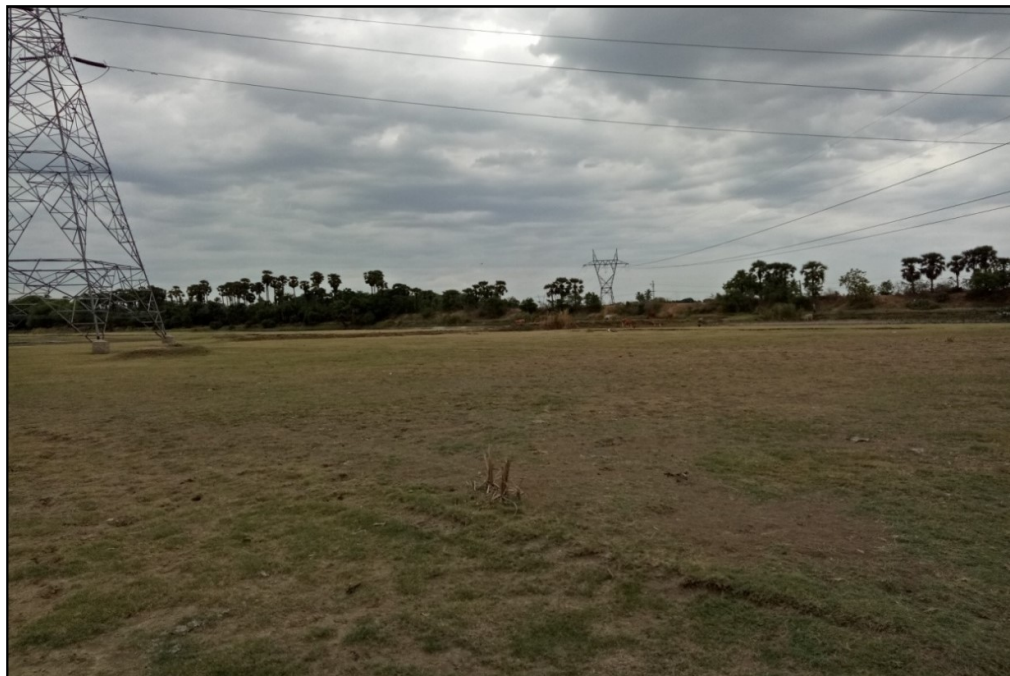
Tank photos before execution of the work:

Components		Condition	Remarks
Tank bund		Poor	Metalled road (fully) at toe; the sideslopes, height and thickness are not as per standards; During flood, it overtops the bund at Vakran eri and Sitheri junction.
Tank bed		Average	Moderately silted; Infested heavily with weeds (Ipomoea); moderately encroached
Sluices	1	Poor	Head wall – no shutters; temporarily closed; major damages; pipe blockages more than 50%
	2	Poor	Head wall – no shutters; temporarily closed; major damages; pipe blockages more than 50%
Field channels	1	Poor	Earthen channel with dense vegetation and obstructions; heavy encroachment; silted; drainage problem at middle and tail reaches
	2	Poor	Earthen channel with more vegetation and obstructions; heavy encroachment; silted; drainage problem at middle and tail reaches
Weir	1	Poor	Culvert, dilapidated condition.
Feeder canals	1	Poor	Vakran eri feeder channel from Vannan eri through Pura kuttai; encroached; silted; more vegetation

Works (on priority)	What is required?
Tank bund	Standardisation
Tank bed	Removal of weeds, encroachment and desiltation
Sluices	Repairing and shutter provision
Field channel	Clearing and lining (shall overcome drainage problem as well)
Feeder canals	Both the channels – clearing and standardization

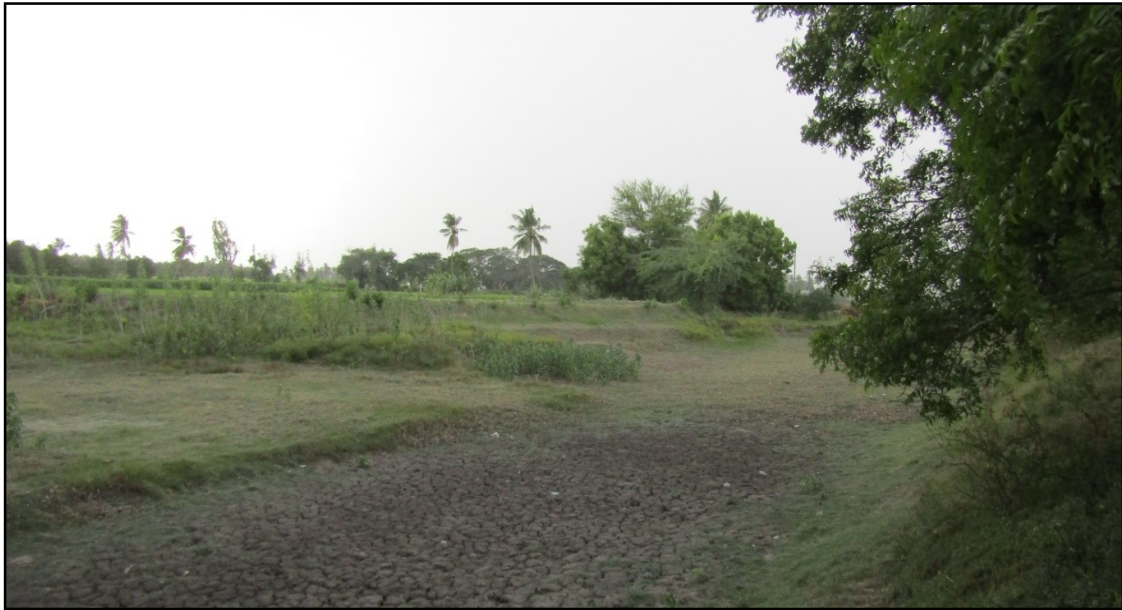
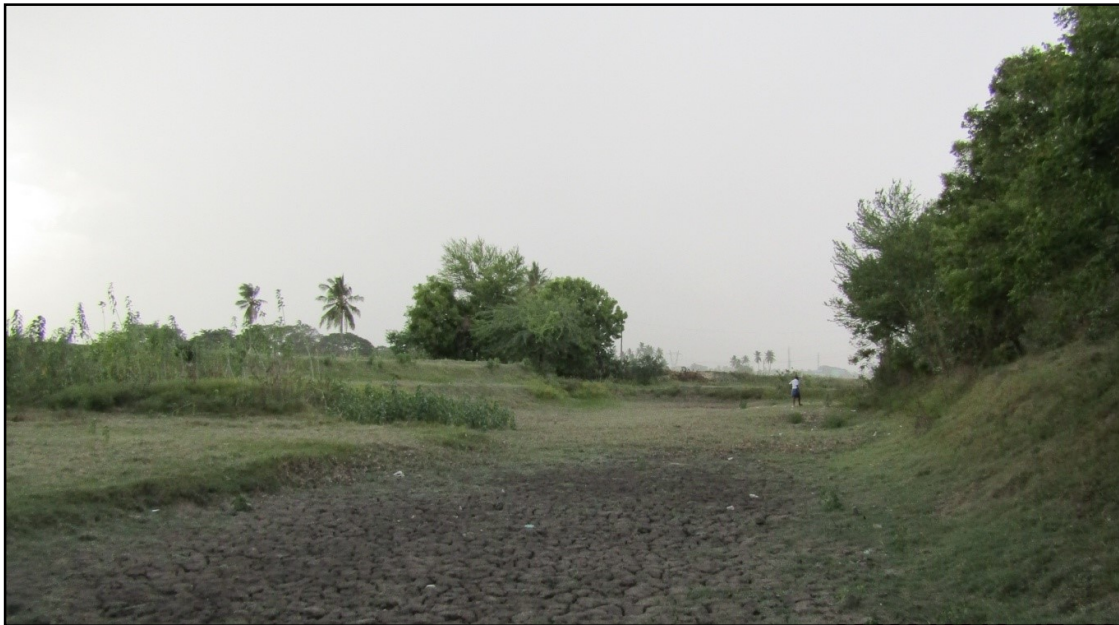
Tank photos before execution of the work:

Components	Condition	Remarks
Tank bund	Poor	Metalled (fully) road at toe; Thickness, height and side slopes are not as per standards; During flood time, it overtops the bund at Vakran eri and sitheri junction point
Tank bed	Average	Moderately silted; Infested heavily with weeds (Ipomea); moderately encroached
Sluices 1	Poor	Head wall – no shutters; temporarily closed; major damages; pipe blockages more than 80%
2	Poor	Head wall – no shutters; temporarily closed; major damages; pipe blockages more than 80%
3	Poor	Head wall – no shutters; temporarily closed; major damages; pipe blockages more than 80%
Field channels 1	Average	Earthen channel with less vegetation and obstructions; heavy encroachment; silted; drainage problem at middle and tail reaches
2	Poor	Earthen channel with more vegetation and obstructions; heavy encroachment; silted; drainage problem at middle and tail reaches
3	Poor	Earthen channel with more vegetation and obstructions; heavy encroachment; silted; drainage problem at middle and tail reaches

Works (on priority)	What is required?
Tank bed	Removal of weeds and encroachment; Desiltation
Sluices	Repairing and shutter provision
Field channel	Clearing and lining; it would also assist the drainage problem
Tank bund	Standardisation

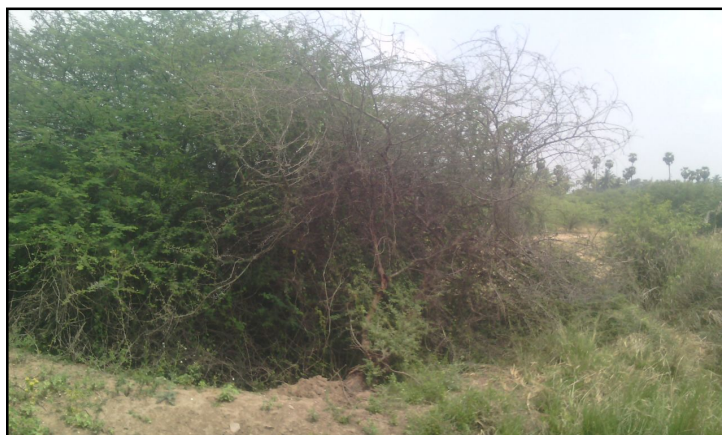
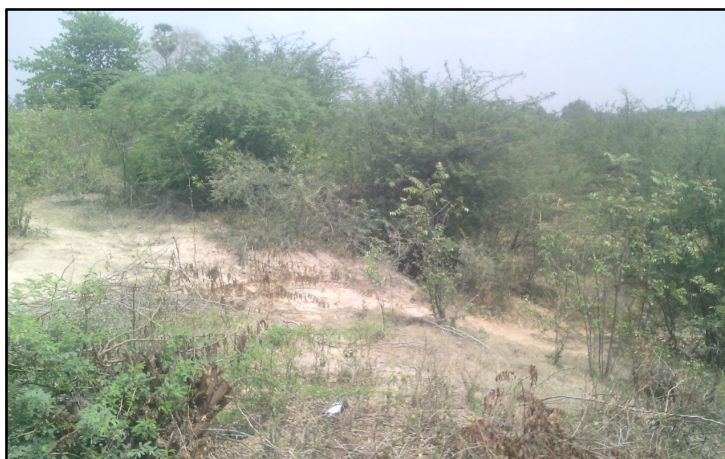
Tank photos before execution of the work

Components		Condition	Remarks
Tank bund		Good	Side slopes and thickness are good
Tank bed		Average	Moderately silted;
Sluices	1	Poor	Head wall – no shutters; piping problem exists; pipe blockage 100%
	2	Poor	Head wall – no shutters; piping problem exists; pipe blockage 100%
	3	Average	Head wall – shutters exists; pipe blockage 25% minor repairs
Field channels	1	Poor	More vegetation and obstruction, heavy encroachment
	2	Poor	More vegetation and obstruction, heavy encroachment
	3	Average	More vegetation and obstruction, heavy encroachment
Weir	1	Average	BC – covered by vegetation on all sides
Feeder canals	1	Average	From Bangaru vaykkal; less vegetated and encroached
Surplus courses	1	Poor	No defined channel, drains over the ayacut and falls into ponnaiyar

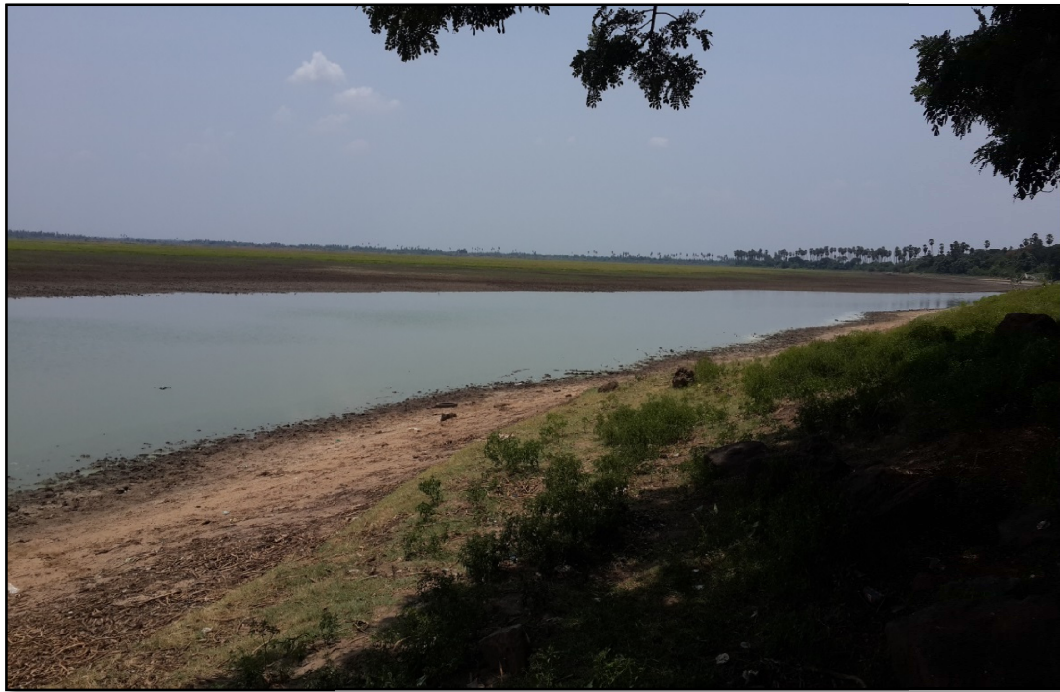
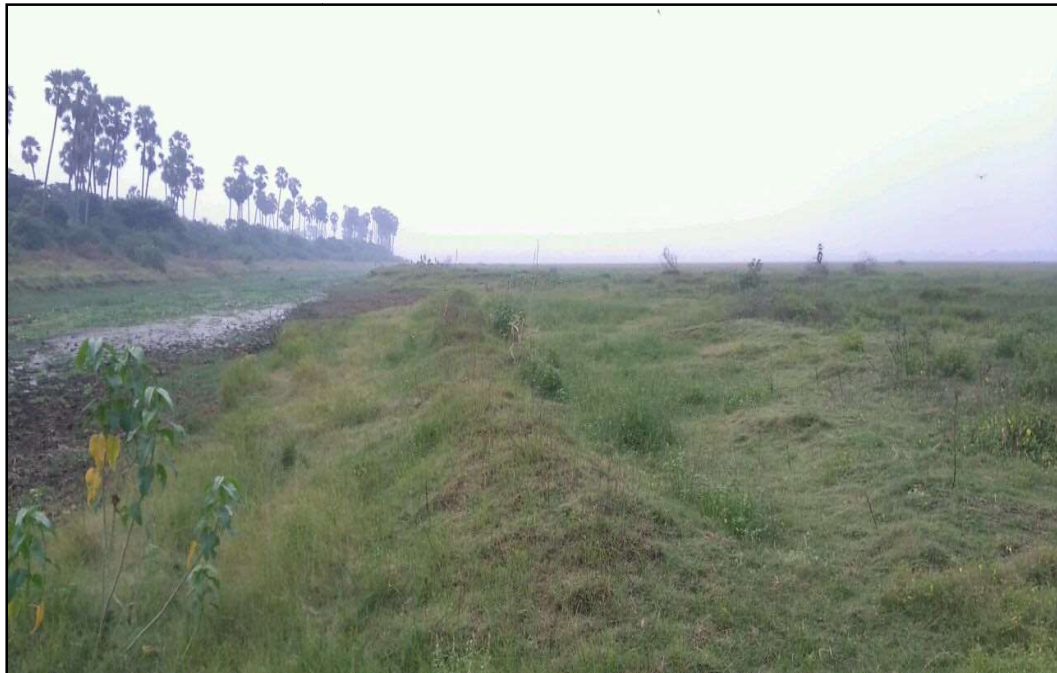
Tank photos before execution of the work

Components	Condition	Remarks
Tank bund	Good	Kutchra road on top (partly); retaining wall on d/s side (partly)
Tank bed	Average	Silted; no encroachment but 46 ha has been given as special rate dry land patta
Sluices	1	Average
	2	Good
	3	Good
	4	Good
	5	Good
	6	Good
	7	Average
	8	Average
Weir	1	Good
	2	Average
Feeder canals	1	Good
Surplus courses	1	Average

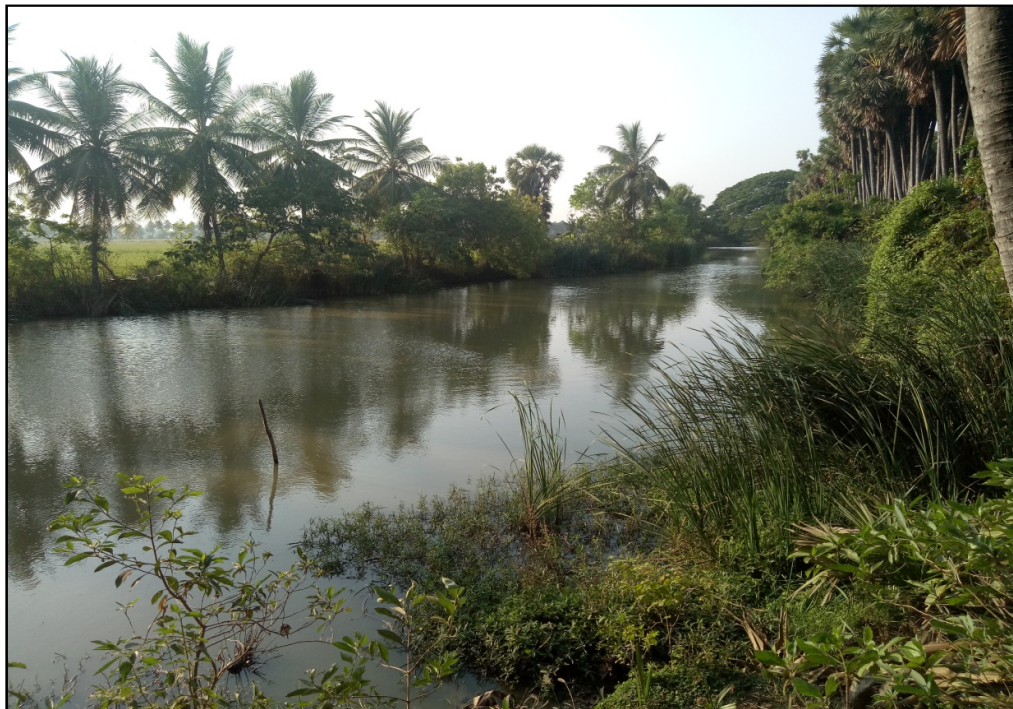
Tank photos before execution of the work

Components		Condition	Remarks
Tank bund		Average	Cart track on toe (partly); two vulnerable points, the bund height are not to standards
Tank bed		Poor	Infested with water hyacinth;
Sluices	1	Poor	Head wall no shutter; major repairs; heavily silted pipe; leaky
	2	Poor	Head wall – No shutters; minor repairs; partly silted pipe; leaky
Field channels	1	Poor	More vegetation, more obstructions and more encroachment
	2	Average	More vegetation, less obstructions and less encroachment
Weir	1	Good	Culvert; minor repairs
Feeder canals	1	Poor	Kirumbakkam vaykkal from Seliamedu madagu of Bahur tank; more vegetated, silted and encroached
Surplus courses	1	Average	Only 10 m length; falls directly into Bahur surplus course – sparse vegetation and less encroachment

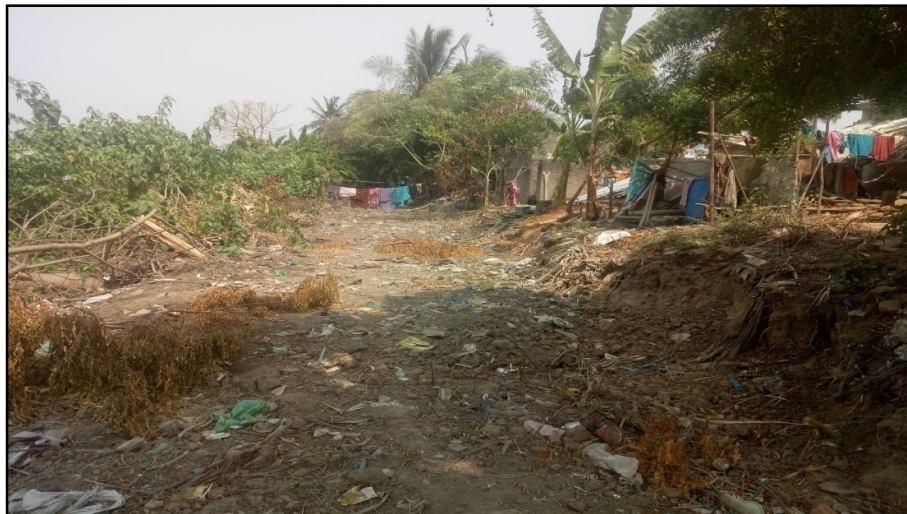
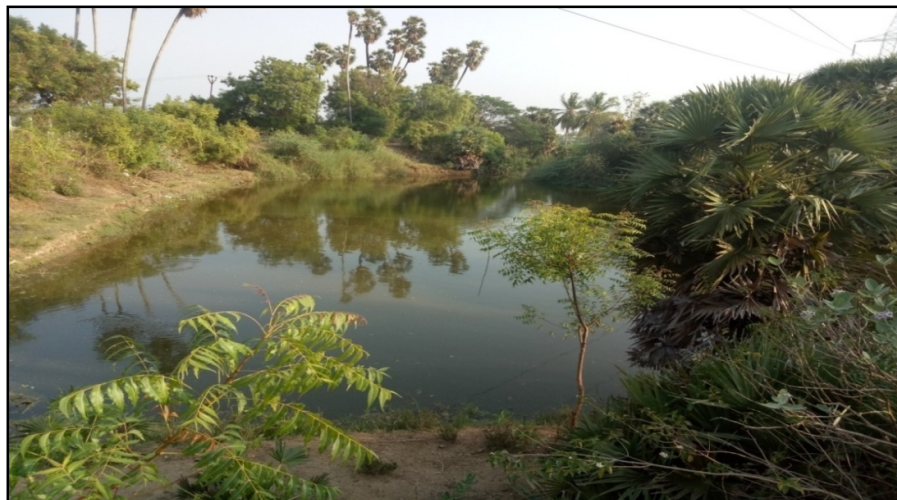
Tank photos before execution of the work:

Components		Condition	Remarks
Tank bund		Average	Cart track on top (partly); no vulnerable points, the height seems to be insufficient
Tank bed		Average	Moderate siltation; Infested with Ipomea and water hyacinth; insignificant encroachment
Sluices	1	Average	Head and wing wall - no shutters; major repairs; less siltation
Field channels	1	Average	Dense vegetation, less obstructions and less encroachment
Weir	1	Average	Repairs required
Feeder canals	1	Poor	Adingapattu vaikkal from palayathu madagu of Bahur tank; dense vegetation, silted and encroached
Surplus courses	1	Poor	More vegetation, more obstruction and more encroachment

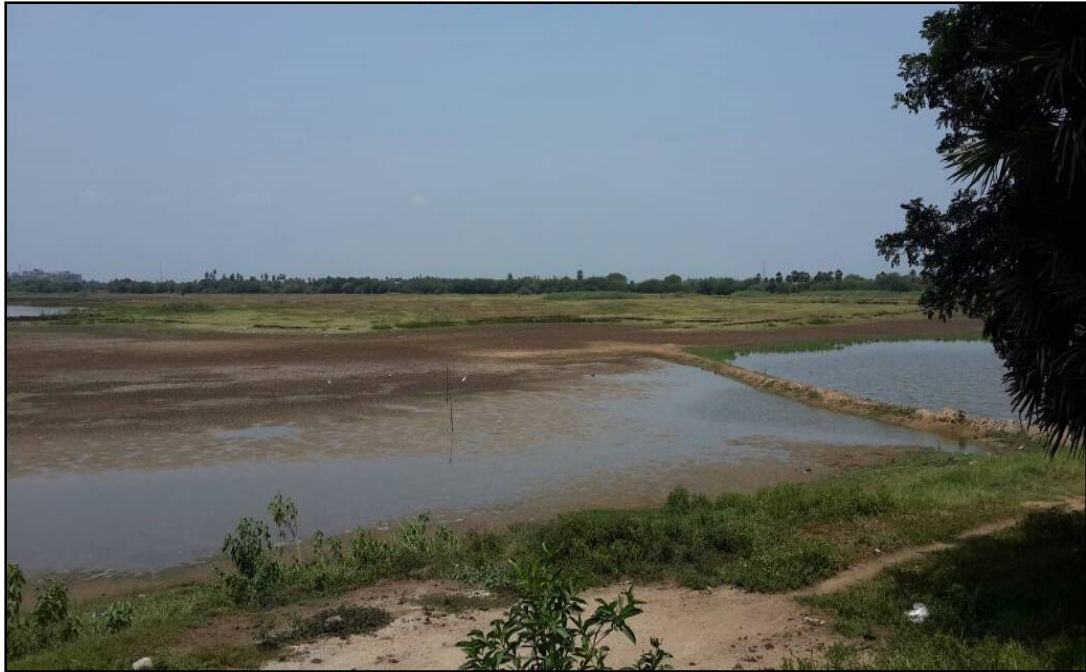
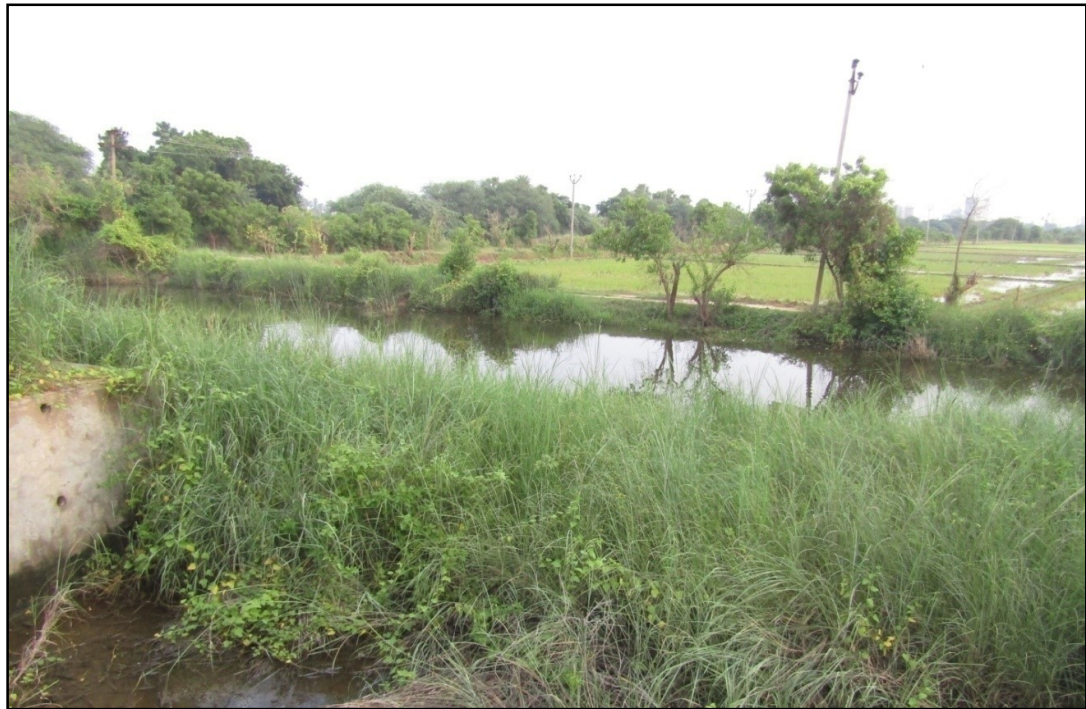
Tank photos before execution of the work

Components	Condition	Remarks
Tank bund	Good	Bunds of both the tanks are in good condition
Tank bed	Average	Peria eri - heavily silted; infected by ipomea Chinna eri - moderately silted; looks like grazing land

Sluices	1	Poor	Peria eri – head wall sluice; major damages; no shutters ; leaky; piping problem
	2	Average	Chinna eri – head and wing wall sluice; looks good with regulators
	3	Average	Chinna eri – head wall sluice; looks good with regulators
	4	Average	Chinna eri – regulator cum sluice; looks with regulators
	5	Poor	Peria eri – regulator; piping problem, major damages
	6	Good	Peria eri – head wall sluice; shutters in good condition
Field channels	1	Average	Less vegetation, less obstructions and less encroachment
	2	Average	Less vegetation, more obstructions and less encroachment
	3	Average	Less vegetation, less obstructions and less encroachment
	4	Average	More vegetation, less obstructions and less encroachment
	5	Average	Less vegetation, more obstructions and less encroachment
	6	Good	More vegetation, high obstructions and more encroachment
Balancing regulator		Average	Repairs Required
Common bund sluice		Average	Looks with shutters and structure condition

Surplus Regulators		Average	Leaky; Repairs Required
Feeder canals	1	Poor	Kirumambakkam vaykkal from selilamedu madagu of Bahur tank - more encroached, illegal diversions; silted; more vegetation
	2	Poor	Kirumambakkam vaykkal from Palayathu madagu of Bahur tank - more encroached, illegal diversions; silted; more vegetation
	3	Poor	Sitheri vaykkal - more encroached, illegal diversions; silted; more vegetation
	4	Poor	Murattupattun anai vaykkal from Bahur surplus course – more encroached, illegal diversions; silted; more vegetation
Surplus courses	1	Poor	Falls into sea after irrigation few areas in Tamil Nadu side also – More vegetation, more obstructions and more encroachment
