BASELINE REPORT

NAFCC PROJECT

INTEGRATED SURFACE WATER MANAGEMENT THROUGH CLIMATE CHANGE ADAPTATION IN U.T. OF PUDUCHERRY

Government of Puducherry

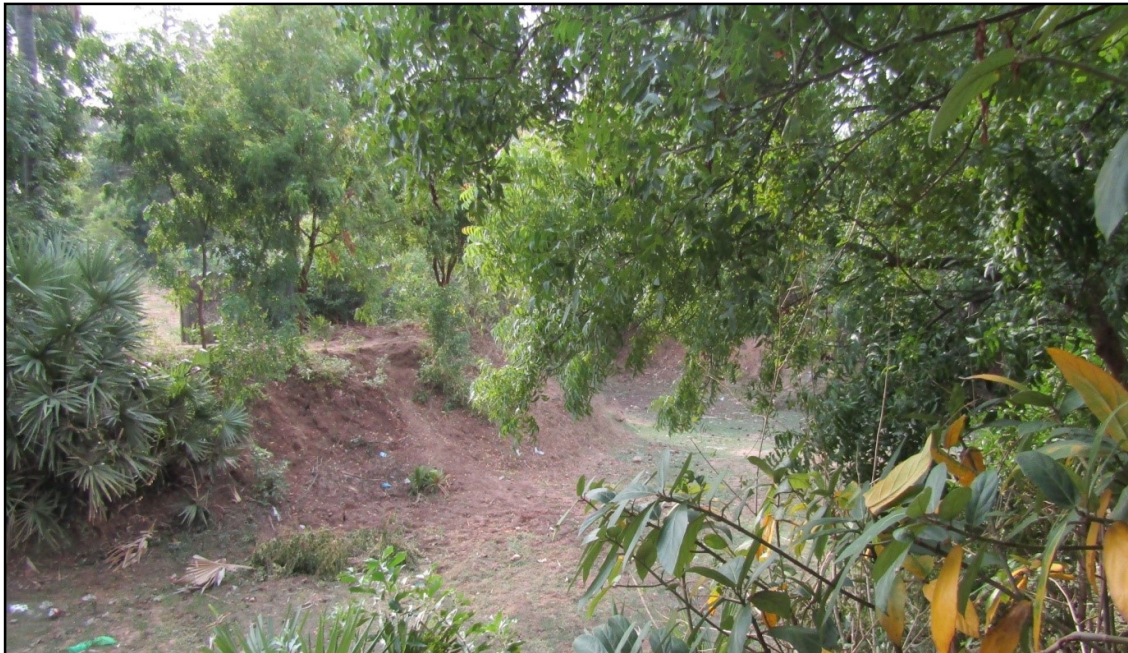
Tank photos before execution of the work

Components	Condition	Remarks
Tank bund	Good	Cart track on top
Tank bed	Average	Moderate siltation; Ipomea weeds; Insignificant
Sluices	1	Poor
	2	Average
Field channels	1	Poor
	2	Poor
Weir	1	Average
Feeder canals	1	Poor
Surplus courses	1	Average

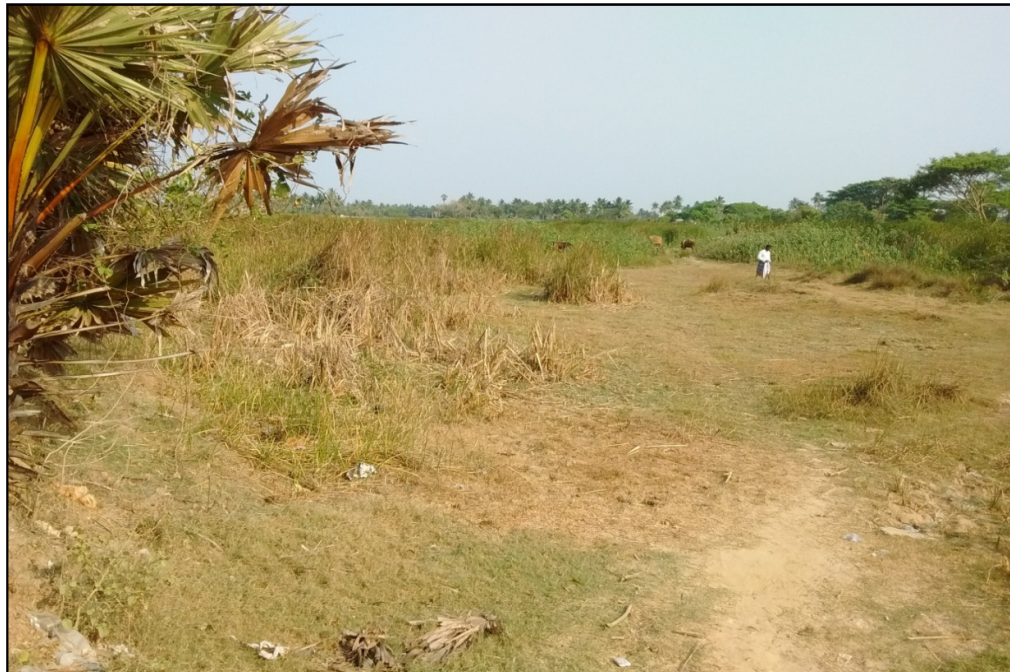
Tank photos before execution of the work:

Components		Condition	Remarks
Tank bund		Average	Low bund height with few vulnerable points; less tree coverage.
Tank bed		Average	Moderately silted; Infested by Ipomea and acacia dead storage throughout the year; no encroachment
Sluices	1	Average	Head wall – no shutter; minor damages; 50% pipe silted
Field channels	1	Poor	More vegetation, obstructions and encroachment
Weir	1	Average	BC Weir; minor damages
Feeder canals	1	Poor	Sitheri vaykkal diversion; the channel from Sitheri vaykkal is in poor condition with more encroachment, vegetation and obstructions
Surplus courses	1	Poor	Silted; more vegetation; moderate encroachment
