केन्द्रीय प्रदूषण नियंत्रण बोर्ड
CENTRAL POLLUTION CONTROL BOARD
पर्यावरण, वन एवं जलवायु परिवर्तन मंत्रालय भारत सरकार
MINISTRY OF ENVIRONMENT, FOREST & CLIMATE CHANGE GOVT. OF INDIA

Sub: Status and action taken report on pollution caused by the operation of M/s Karaikkal Port Private Ltd., Karaikkal, Puducherry - reg

**Status and action taken report on Air Pollution caused by the operation of M/s
Karaikal Port Private Ltd., Karaikal, Puducherry**

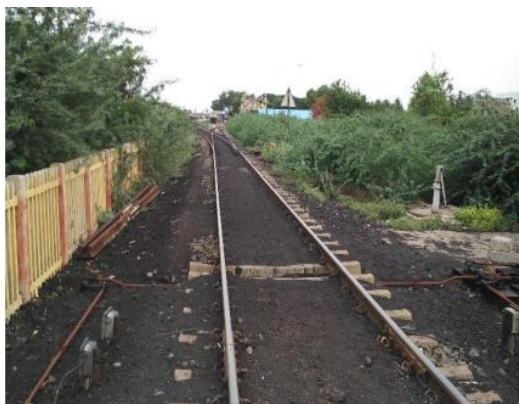
Picture-1

The complainants and the public of Keelavanjore village, Pondicherry also claimed that trees and soil are damaged due to the spread of coal carried through wind from Karaikal Port.

During the field survey by the officials of CPCB & PPCC along with the complainants/public, the coal deposit on the railway track from Karaikkal Port to Nagore Railway station was observed. It is reported that these coal deposits are the leaks from the bottom opening of wagons while moving on the track if the doors are not properly closed. The deposit of a coal on the railway track appears to be an accumulated from many days/ even months added with the present leakages. It seems such leaks are not regularly taking place. No leakages have found during the investigation/monitoring period. However, nowhere on the open land/buildings of the Nagore in Tamil Nadu coal deposit was seen. The extent of damage of trees at Keelavanjore village, Pondicherry indicates that those trees are damaged from many years back.

- To ensure proper closing of the mouth of bottom opening wagons while before leaving the port to avoid coal deposits on the track,
- To replace damaged/torn wind screens from time to time and maintain records,

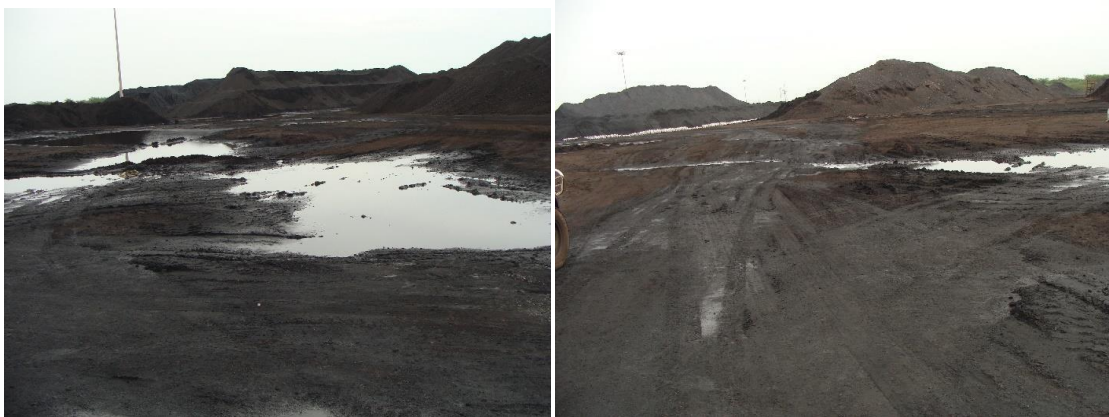
not properly designed and designated. The coal is dumped in the yard haphazardly. There is no labelling about coal yard size, plot identity, quantity, details of order of coal received and name of roads connecting the plots. The condition of coal yard is not scientifically maintained/stored but excess water is applied to suppress the coal fly particles. Application of more water has resulted in stagnation of water mixed with coal/dust powder forms as slurry on the ground particularly around the yards and on roadsides. ***These wetted coal/dust again carried away along with the tyres of heavy vehicles and spreading all over the area.*** The entire floor area and road of the Port is excessively wetted because of water is pumped rather than sprinkling. The photo nos. 4, 5, 6, 7, & 8) below depicts the condition of storage and stagnation of water between coal yards and on roadsides. ***There is no proper slope/barrier for collecting sprinkled and storm water around each yard.***

Photo Nos. 4, & 5: Status of coal storage, water stagnation and undulance of the floor

Application of excess water on coal transfer process & on coal storage areas, water stagnation around the coal yards and on the road connecting coal yard was found. Movement of heavy vehicles from coal yard and on road, further accelerates the deposit of dust mixed with coal on road and spreads on road for longer distance in the premises.

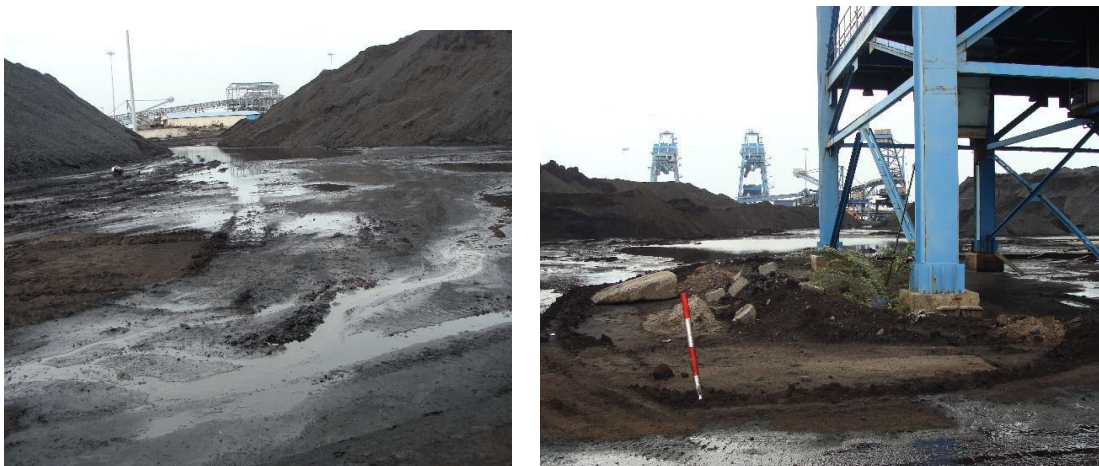
Photo Nos. 6 & 7: Kind of storage of coal and water stagnation on the floor

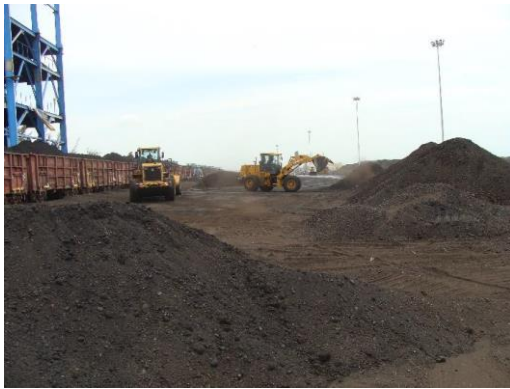
photo no. 8 again lifted for loading into wagons. During unloading onto the ground and loading into the wagons, the spread of fine dust is suppressed by fogging machine and by the sprinklers. This railway siding is located near by the village Keelavanjore at an ariel distance of 0.5 km. There are layers of windscreens, rows of plantations to suppress the dust flying towards Keelavanjore village. Since the coal and roads are excessively wetted, the chance of coal flying is minimized. Coal is transported to customer by Road or by Rail is adequately wetted and covered with Tarpaulin to avoid spillage while in motion as shown in photo no. 9.

Photo No. 8: Loading coal in to wagon/Rake

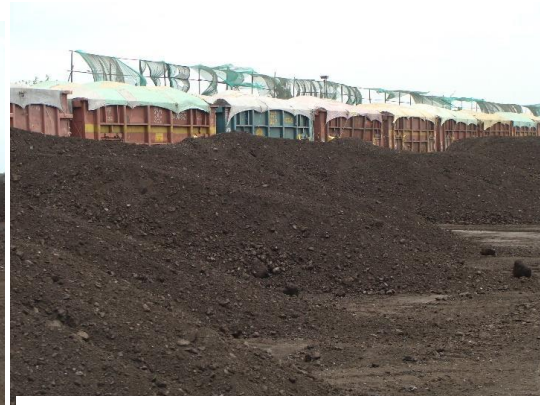
Photo No. 9: Loading of general cargo in to wagon

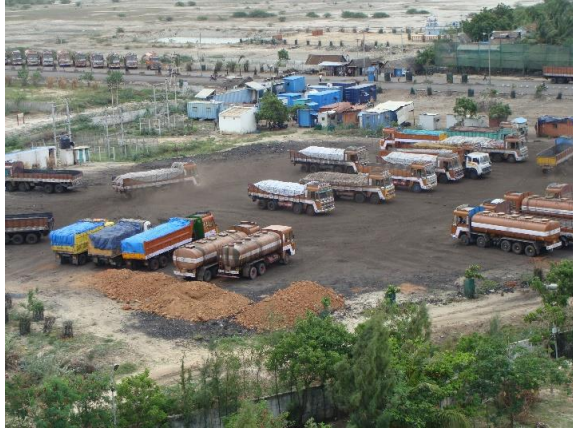
The loose fine soil (about half feet height) from the surface of floor allotted for parking of trucks (photo no.10) nearby the petrol bunk in front of main gate is flying heavily on the movement of every vehicle. Similar kind of loose fine soil found at the tipper maintenance area too (photo no.11). This loose soil not only flies during the movement of heavy vehicles also flies during small wind and spreads lot of dust around the area. Photo nos. 10 & 11 below indicates the condition of vehicle parking area.

Photo No. 10: Loose soil at Parking area nearby the petrol bunk in front of main gate

Karaikal port has allotted parking area near main gate and another at tipper maintenance area. Due to loose soil about half feet on the parking area, lot of soil dust is carried through tires of heavy vehicle towards in & outside the port. Such dry dust deposit found on road from Karaikal main road to custom office of port premises which need to be cleaned regularly. Though, the Karaikal port has provided adequate wind screens, the practice of replacing the torn /damaged is not regular.

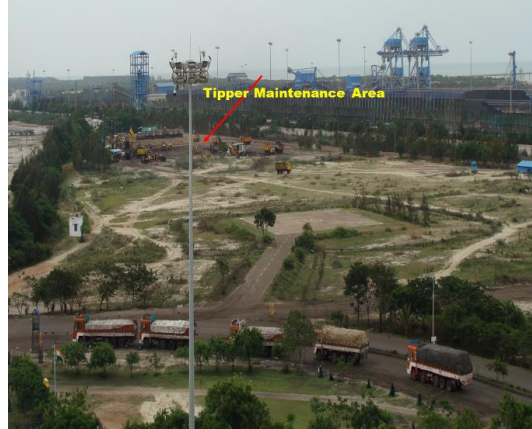
Photo No. 11: Loose soil at Tipper Maintenance area having

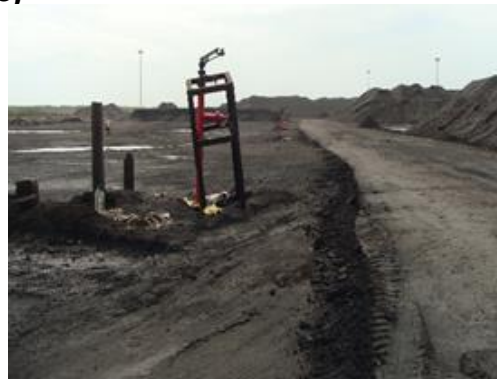
Photo No. 12: sprinkling machine

During inspection, it was asked to operate all the sprinklers, ***none of the sprinklers are sprinkling the water towards the designed distance (30 mt) and the sprinkled water falling at the front portion of the coal yard but not covering the maximum area of coal yard.*** Few sprinklers are pumping the

The sprinklers or fogging machines are used to suppress the dust flying. Due to improper maintenance of sprinklers, the sprinklers pumps the water rather than

water towards coal yard rather sprinkling. Regular maintenance of these sprinklers and more no. of sprinklers needs to be adopted.

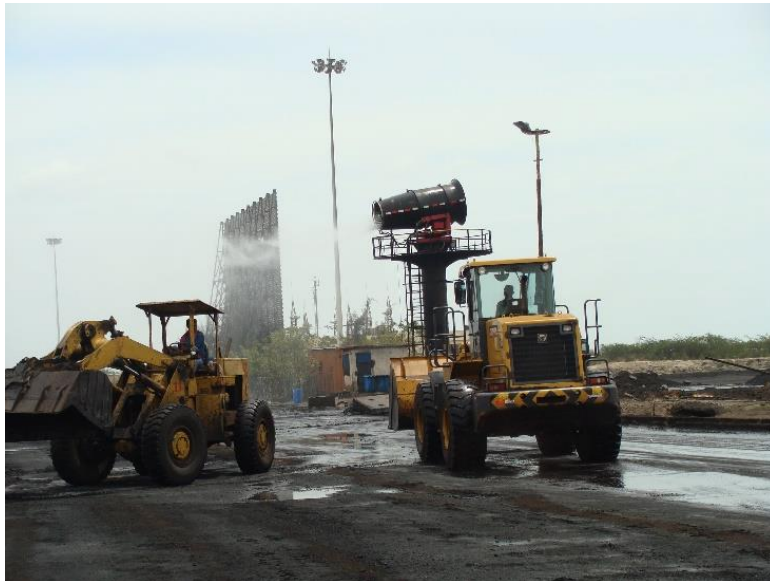
There are two fogging machines (called as DS 150 (mobile) and DSS 200) one is fitted on the mobile vehicle and another is mounted on the raised platform towards North end of the port nearby railway sidings. Both the fogging machines are working effectively.

Photo No. 13: Fogging Machine

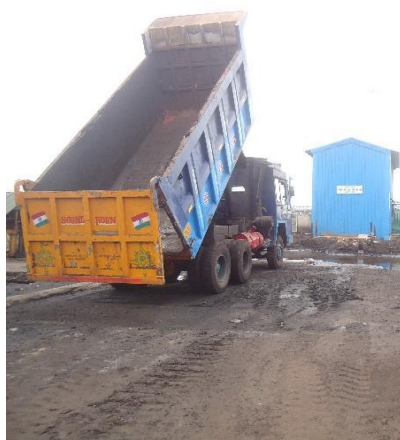
Vehicle washing is connected with 16 KLD **ETP-II**, the floor of vehicle wash is lower than the collection tank of the washed water. Hence, the floor of the vehicle wash is to be elevated so as to washed water will flow to collection tank on gravity instead of stagnating /overflowing in front of ETP-II.

Photo No. 14: ETP-II

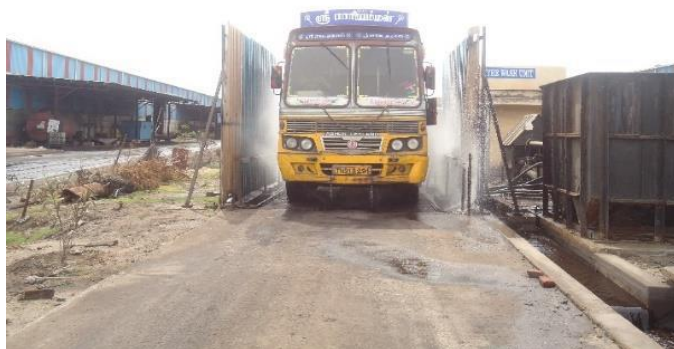
Automatic tyre washing system is working well but since the lot of wet dust is already deposited on the roadside, the cleaned tyre is again moving on dirty road and the effectiveness of tyre cleaning become ineffective.

Photo No. 15: Vehicle washing and ETP-I

However, the washed water is fed to 25 KLD **ETP-I** and after filtration and settling, the suppurated water again reused for the same purpose of cleaning.

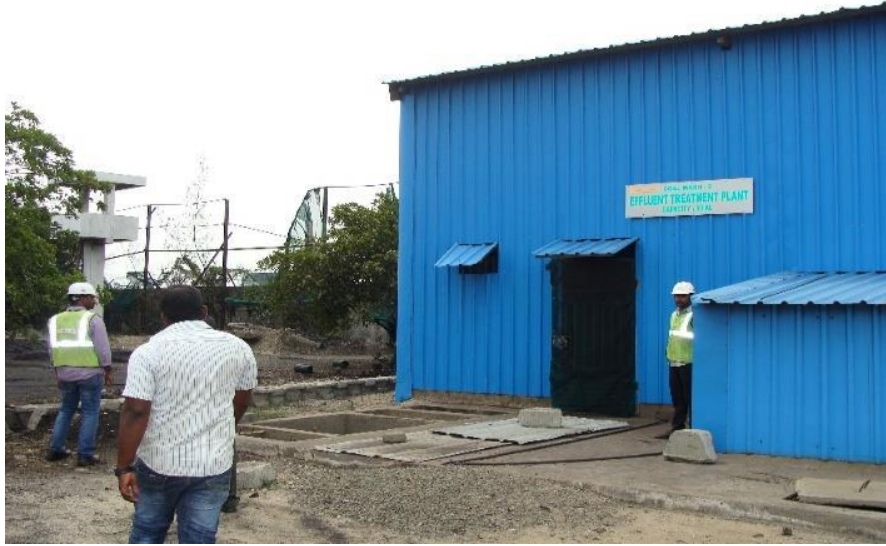
The coal wash water and storm water are routed through open channel to ETP-III of the 50KLD capacity. The collection tank of the ETP-III is not adequate to receive both wash and storm waters.

Photo No. 16: ETP-III:50KLD

However, the storm water at all location are not properly centralized. The treated water again reused for coal washing and the slurry taken to the storage area.

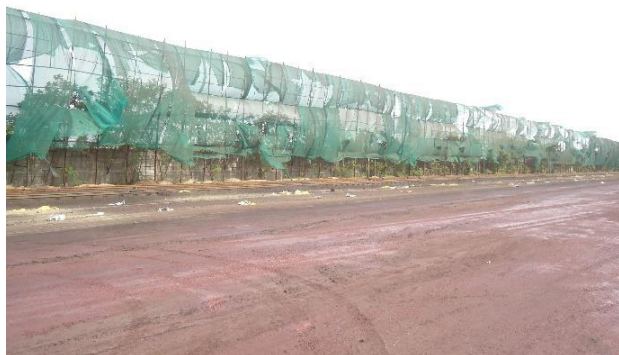
Dust separation screens made of high quality polymer meshes have been provided adjacent to the coal yard towards the road no. 2. to a height of 15 m of length 1.1 km to acts as primary wind barrier and similar quality nets have also been provided on the other side of road no. 2 towards rail way track to a height of 09 or 12 m of length 1.5 km, to act as a secondary barrier. It is observed that most of the windscreens are damaged and not practiced to replace periodically. Photo nos.17 & 18 below indicates extent of damage.

Photo No. 17: Wind Screen second barrier from coal yard towards railway track

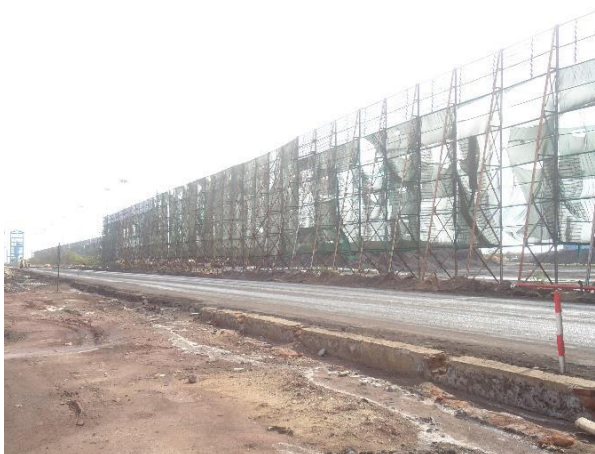
Photo No. 18: Wind Screen first barrier from Coal yard

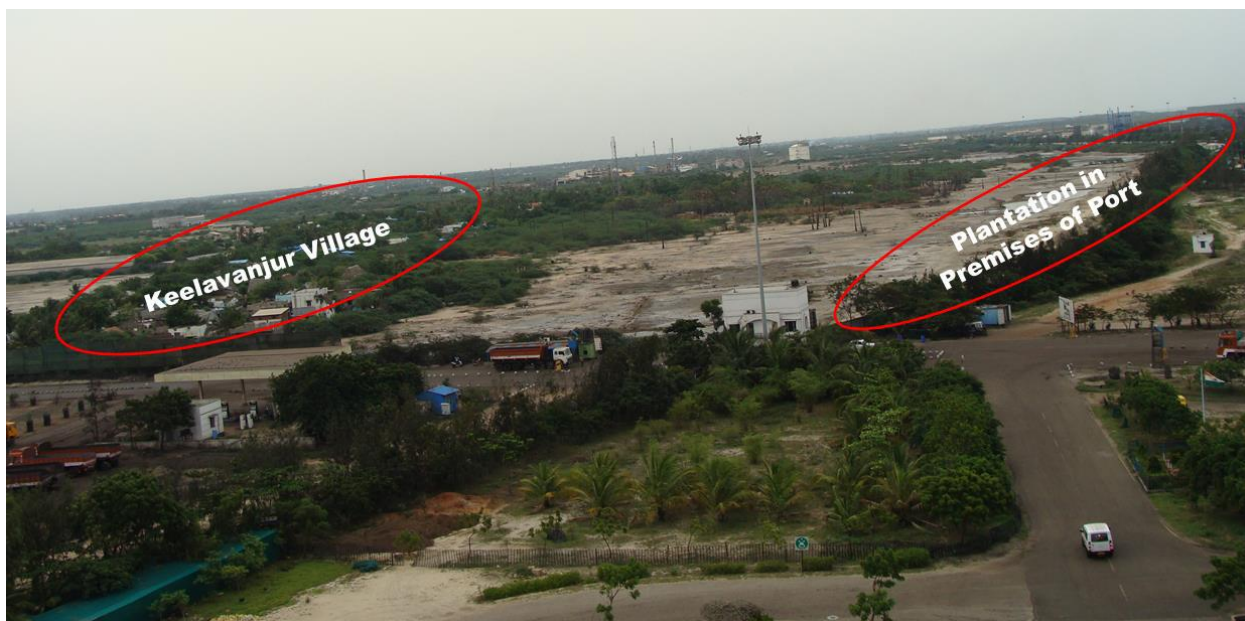
(I) Three tier system of plantation (Photo no. 19) is developed towards Keelavanjore village in which the first tier is Casurina, second tier is Ashoka or Pencil tree and the third tier is Pungam, Badam, Poovarasuetc to act a third tier wind barrier. This are the effective dust barriers towards Keelavanjore village

Photo No. 19: Plantation acting as third barrier from coal yard towards Keelavanjore village, Pondicherry

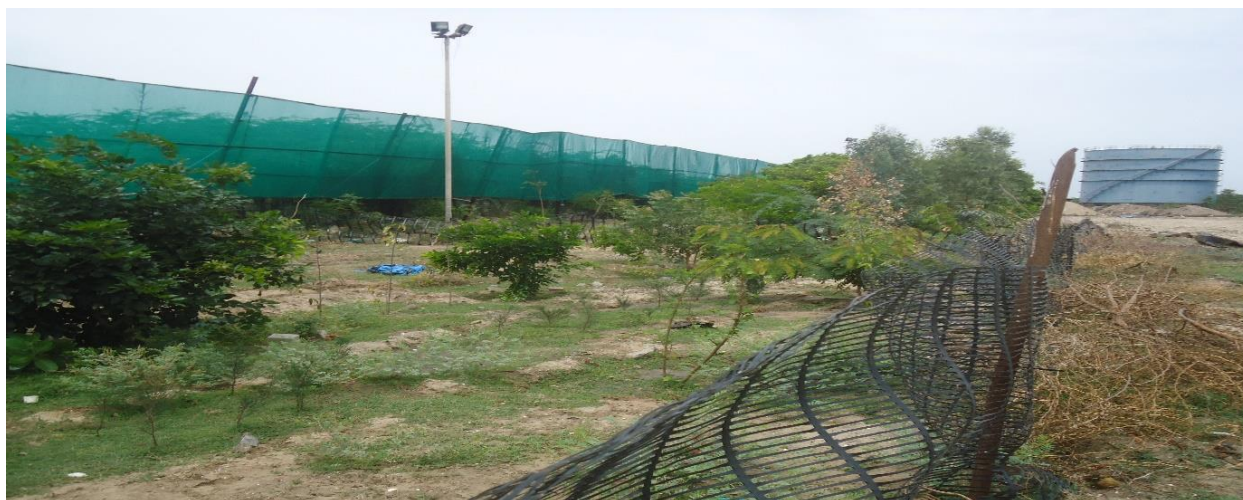
(m) Two tire system of trees and wind screen (Photo no. 20) are developed at the tank form area which eliminate the dust emission towards Nagore area of Tamil Nadu

Photo No. 20: Wind screen towards Nagore area of Tamil Nadu
