BASELINE REPORT

NAFCC PROJECT

INTEGRATED SURFACE WATER MANAGEMENT THROUGH CLIMATE CHANGE ADAPTATION IN U.T. OF PUDUCHERRY

Government of Puducherry

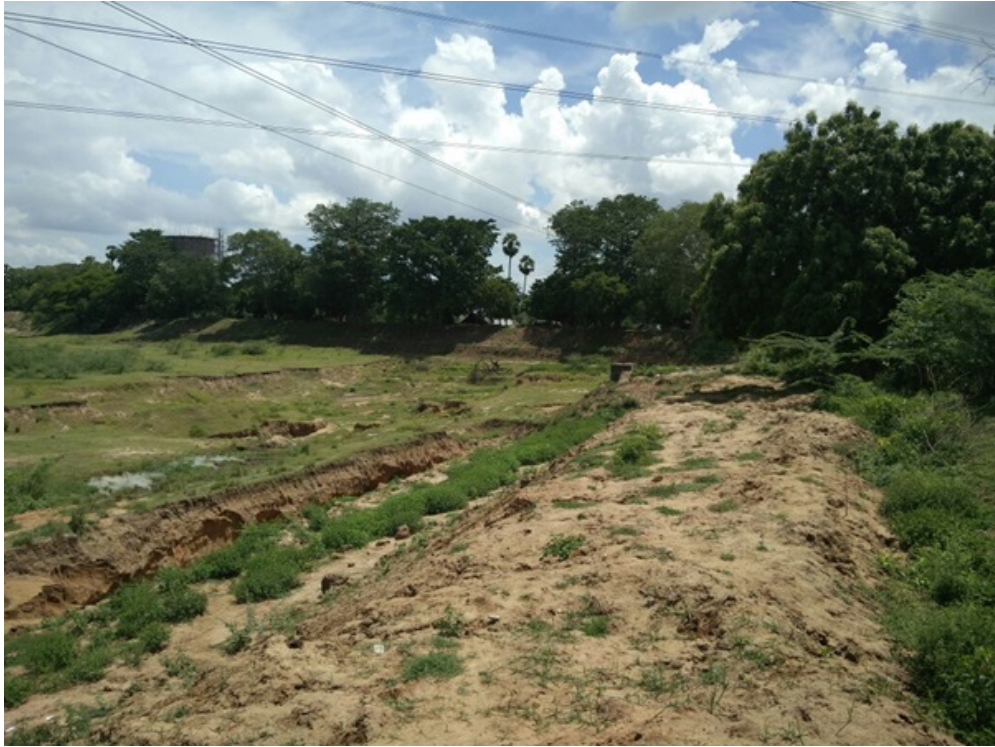
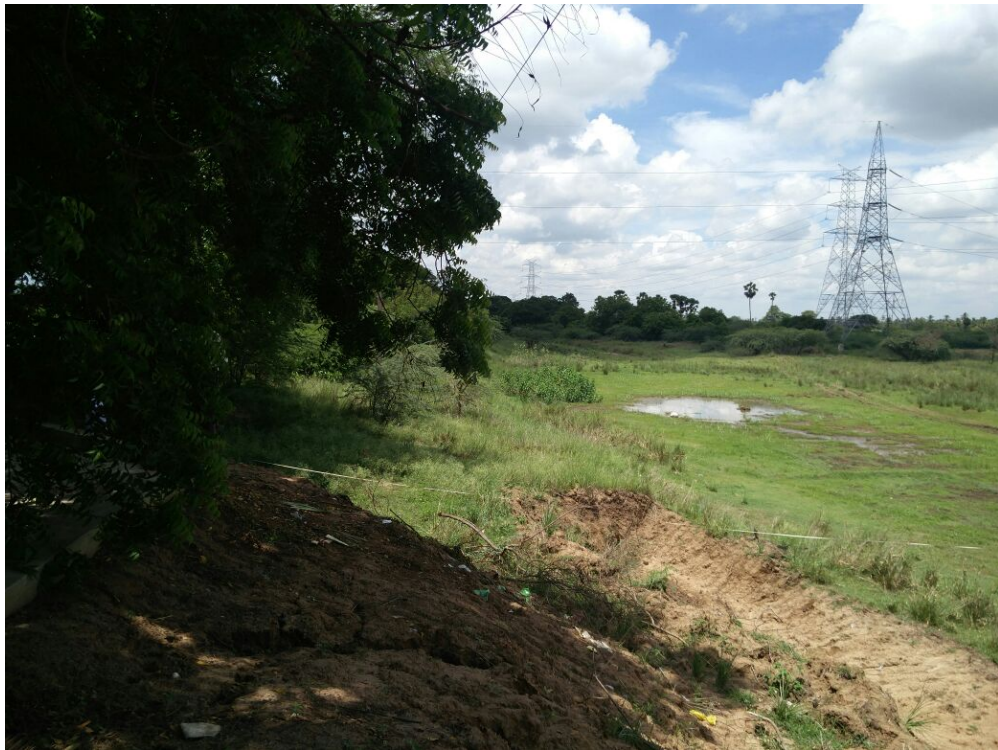
Tank photos before execution of the work:

Components	Condition	Remarks	
Tank bund	Average	Metalled road for full length at toe and it has few weak points as per farmers' view	
Tank bed	Poor	Heavily silted and insignificant encroachment; partly infested with ipomea	
Sluices	1	Average	Weir vent – Weak. to be repaired
	2	Good	Head and wing wall – leaky; shutter exists; pipe blockage 50%
	3	Good	Head and wing wall – leaky; shutter exists; pipe blockage 50%
	4	Good	Head wall – shutter exists; pipe blockage 10%
	5	Good	Head wall – leaky; shutter exists; pipe blockage 50%; minor damages

6	Average	Head wall – no shutter; leaky; minor damages; pipe blockage 90%
Field channels	1	Average	Line channel – more vegetation; silted
	2	Average	Line channel – less vegetation; silted
	3	Average	Line channel – less vegetation; silted
	4	Good	Earthen channel – less vegetation; less encroachment
	5	Good	Lined channel – less vegetation
	6	Poor	Earthen channel – more encroachment; more vegetation; silted
Weir	1	Average	BC – leaky; minor damages
Feeder canals	1	Average	Suttukeni vaykkal – less encroachment
Surplus courses	1	Average	Sluice 1 field channels acts as surplus channel’ which is not sufficient during the surplus periods due to its present width of 0.3m

Works (on priority)	What is required?
Tank bed	Removal of weeds and desiltation
Tank bund	Widening and strengthening
Field channels	Clearing and repairing the lined channels and lining for the remaining portion; it will help reducing the drainage problem
Feeder canals	Clearing
Community well	Small farmers opt for community well and they are willing to contribute

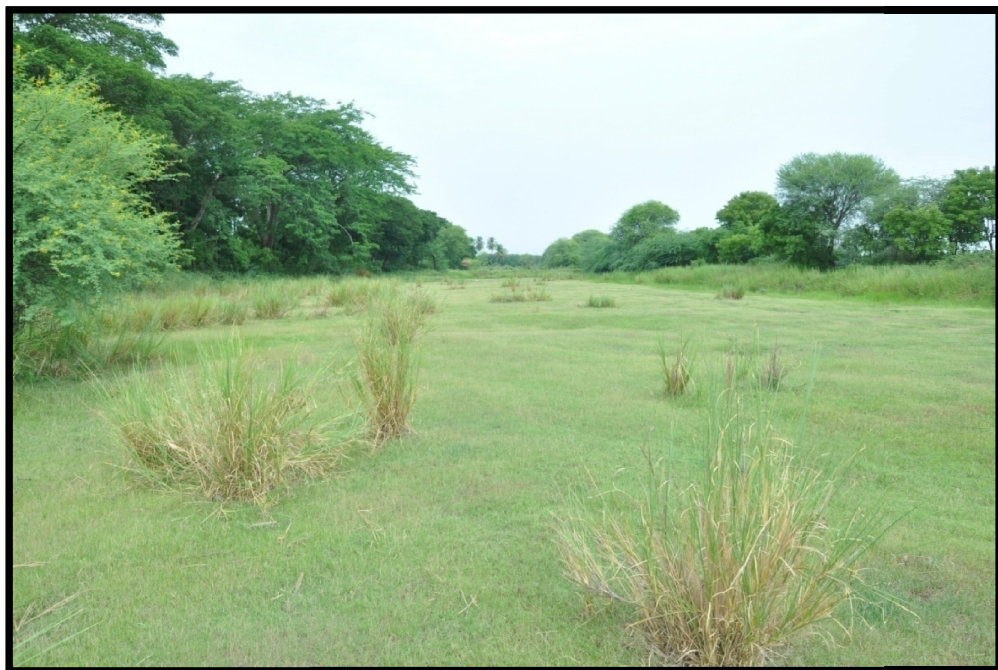
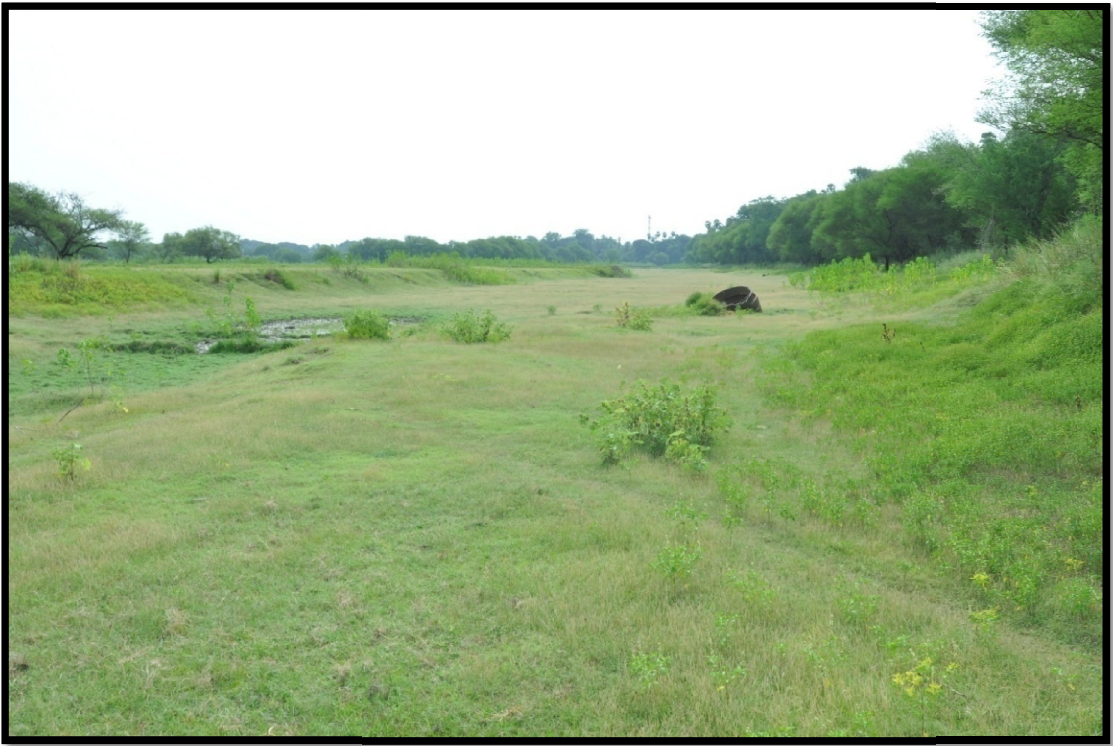
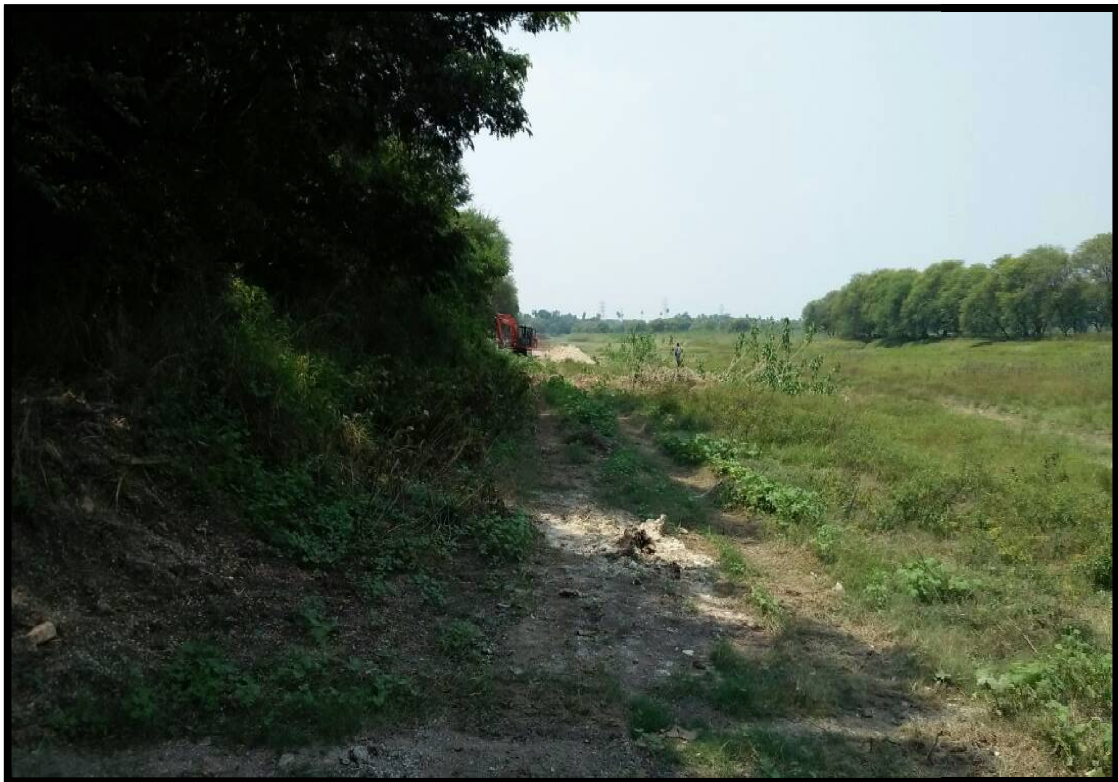
Tank photos before execution of the work:

Components	Condition	Remarks
Tank bund	Poor	Four vulnerable points; not in designed dimension; no approach road on top
Tank bed	Poor	Heavily silted and insignificant encroachment; infested with ipomea
Sluices 1	Average	Head wall – no shutter; leaky ; piping problem; pipe blockage 50%; minor damages
2	Poor	Head wall –no shutter ; leaky; pipe blockage 75% major damages

3	Average	Head and wing wall; no shutter leaky; pipe blockage 80%; minor damages
	4	Average	Head wall – no shutter; leaky; pipe blockage 100% minor damages
Field channels	1	Poor	Earthen channel with more vegetation and obstruction; more encroachment; silted
	2	Poor	Earthen channel with more vegetation and obstruction; more encroachment; silted
	3	Poor	Earthen channel with more vegetation and obstruction; more encroachment; silted
	4	Poor	Earthen channel with more vegetation and obstruction; more encroachment; silted
Weir	1	Average	BC- Calingulah – minor damages to dam stones
Feeder canals	1	Poor	Suttukeni periya eri surplus channel – encroached, more vegetation
	2	Poor	Vidur channel – no supply for the past ten years due to encroachment, siltation and vegetation
Surplus courses	1	Poor	Leads to Kuppam tank (partly) and the rest flow to Suttukeni vaykkal – encroached, more vegetation; silted up

Works (on priority)	What is required?
Tank bed	Desiltation
Sluice	Reconstruction and shutters provision
Tank bund	Strengthening and standardisation
Feeder canals	Removal of encroachment and clearance of Vidur channel
Surplus courses	Clearing and removal of encroachment

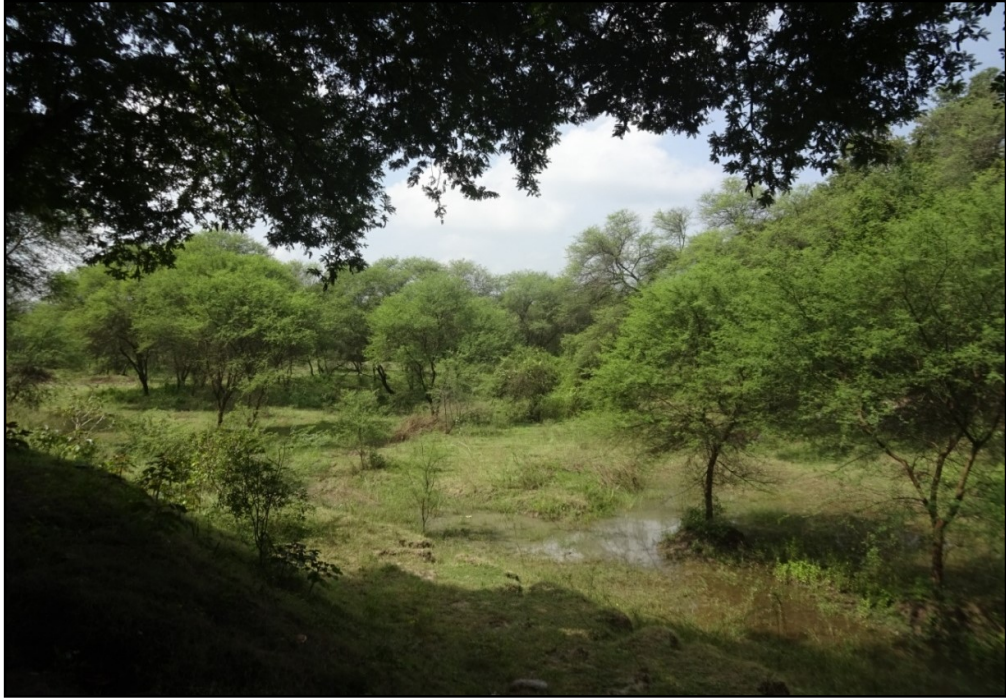
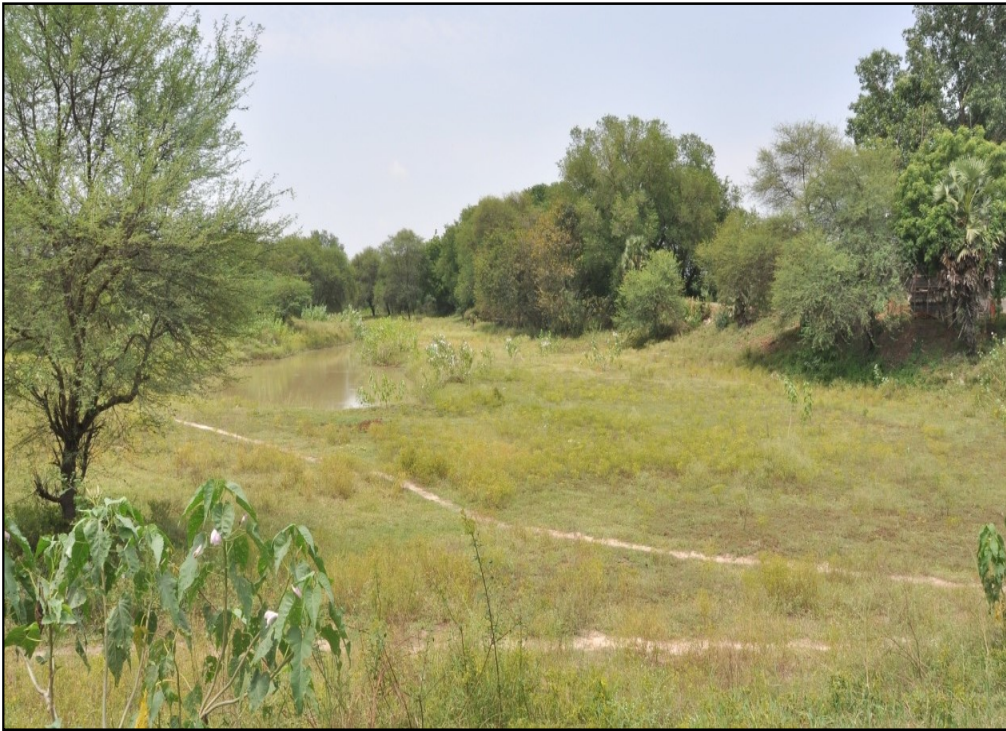
Tank photos before execution of the work:

Components	Condition	Remarks
Tank bund	Average	BT road formed in the offshore bund
Tank bed	Average	Moderately silted and less encroachment
Sluices 1	Average	Sluice under repair
Field channels 1	Poor	Earthen channel with less vegetation and obstruction; more encroachment; silted
Weir 1	No	No weir, cut opening bund to release water in practice
Feeder canals 1	Good	Branch channel from Tirukkanur peria eri feeder channel from vikravandy main channel- recently desilted
Surplus courses 1	No	No surplus channel

Works (on priority)	What is required?
Tank bed	Desiltation
Tank bund	Standardisation and needs a cart track
Field channels	Clearing and lining
Diversion structure	Inlet shutter is damaged and needs to be repaired.
Community well	New community well to supply water to small farmers. These are more than 30 farmers having less than 1 ha of land.
Sluice	Sluice arrangement needs to be replaced

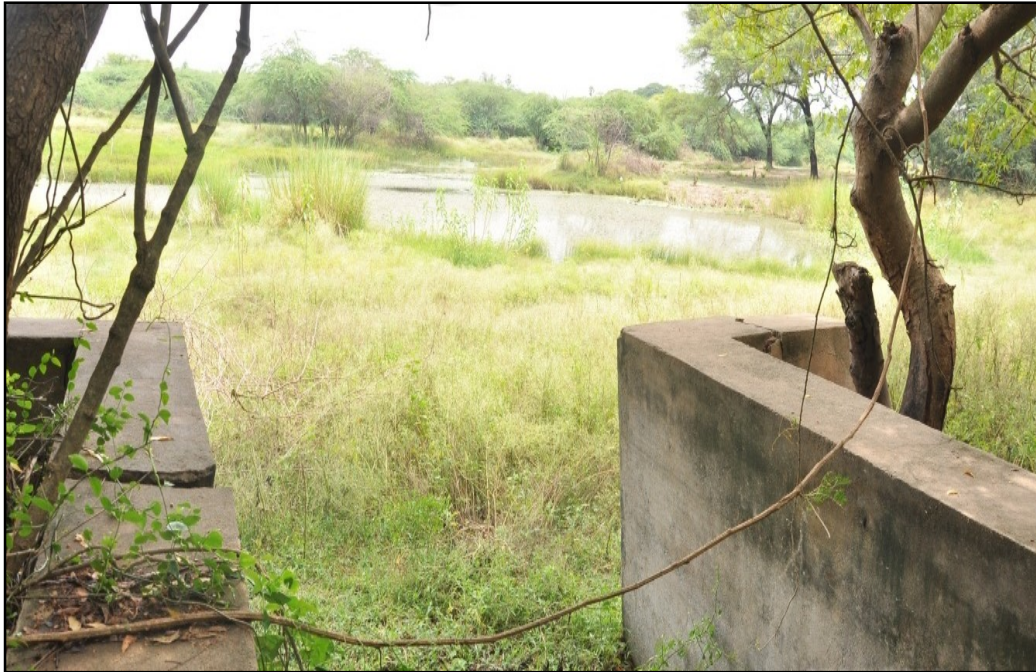
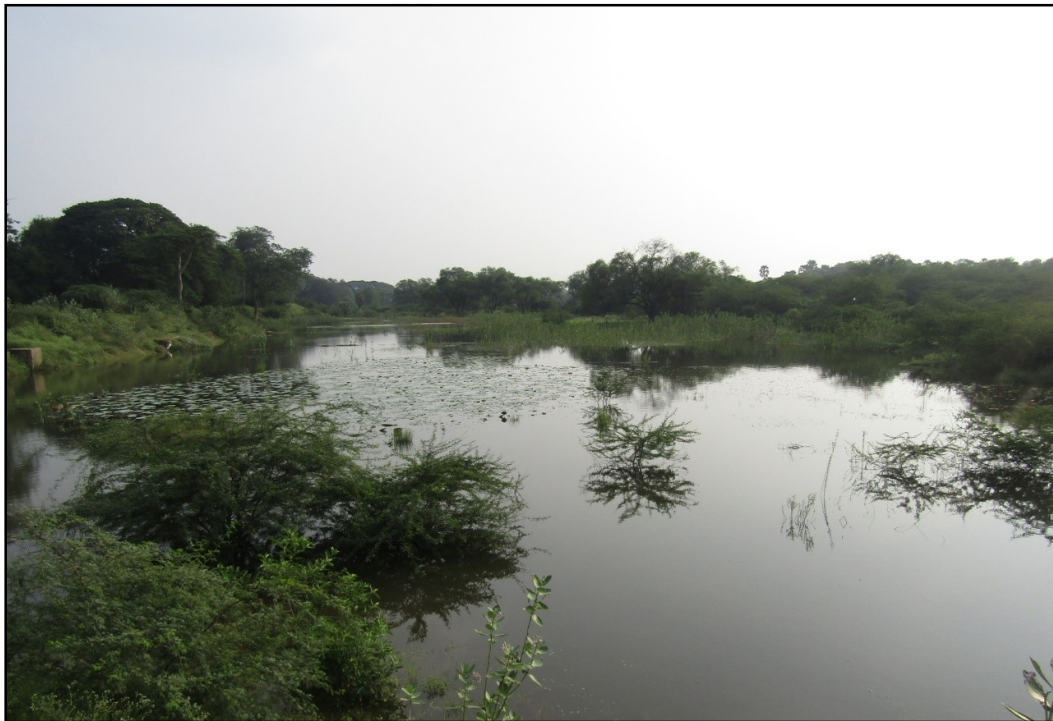
Tank photos before execution of the work:

Components		Condition	Remarks
Tank bund		Average	Partly metal road, at toe; not to the standard height and width.
Tank bed		Poor	Heavily silted and less encroachment;
Sluices	1	Poor	Heavily damaged
	2	Poor	Heavily damaged
	3	Poor	Heavily damaged
Field channels	1	Poor	Earthen channel with more vegetation and obstructions; more encroachment; silted
	2	Poor	Earthen channel with more vegetation and obstructions; more encroachment; silted
	3	Poor	Earthen channel with more vegetation and obstructions; more encroachment; silted
Weir	1	No	No weir, sluice acts as surplus channel
Feeder canals	1	Good	Tirukkanur peria eri feeder channel from Vikravandi channel – recently cleared
Surplus courses	1	No	Over the fields

Works (on priority)	What is required?
Tank bed	Desiltation
Tank bund	Standardisation
Sluice	Reconstruction and shutters provision
Field channel	Clearing and lining

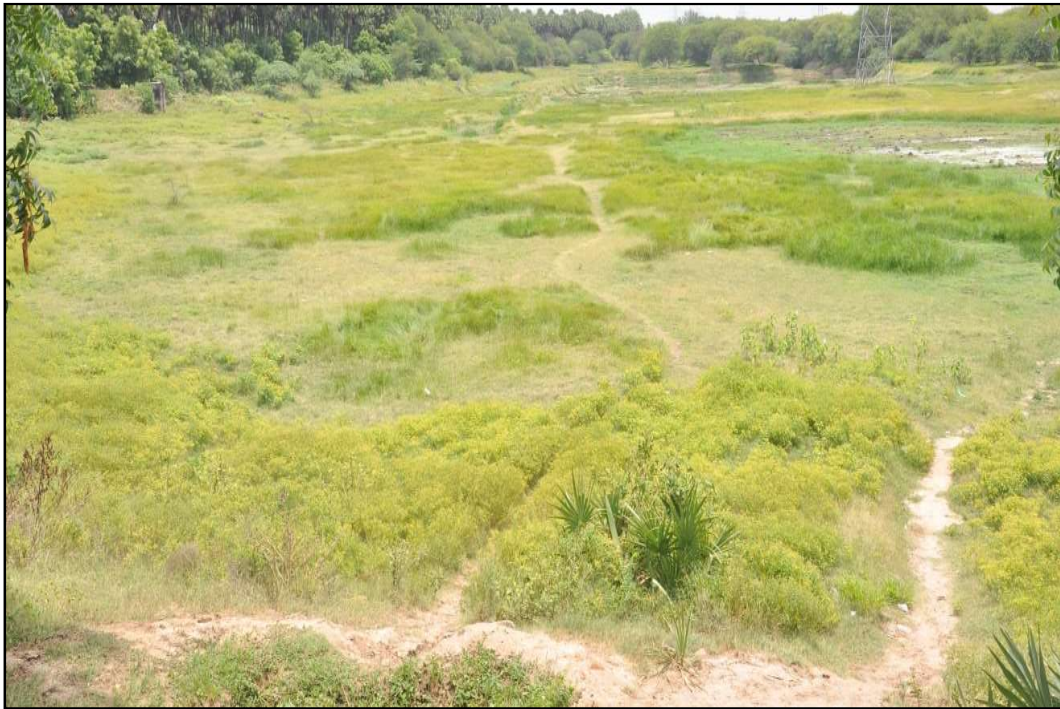
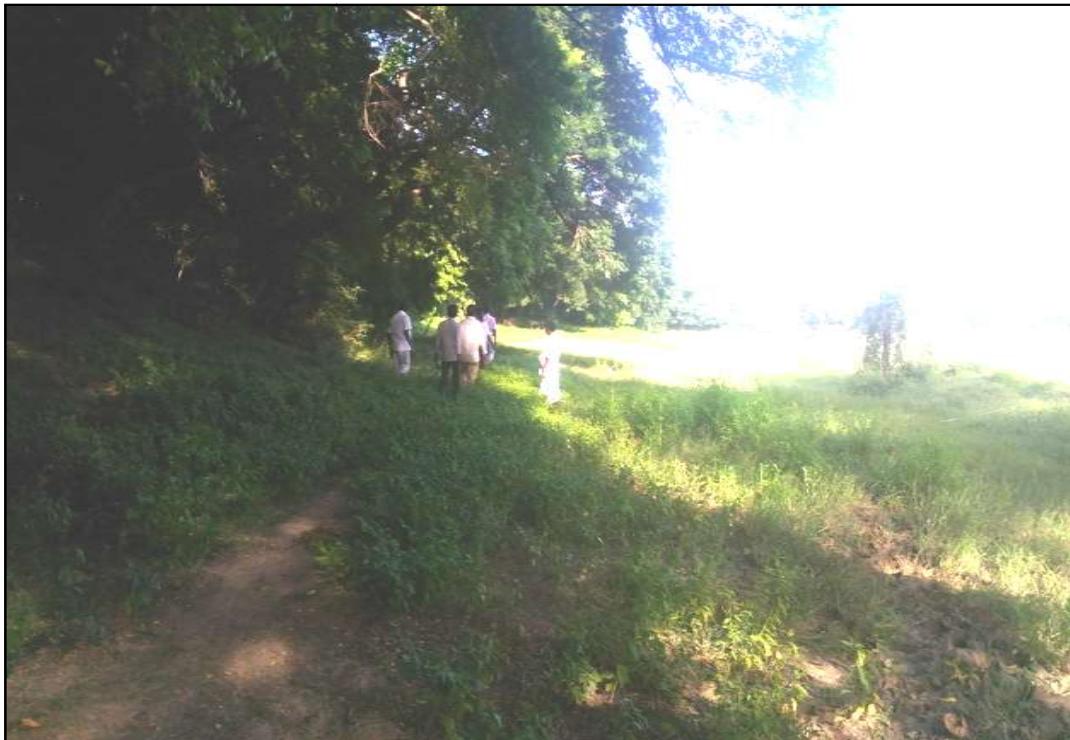
Tank photos before execution of the work:

Components		Condition	Remarks
Tank bund		Average	Partly metal road, at toe;
Tank bed		Poor	Heavily silted
Sluices	1	Poor	Heavily damaged
	2	Poor	Heavily damaged
	3	Poor	Heavily damaged
	4	Poor	Heavily damaged
	5	Poor	Heavily damaged
Field channels	1	Good	Earthen channel with more vegetation and obstructions; more encroachment; silted
Weir	1	Poor	Heavily damaged
Feeder canals	1	Good	Recently desilted
Surplus courses	1	Good	Over the fields

Works (on priority)	What is required?
Tank bed	Desiltation
Tank bund	Standardisation
Sluice	Reconstruction and shutters provision
Field channel	Clearing and lining

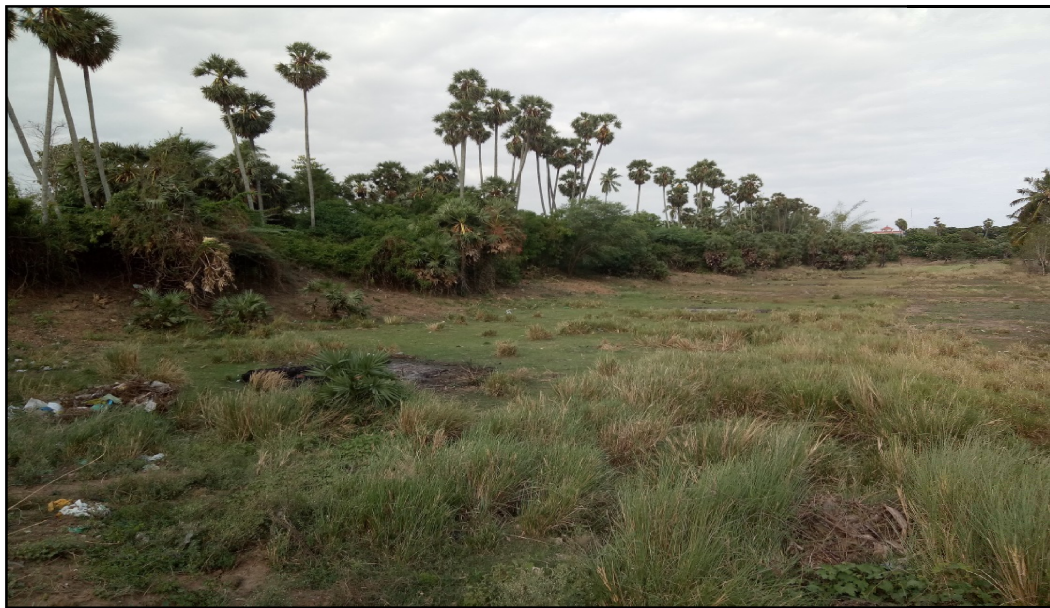
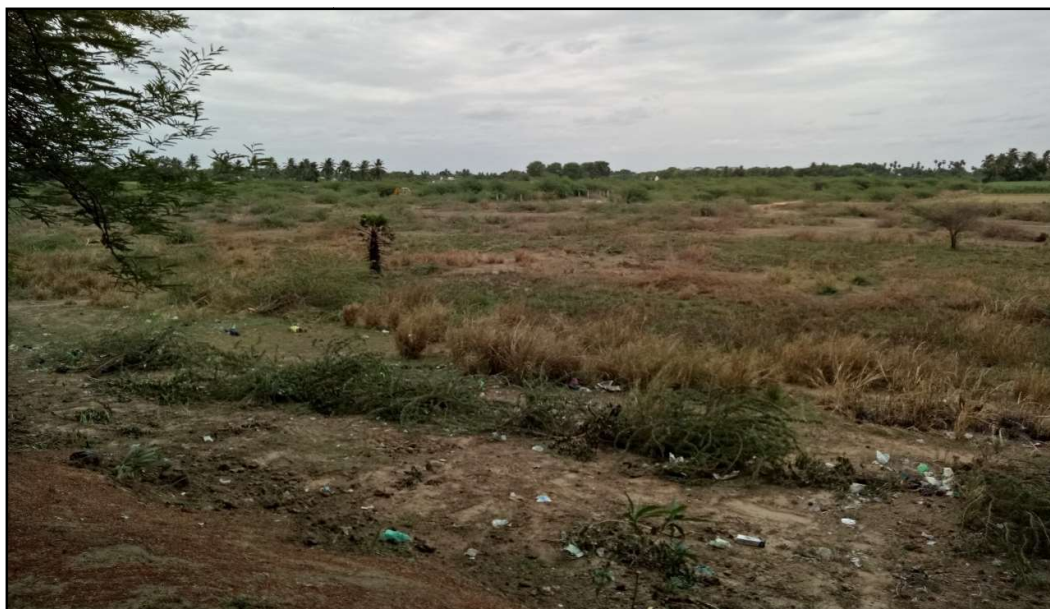
Tank photos before execution of the work:

Components	Condition	Remarks
Tank bund	Average	Both the flank ends are weak with vulnerable points (broken points), metal road on toe (partly).
Tank bed	Poor	Heavily silted;
Sluices 1	Poor	Head wall – it is located in the right flank end and u/s of the small bund across the tank water spread area, which has balancing regulator (not included in the PWD list) – no shutter, heavily damaged; not in use for the past five years.
2	Average	Head wall – no shutter; less leaky; pipe blockage 20%; and minor repair
3	Good	Head & wing wall; plug and rod exists – no leakage; pipe blockage 20% and minor repair
Field channels 1	Poor	Earthen channel with more vegetation and obstructions; less encroachment; silted
2	Poor	Just downstream side Manakkula Vinayagar Engineering collage were constructed – no channel
3	Poor	Earthen channel with more vegetation and obstructions; less encroachment; silted
Weir	No weir	Sluices act as weir

Works (on priority)	What is required?
Tank bed	Desiltation
Diversion structures	Reconstruction and regulator provision
Feeder canals	Clearing of channels
Field channel	Clearing lining
Tank bund	Strengthening and Standardisation
Community well	New well
Sluices	Reconstruction and shutters provision

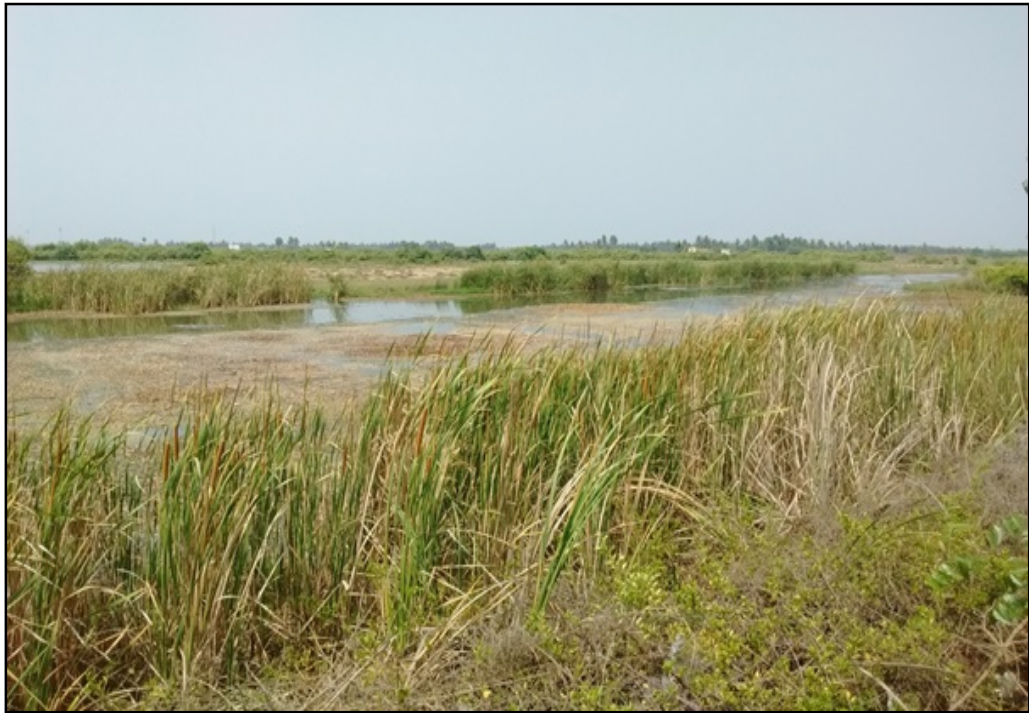
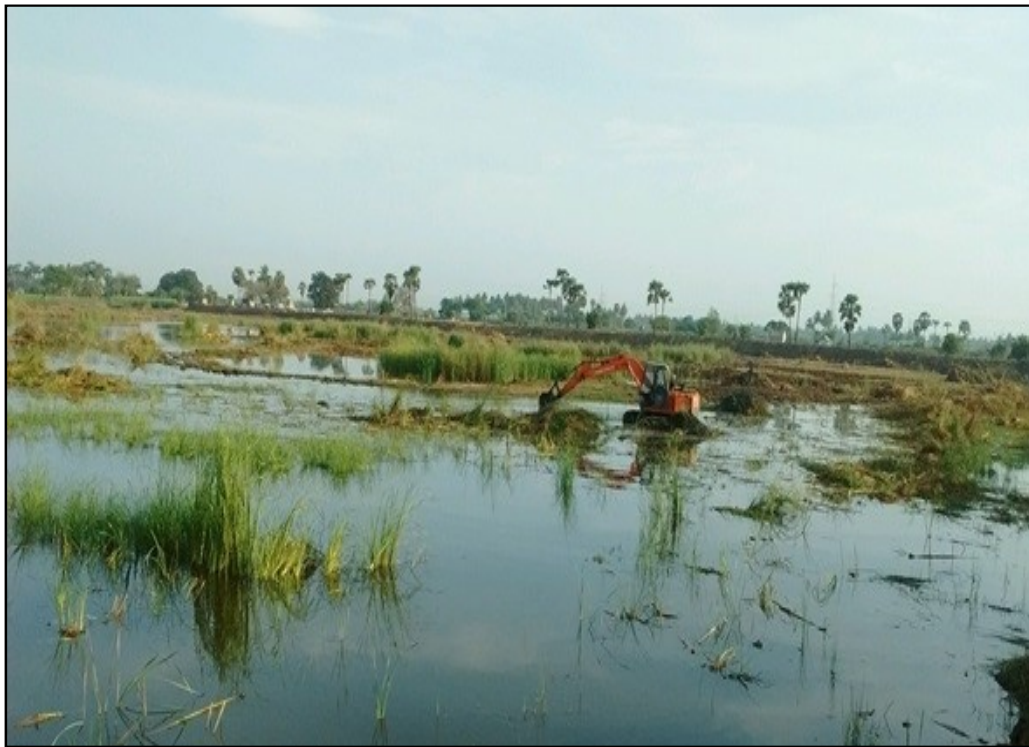
Tank photos before execution of the work:

Components		Condition	Remarks
Tank bund		Average	Low bund height with few vulnerable points; less tree coverage.
Tank bed		Average	Moderately silted; Infested by Ipomea and acacia dead storage throughout the year; no encroachment
Sluices	1	Average	Head wall – no shutter; minor damages; 50% pipe silted
Field channels	1	Poor	More vegetation, obstructions and encroachment
Weir	1	Average	BC Weir; minor damages
Feeder canals	1	Poor	Sitheri vaykkal diversion; the channel from Sitheri vaykkal is in poor condition with more encroachment, vegetation and obstructions
Surplus courses	1	Poor	Silted; more vegetation; moderate encroachment

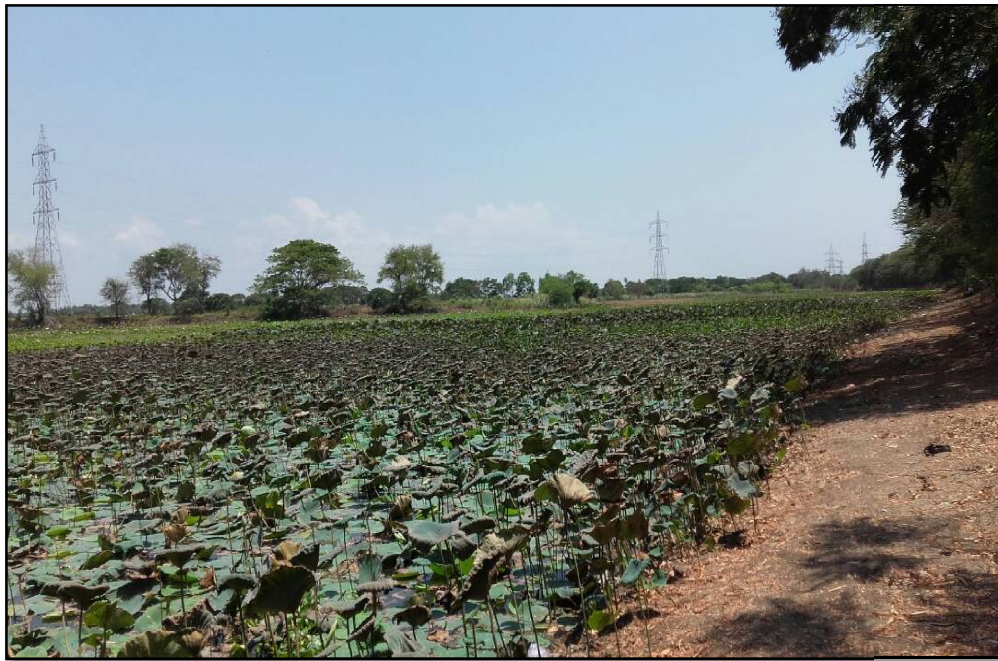
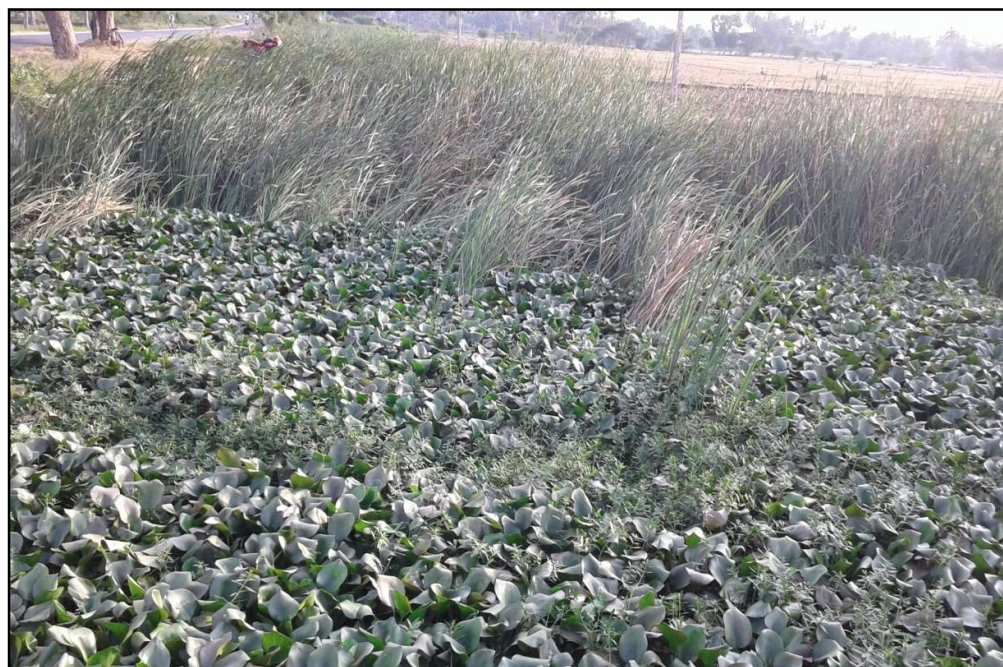
Tank photos before execution of the work:

Components	Condition	Remarks
Tank Bund	Good	Metal road top
Tank Bed	Poor	Moderate siltation; Infected by Ipomea; less encroachment
Sluices	1	Poor
	2	Good
Field channels	1	Average
	2	Poor

Weir	1	No	Sluice 2 acts as a weir
Feeder canals	1	Poor	Bahur Cherry madagu vaykkal- encroached, reduced width; silted
Surplus courses	1	No	As in field channels 2, It joins with Manapattu pudu thangal surplus course

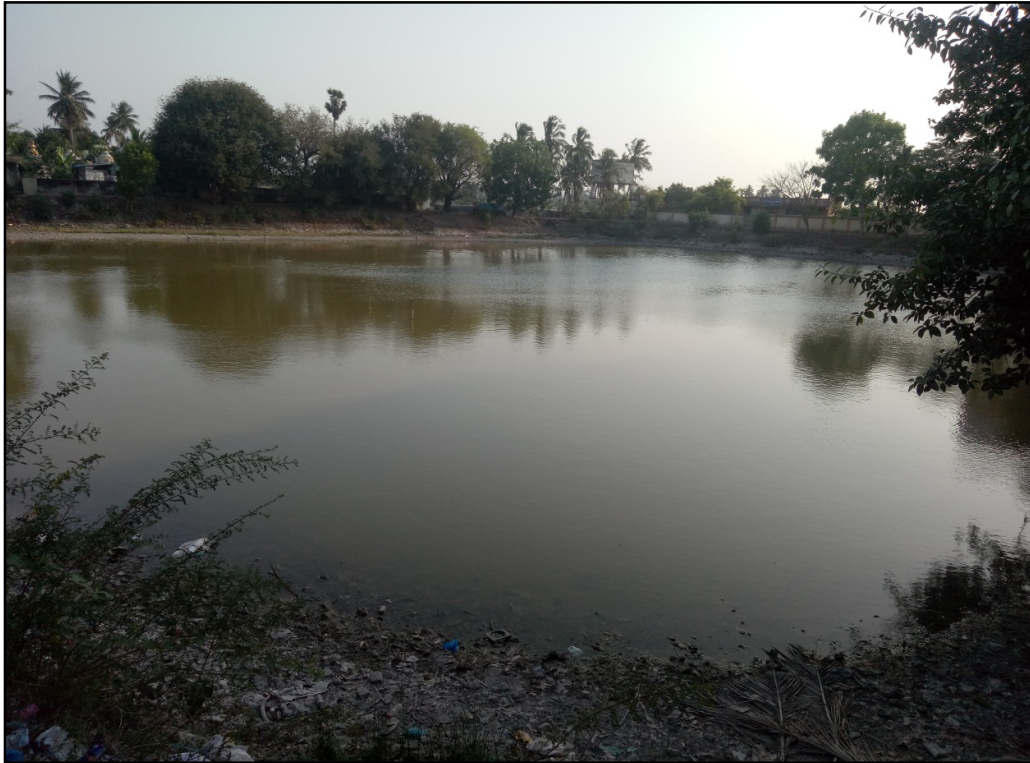
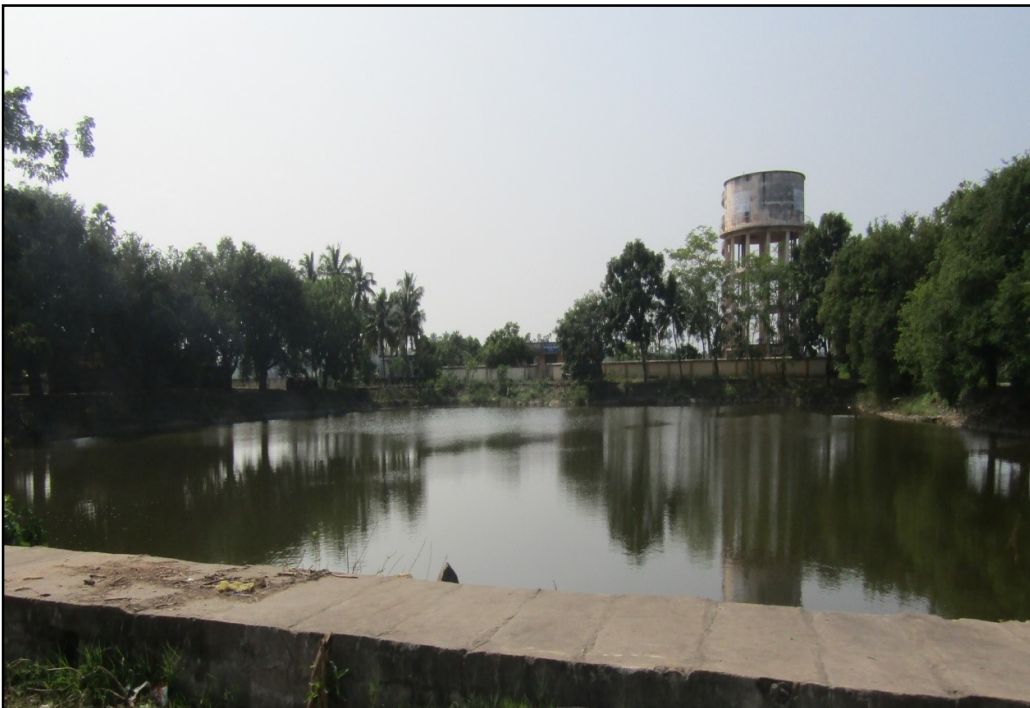
17. Pond photos before execution of the work:

10. Source of water: Rain
11. Status of bund? Bunds were built with stones and found to be in damaged condition
 - i. Is strengthening required? Yes
 - ii. Are planting trees possible? Yes

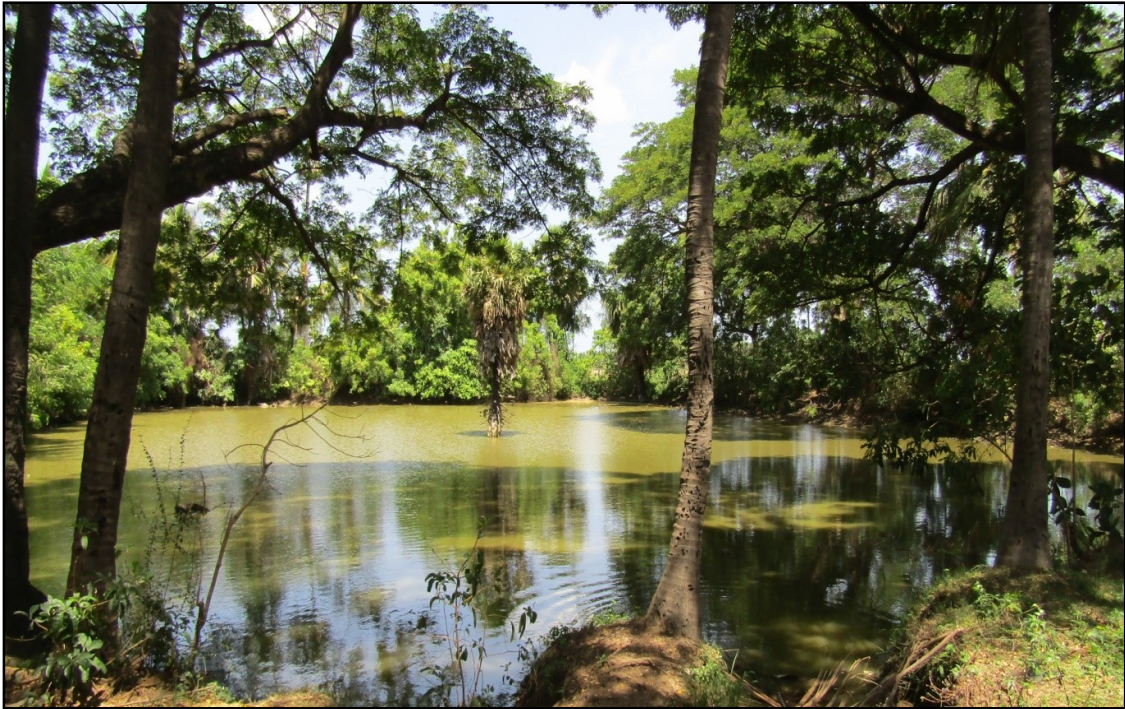
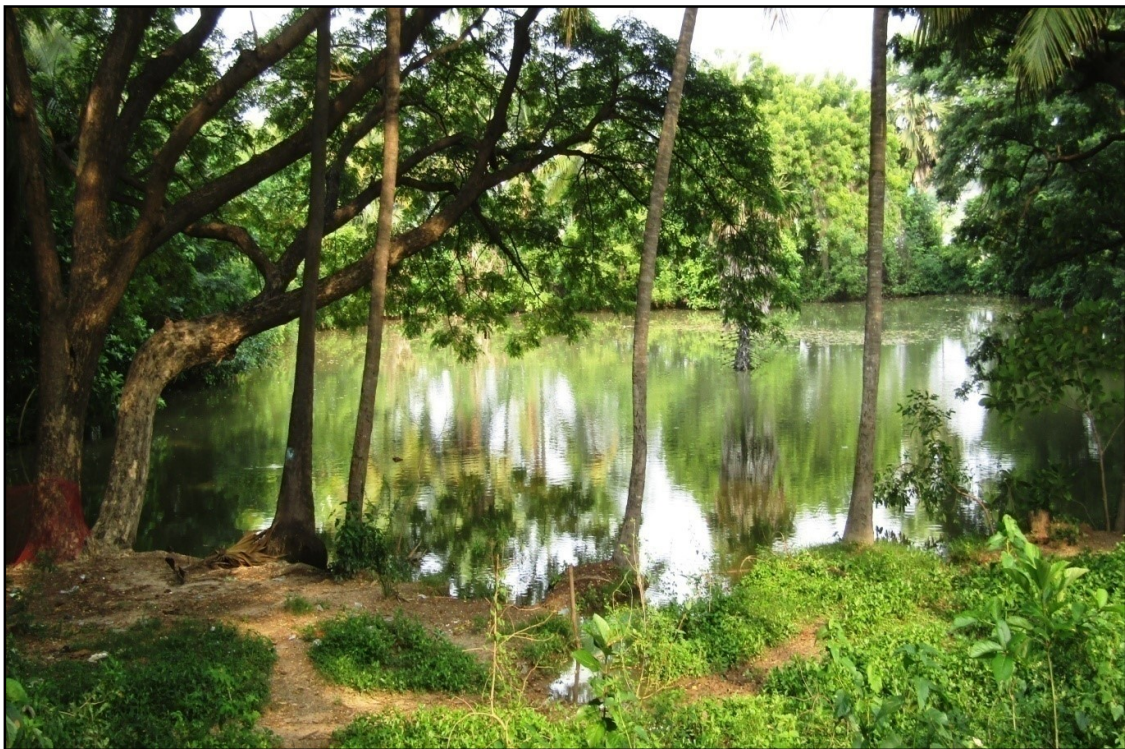
17. Pond photos before execution of the work:

b. Inlet channel (Channel from Kudiyiruppupalayam tank)
11. Status of bund? No proper bunds were found
 - i. Is strengthening required? Yes
 - ii. Are planting trees possible? Yes

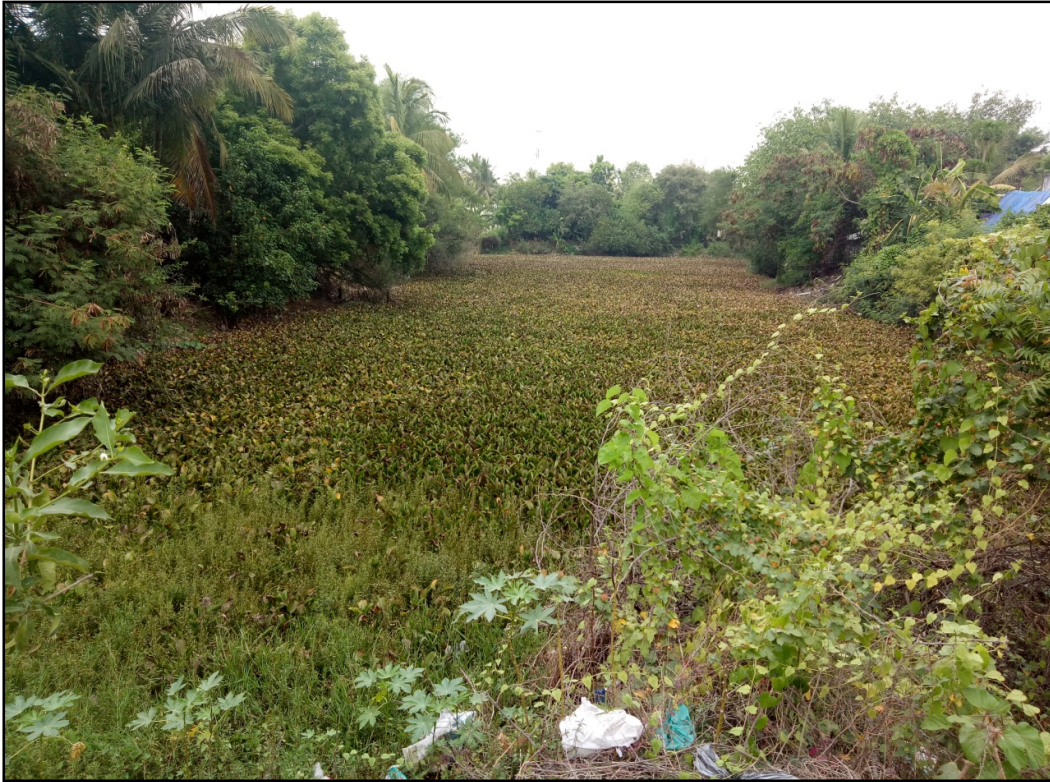
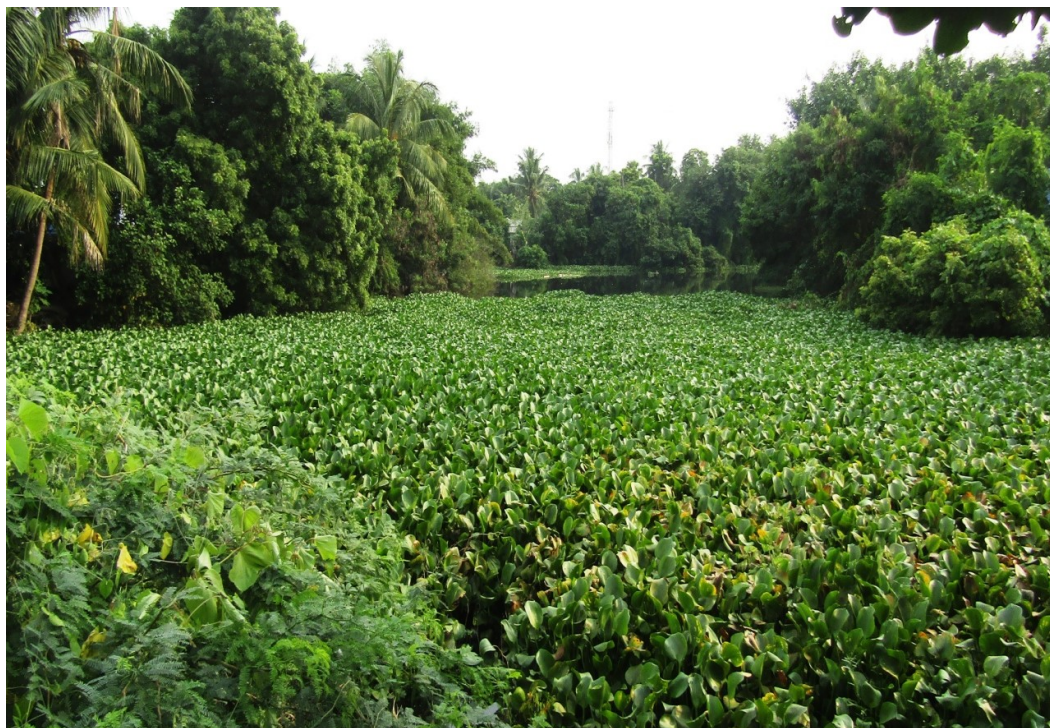
17. Pond photos before execution of the work:

1. Commune: Bahour Commune Panchayat
2. GPS coordinates: 11° 49' 57.53" N 79° 45' 04.13" E
3. Dimension: Side 1: 419 ft.,
Side 2: 172.75 ft.,
Side 3: 171 ft.,
Side 4: 418 ft.
4. Total Area: 71,932 sq. ft.
5. Depth of pond: Depth 1: 7 ft.,
Depth 2: 8 ft.,
Depth 3: 6 ft.
6. Is water available: Yes, if yes, water level from top: 3 ft.
7. Status of Eutrophication: Fully present
8. Is water available throughout the year: Yes
9. Are inlet and outlet available: Yes, if yes, are they alive? Yes
10. Source of water: Rain
11. Status of bund? No proper bunds were found, fully covered with bushes
 - i. Is strengthening required? Yes
 - ii. Are planting trees possible? Yes
12. Do people use the pond: Yes
13. Is waste water discharged inside the pond? No
14. Is it given for lease? No.
15. Whether desilted earlier? Yes. 20 years back.
16. No of trees around the bund: 30 trees alive.

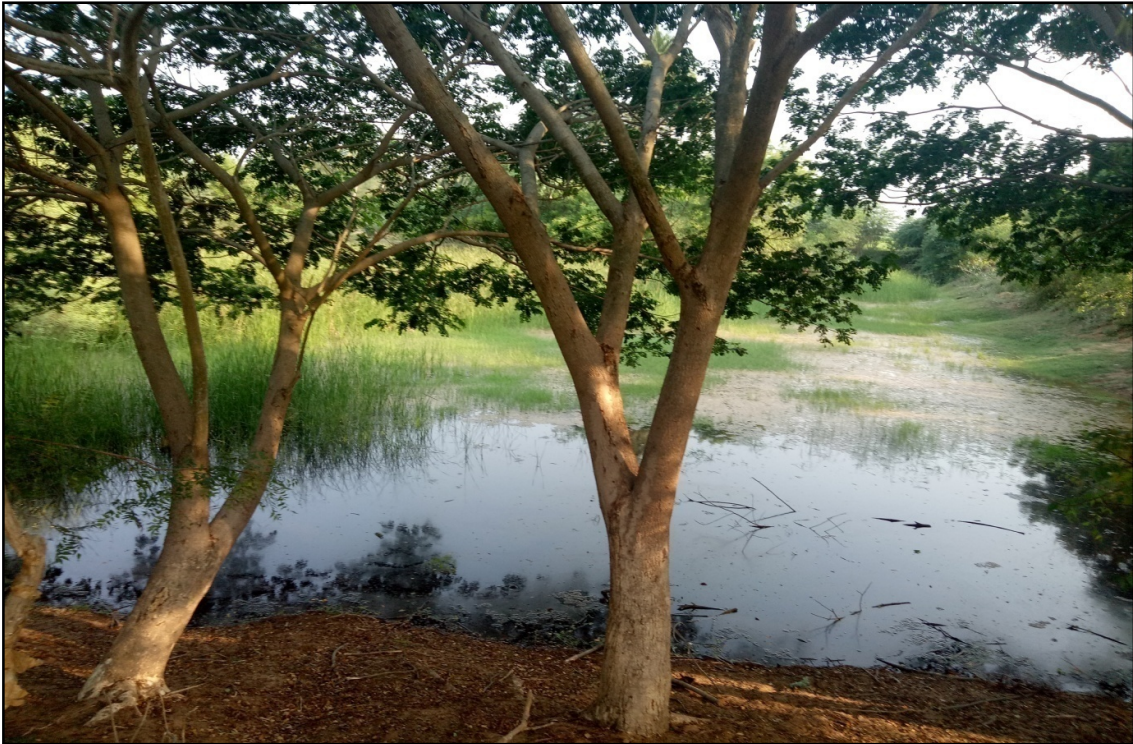
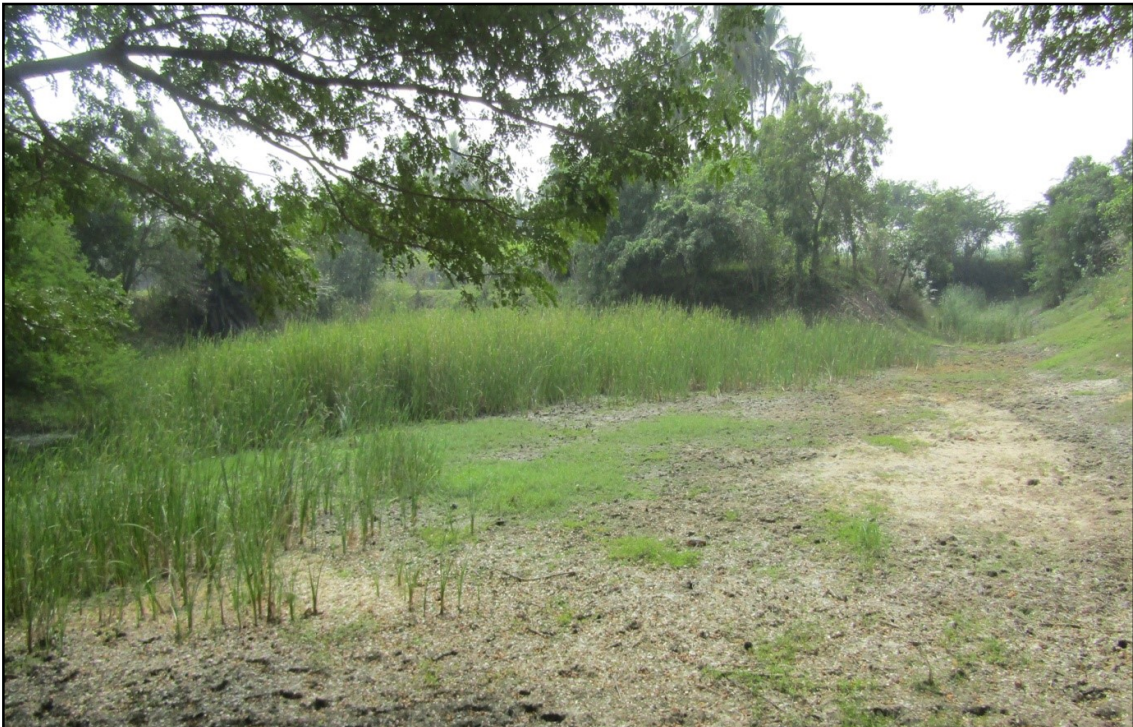
16. Pond photos before execution of the work:

c. Pumping
10. Status of bund? good condition
 - i. Is strengthening required? No
 - ii. Are planting trees possible? Yes
11. Do people use the pond a. for cattle,

15. No of trees around the pond: Nil
