BASELINE REPORT

NAFCC PROJECT

INTEGRATED SURFACE WATER MANAGEMENT THROUGH CLIMATE CHANGE ADAPTATION IN U.T. OF PUDUCHERRY

Government of Puducherry

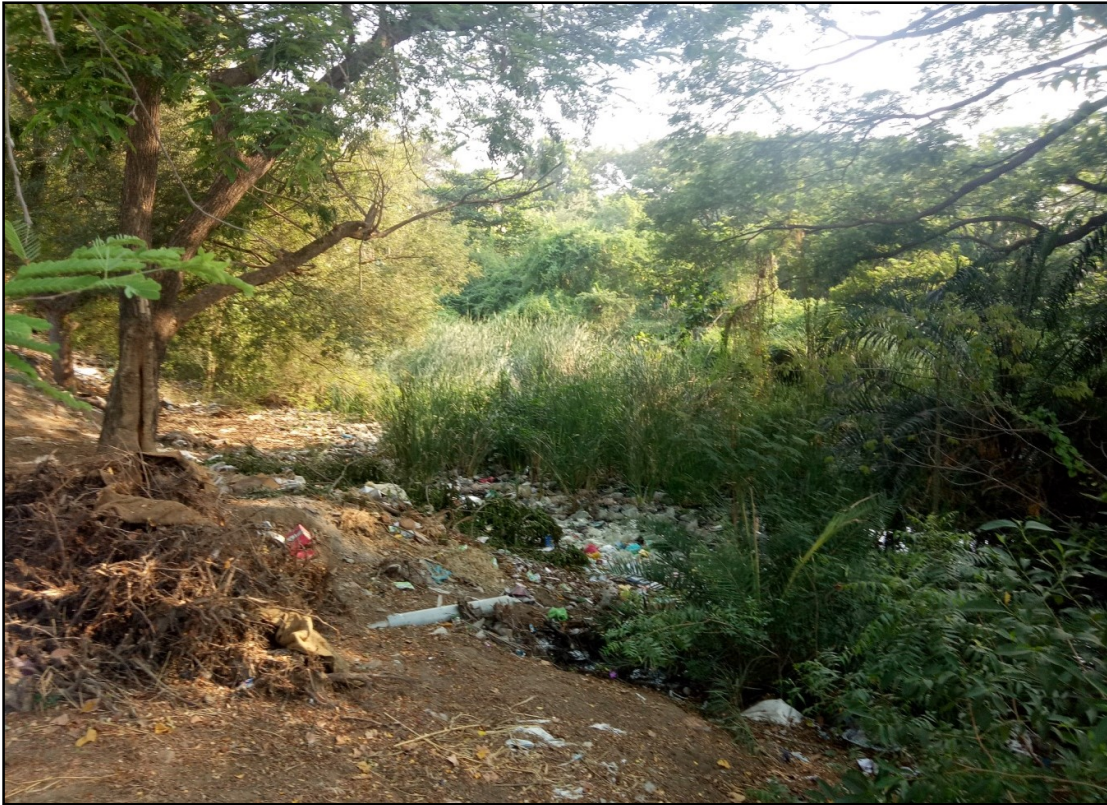
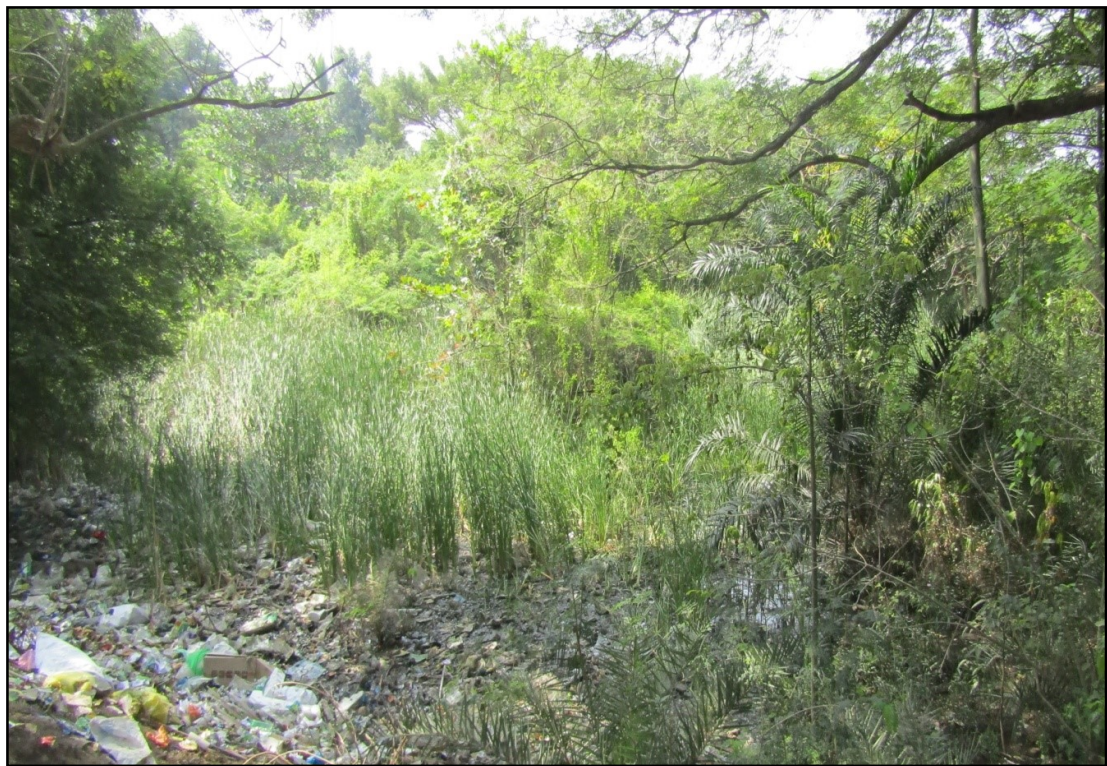
16. Pond photos before execution of the work:

1. Commune: Manadipet commune Panchayat
2. GPS coordinates: 12° 00' 14.35" N 79° 37' 45.65" E
3. Dimension: Side 1: 217 ft.,
 Side 2: 183 ft.,
 Side 3: 217 ft.,
 Side 4: 183 ft.
4. Total Area: 18514 sq. ft.
5. Is water available: No
6. Status of Eutrophication: Not present
7. Is water available throughout the year: No
8. Are inlet and outlet available: No
9. Source of water: Rain
10. Status of bund? No proper bunds
 - i. Is strengthening required? Yes
 - ii. Are planting trees possible? Yes
11. Do people use the pond: Recharging
12. Is waste water discharged inside the pond? Yes.
 If Yes, Source: domestic waste water
13. Is it given for lease? No.
14. When was it desilted? Nil
15. No of trees around the bund : 6 and its status: Alive

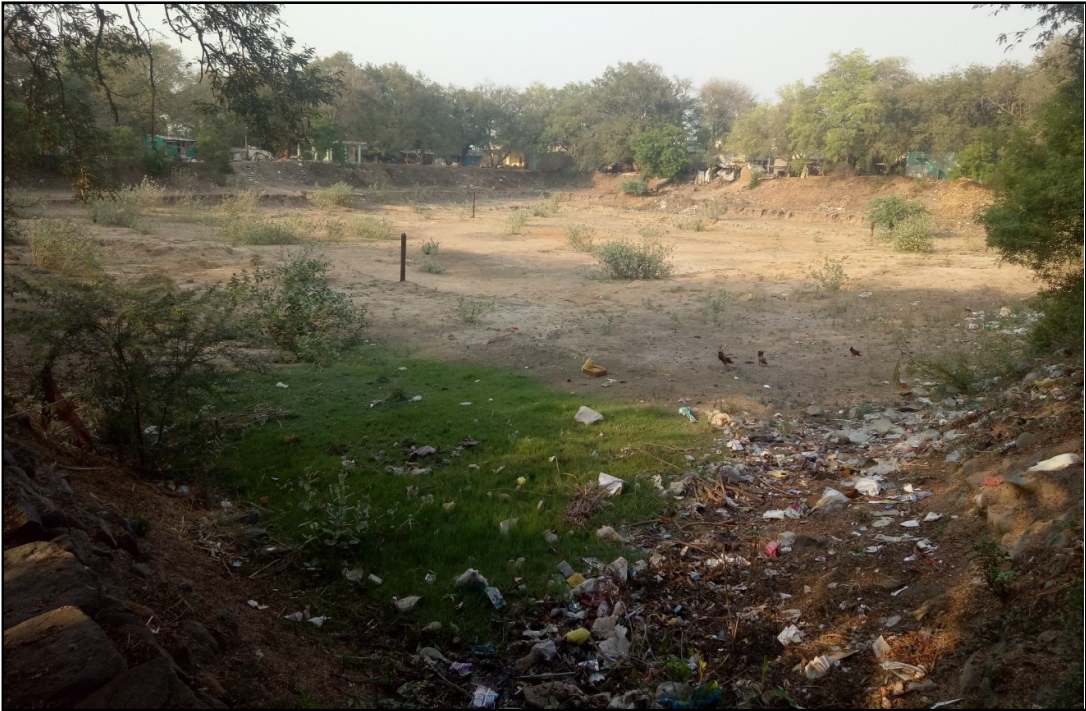
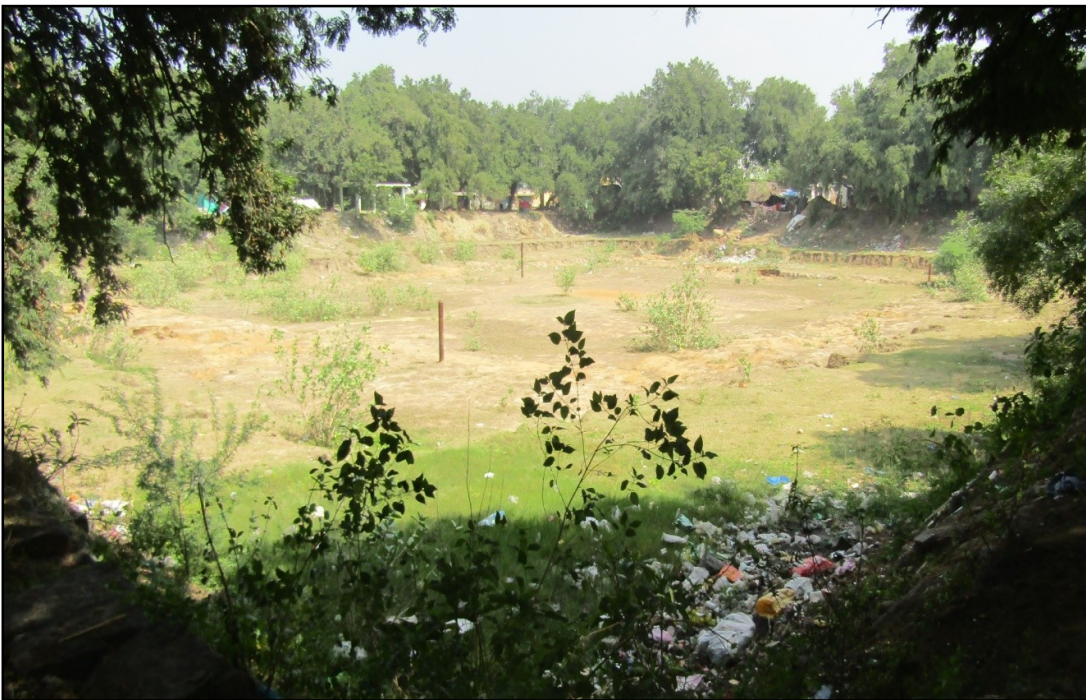
16. Pond photos before execution of the work:

9. Source of water: a. Rain,
 b. Inlet channel (channel from Koonichempet tank)
10. Status of bund? Good condition
 - i. Is strengthening required? No
 - ii. Are planting trees possible? Yes

14. Whether desilted earlier? Yes
 - If yes, i. When was it desilted?: 2016
 - ii. by whom?: DHAN Foundation
15. No of trees around the bund: 20 and its status: Alive

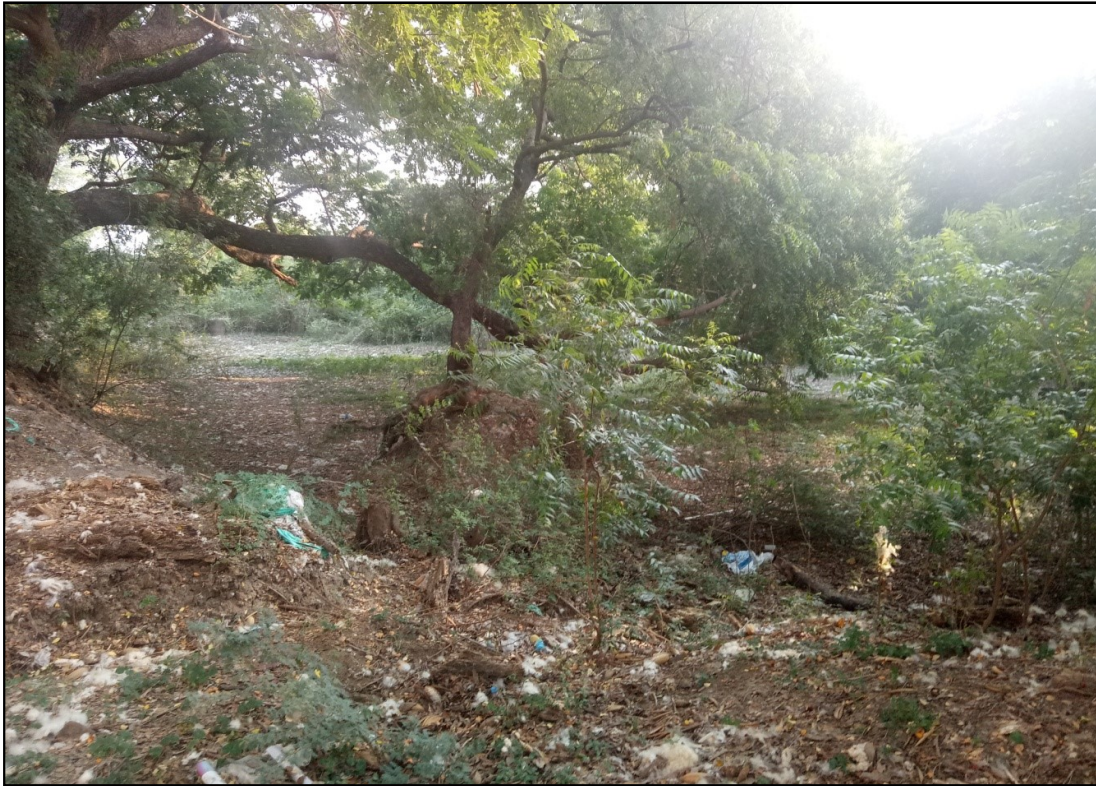
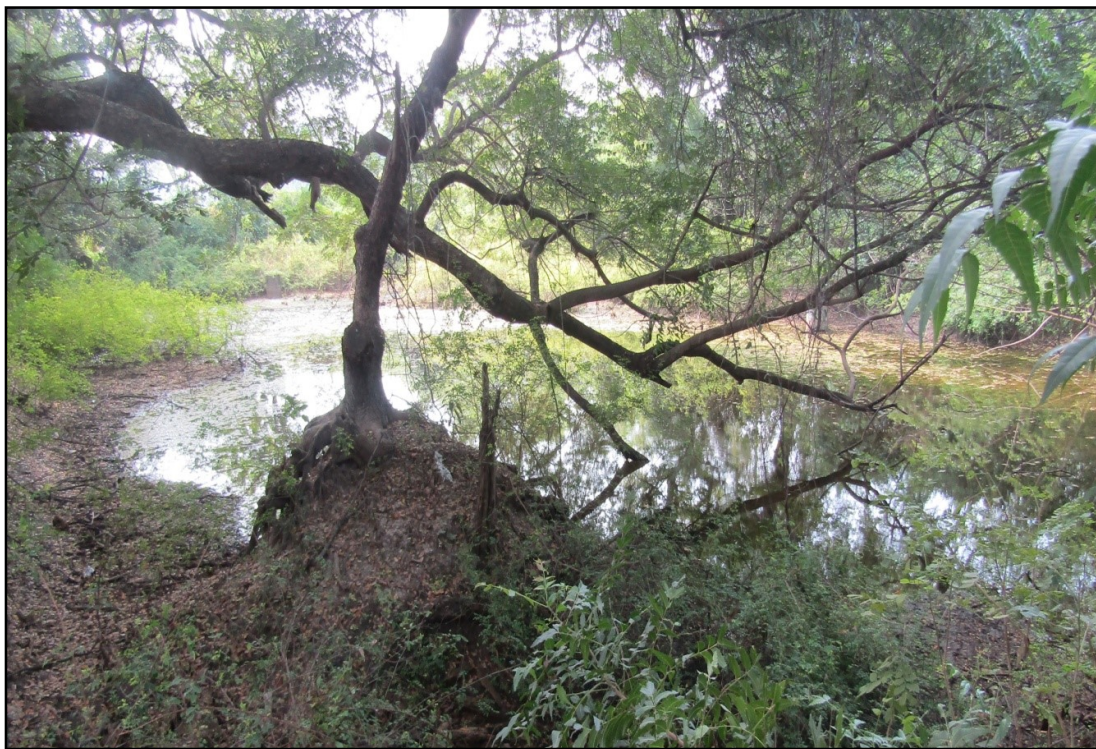
16. Pond photos before execution of the work:

1. Commune: Mannadipet Commune Panchayat
2. GPS coordinates: 12° 00' 15.84" N 79° '37' 47.49" E
3. Dimension: Side 1: 167 ft.,
 Side 2: 200 ft.,
 Side 3: 167 ft.,
 Side 4: 200 ft.
4. Total Area: 16791.70 sq. ft.
5. Is water available: No
6. Status of Eutrophication: Partially present
7. Is water available throughout the year: No
8. Are inlet and outlet available: No
9. Source of water: a. Rain,
 b. Inlet channel (channel from Koonichempet tank)
10. Status of bund? No proper bunds
 - i. Is strengthening required? Yes
 - ii. Are planting trees possible? Yes
11. Do people use the pond: a. for cattle,
 b. fishing,
 c. Recharging
12. Is waste water discharged inside the pond? No.
13. Is it given for lease? No.
14. Whether desilted earlier? Yes Nil.
15. No of trees around the bund: 5 and its status: Alive

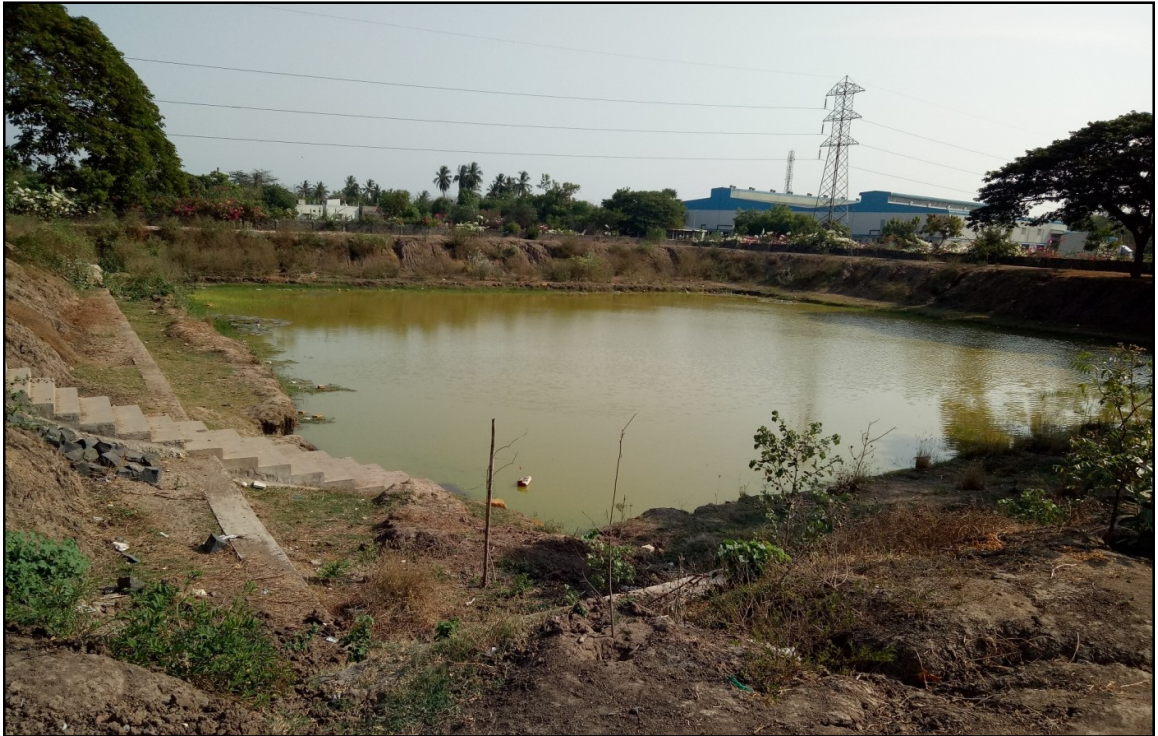
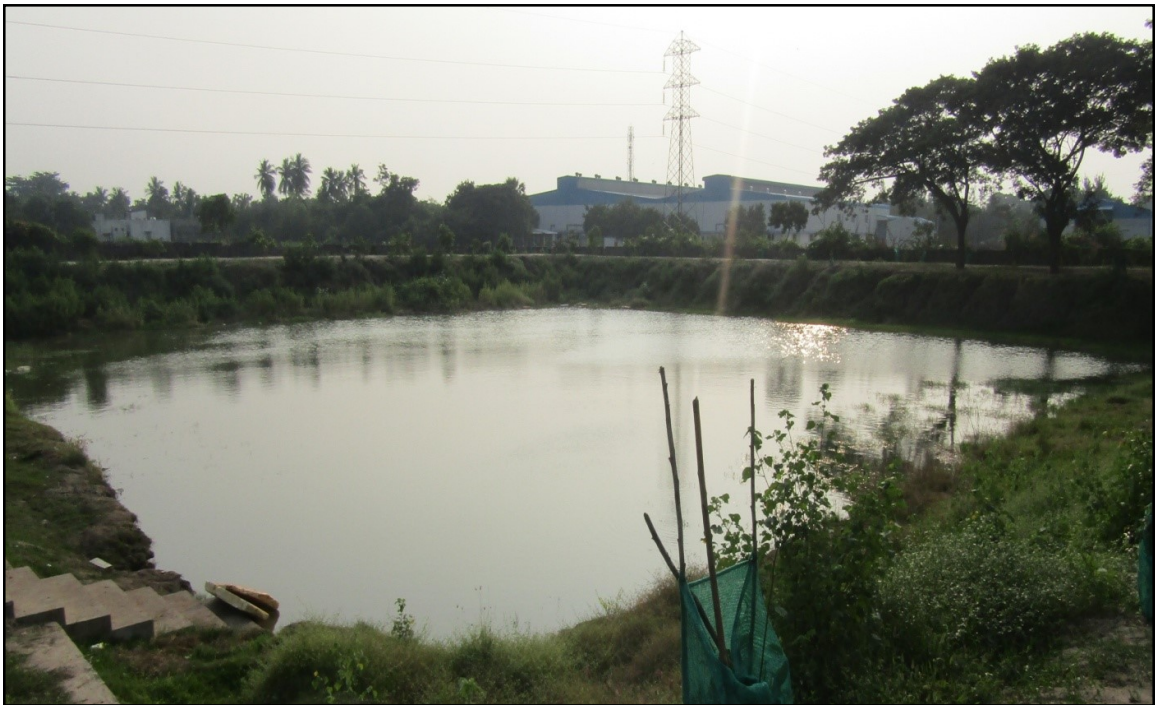
16. Pond photos before execution of the work:

1. Commune: Manadipet Commune Panchayat
2. GPS coordinates: 11° 55'30.50" N 79° `38'59.48" E
3. Dimension: Side 1: 230 ft.,
 Side 2: 203 ft.,
 Side 3: 230 ft.,
 Side 4: 203ft.
4. Total Area: 48437.6 sq. ft.
5. Is water available: Yes,
 If yes, water level from top: 5 ft.
6. Status of Eutrophication: Not present
7. Is water available throughout the year: Yes
8. Are inlet and outlet available: No
9. Source of water: a. Rain,
 b. Pumping
10. Status of bund? Good condition
 - i. Is strengthening required? No
 - ii. Are planting trees possible? Yes
11. Do people use the pond a. bathing/washing of cloths,
 b. for cattle,
 c. fishing,
 d. Recharging
12. Is waste water discharged inside the pond? No.
13. Is it given for lease? No.
14. Whether desilted earlier? Yes
 - If yes, i. When was it desilted? 2016
 - ii. by whom? DHAN Foundation
15. No of trees around the bund: 6 and its status: alive

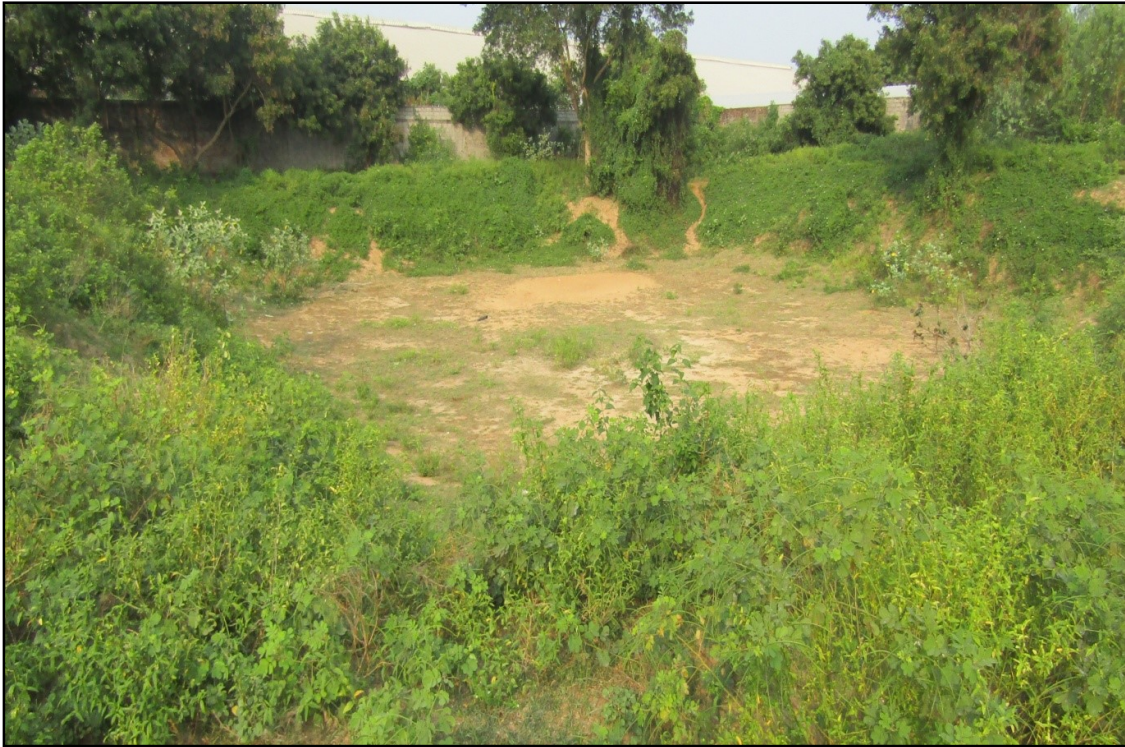
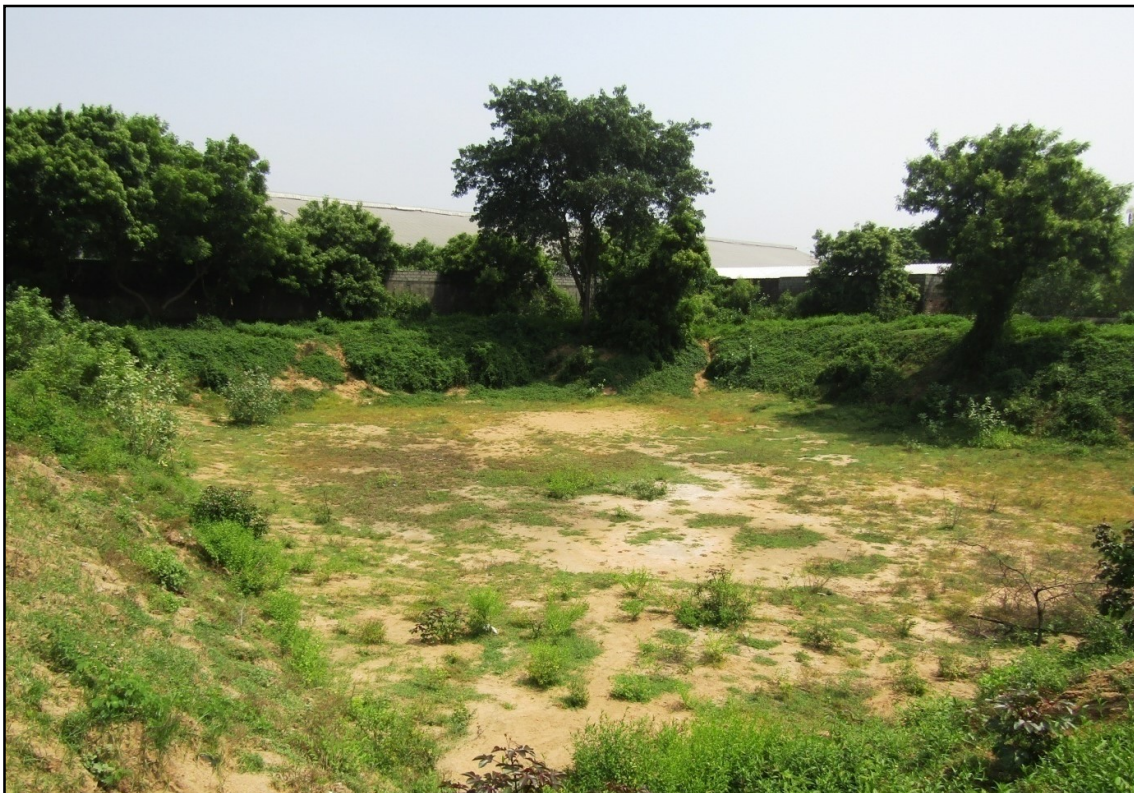
16. Pond photos before execution of the work:

1. Commune: Manadipet Commune Panchayat
2. GPS coordinates: 11° 54' 54.46" N 79° 39' 35.14" E
3. Dimension: Side 1: 125 ft.,
 Side 2: 115 ft.,
 Side 3: 125 ft.,
 Side 4: 115 ft.
4. Total Area: 64906.38 sq. ft.
5. Is water available: No
6. Status of Eutrophication: Not present
7. Is water available throughout the year: No
8. Are inlet and outlet available: Yes,
 If yes, are they alive? : Yes. Inlet alive
9. Source of water: a. Rain,
 b. Inlet channel (Azhiyar channel)
10. Status of bund? Good condition
 - i. Is strengthening required? No
 - ii. Are planting trees possible? Yes
11. Do people use the pond: a. bathing/washing of cloths,
 b. for cattle,
 c. Recharging
12. Is waste water discharged inside the pond? No.
13. Is it given for lease? No.
14. Whether desilted earlier? No
15. No of trees around the bund: 6 and its status: alive

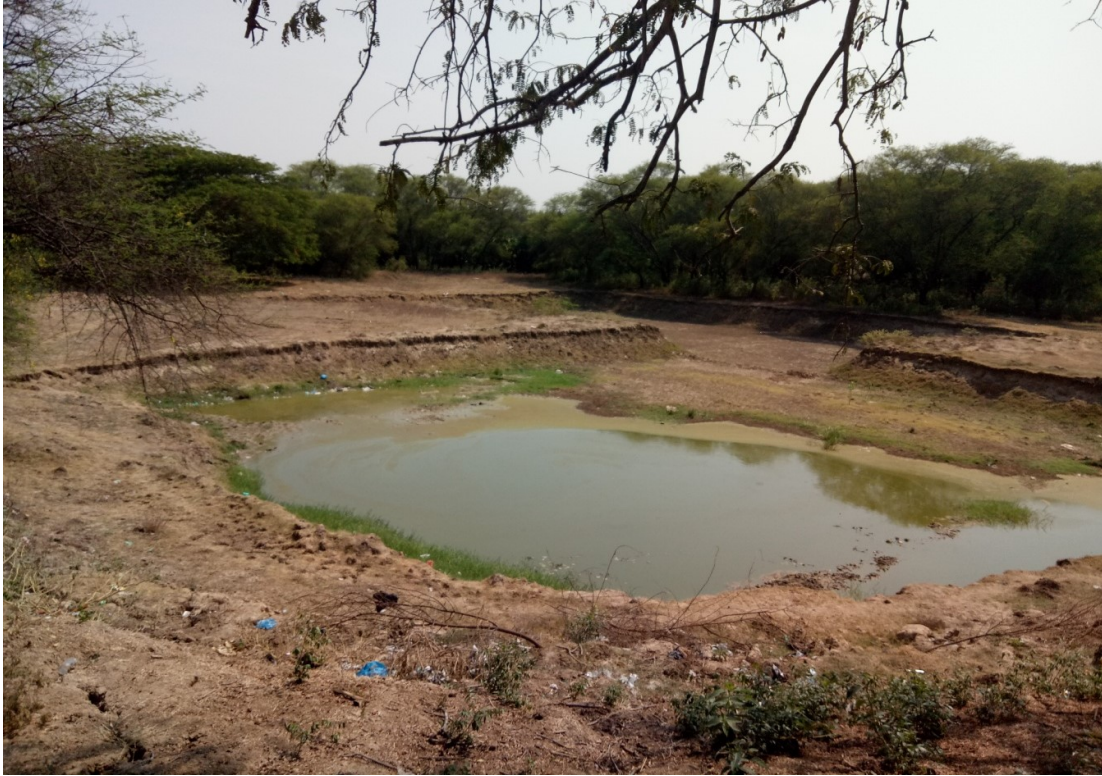
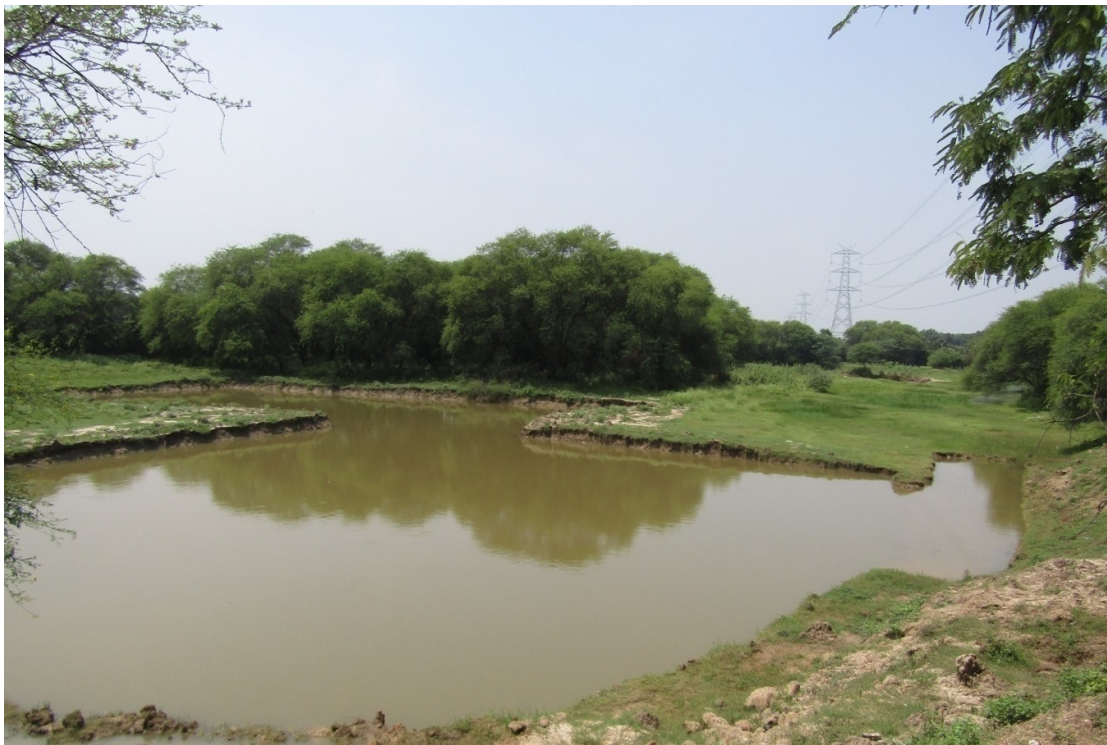
16. Pond photos before execution of the work:

13. Is it given for lease? No.
14. Whether desilted earlier? Yes
 - If yes, i. When was it desilted? 2016
 - ii. by whom? DHAN Foundation
15. No of trees around the bund: 330 and its status: alive

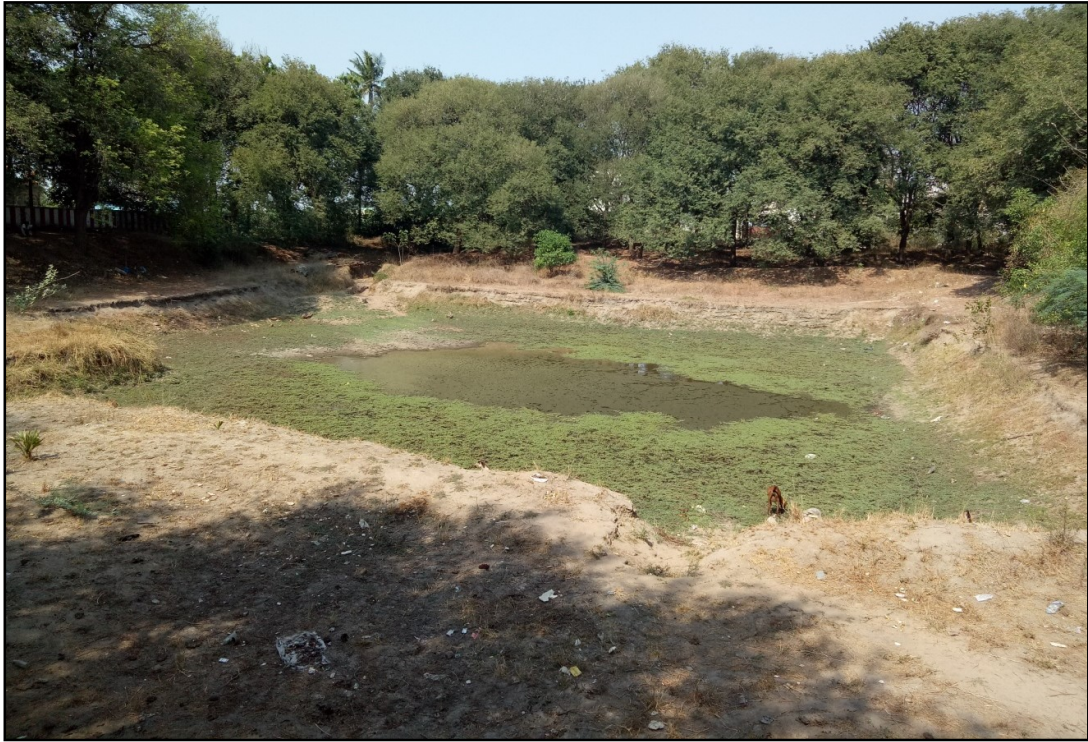
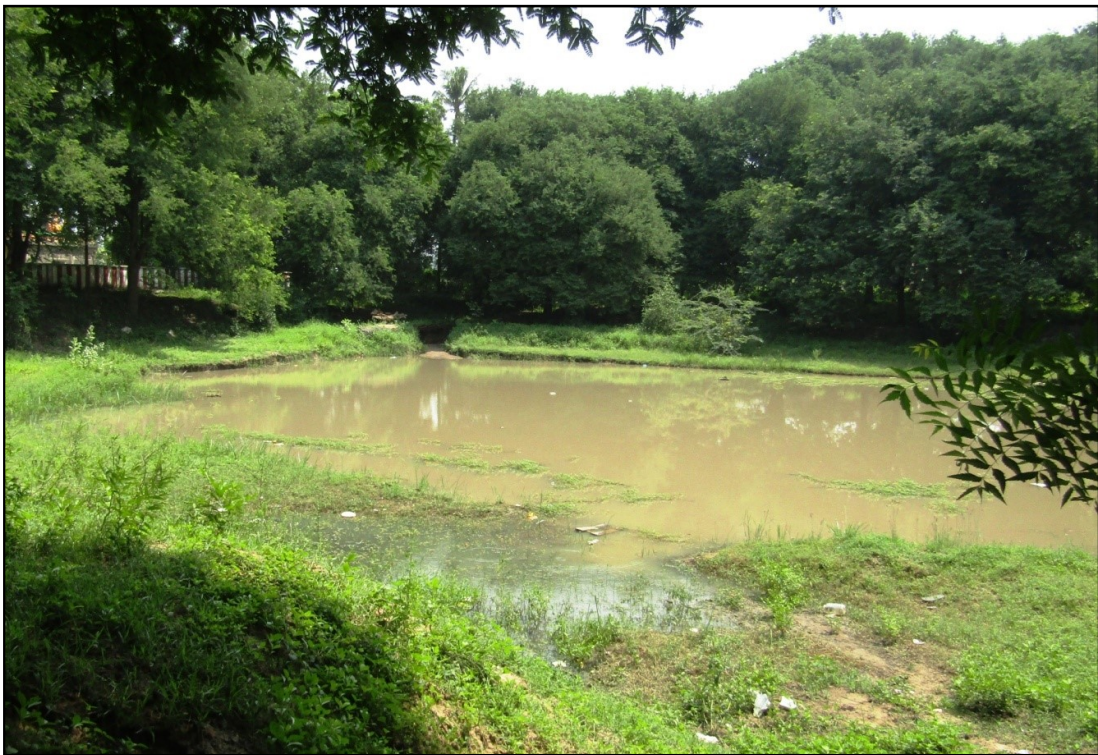
16. Pond photos before execution of the work:

1. Commune: Mannadipet Commune Panchayat
2. GPS coordinates: 11° 55' 56.80" N 79° 38' 53.77" E
3. Dimension: Side 1: 124 ft.
 Side 2: 105 ft.
 Side 3: 124 ft.
 Side 4: 105 ft.
4. Total Area: 12701 sq. ft.
5. Is water available: No
6. Status of Eutrophication: Not Present
7. Is water available throughout the year: No
8. Are inlet and outlet available: No
9. Source of water: a. Rain,
 b. Pumping
10. Status of bund? Good condition
 - i. Is strengthening required? No
 - ii. Are planting trees possible? Yes
11. Do people use the pond a. bathing/washing of cloths,
 b. for cattle,
 c. Recharging
12. Is waste water discharged inside the pond? No.
13. Is it given for lease? No.
14. Whether desilted earlier? Yes (Partially)
 - If yes, i. When was it desilted? 2017
 - ii. by whom? DHAN Foundation
15. No of trees around the bund: 87 and its status: alive

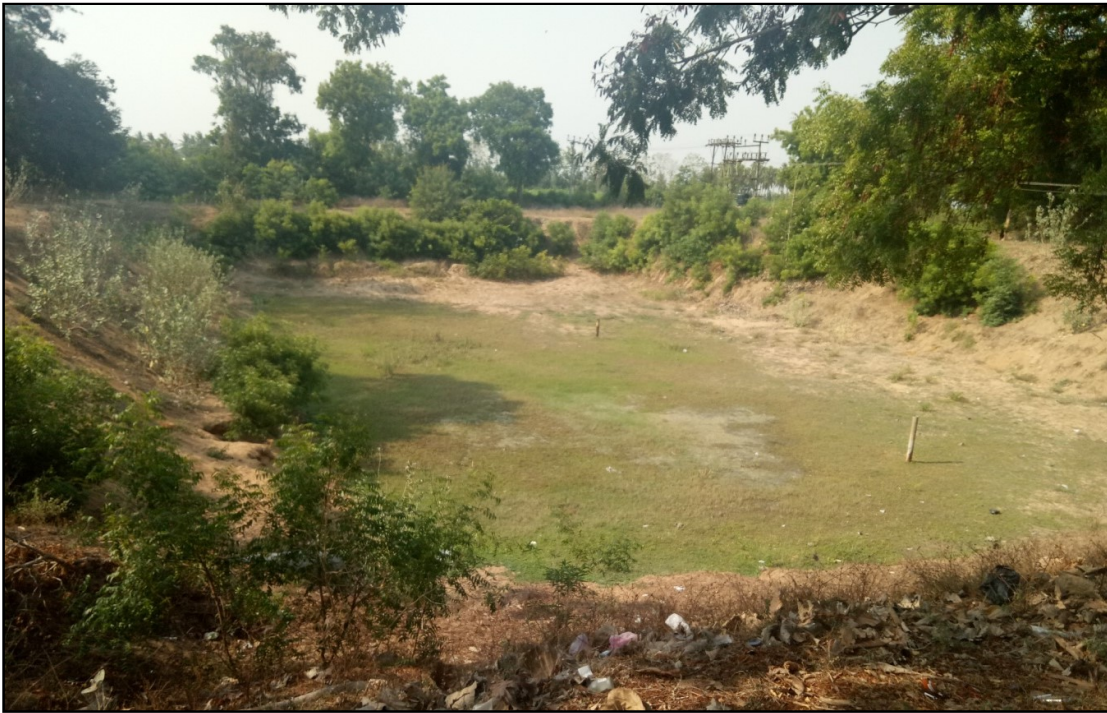
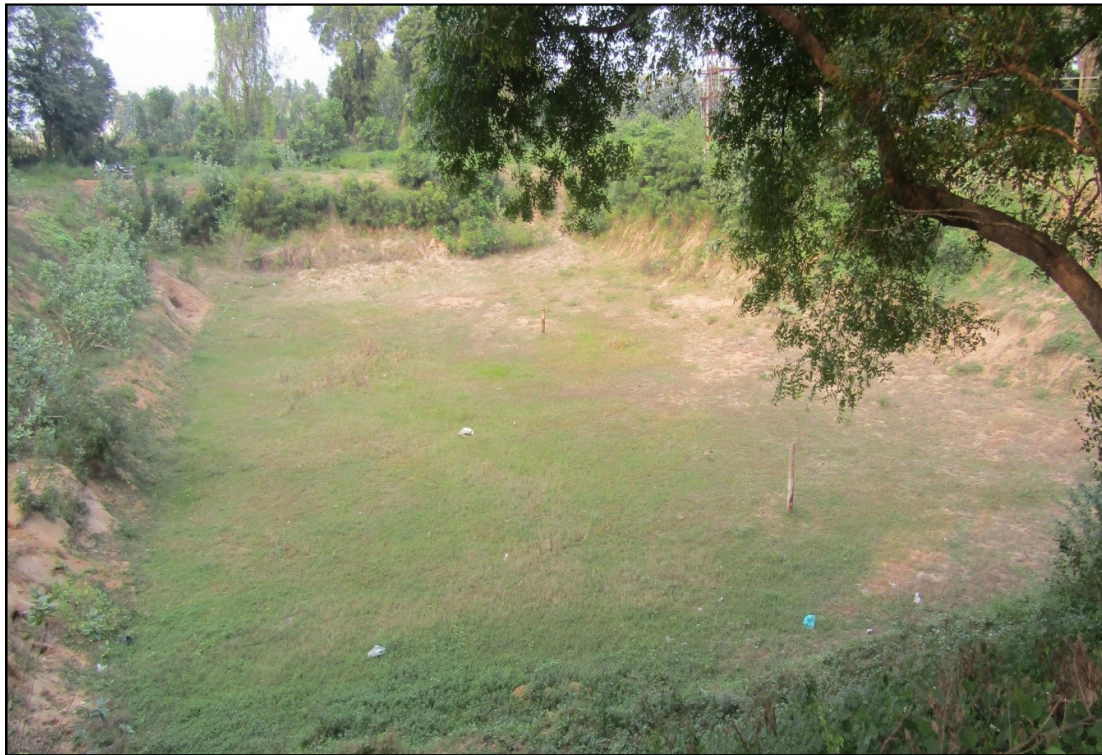
16. Pond photos before execution of the work:

1. Commune: Mannadipet Commune Panchayat
2. GPS coordinates: 11° 56'07.96" N 79° 39'22.34" E
3. Dimension: Side 1: 197 ft.
 Side 2: 128 ft.
 Side 3: 197 ft.
 Side 4: 128 ft.
4. Total Area: 23465.32 sq. ft.
5. Is water available: No
6. Status of Eutrophication: Not Present
7. Is water available throughout the year: No
8. Are inlet and outlet available: No
9. Source of water: a. Rain,
 b. Pumping
10. Status of bund? Good condition
 - i. Is strengthening required? No
 - ii. Are planting trees possible? Yes
11. Do people use the pond a. bathing/washing of cloths,
 b. for cattle,
 c. Recharging purpose
12. Is waste water discharged inside the pond? No.
13. Is it given for lease? No.
14. Whether desilted earlier? No
15. No of trees around the bund: 39 and its status: alive

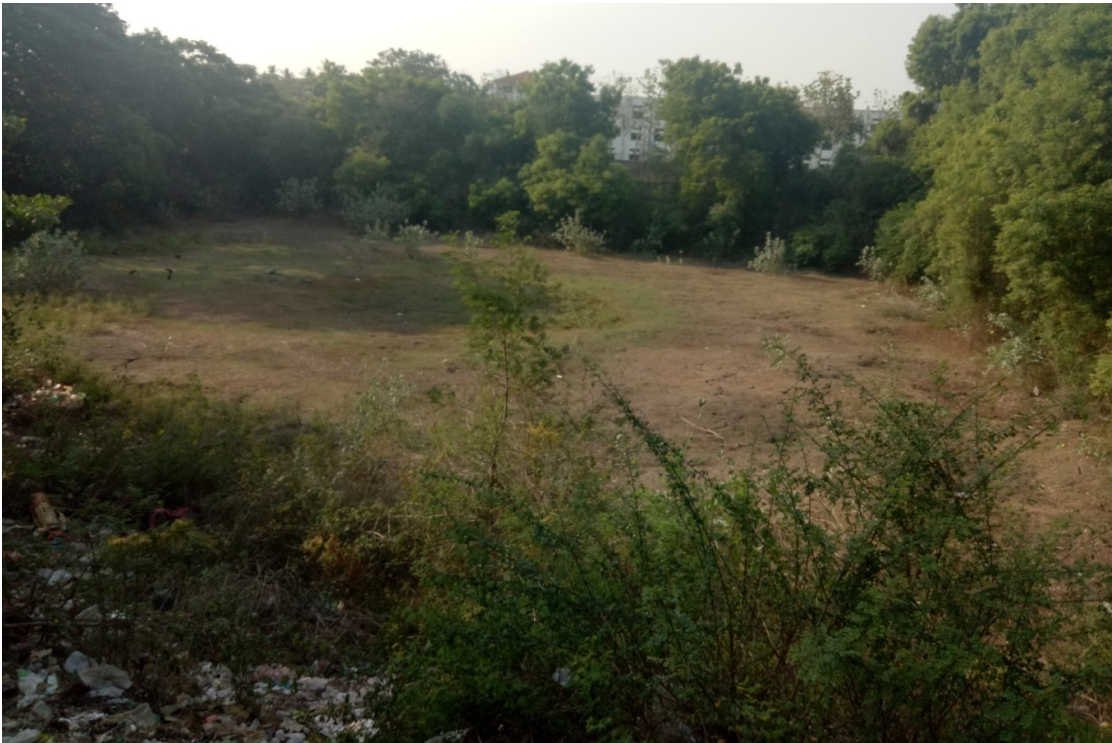
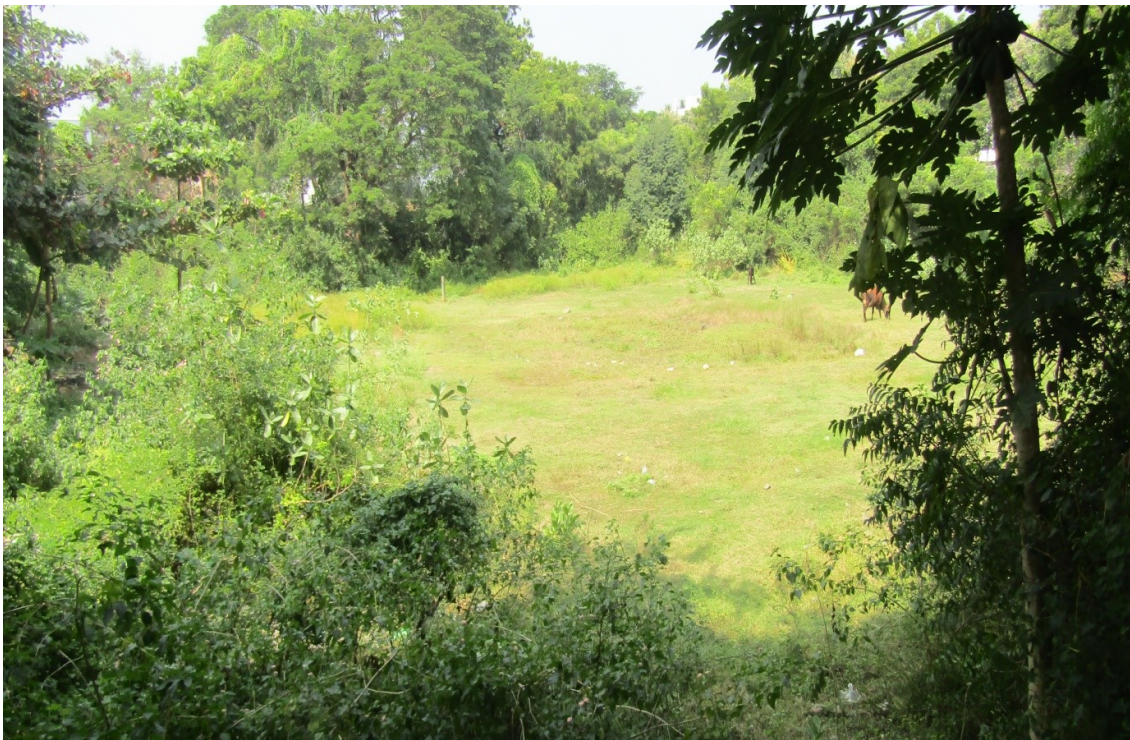
16. Pond photos before execution of the work:

1. Commune: Mannadipet Commune Panchayat
2. GPS coordinates: 11° 58'44.20" N 79° 39'45.05" E
3. Dimension: Side 1: 233 ft.
 Side 2: 183 ft.
 Side 3: 233 ft.
 Side 4: 183 ft.
4. Total Area: 46607.73 Ha
5. Is water available: No
6. Status of Eutrophication: Not Present
7. Is water available throughout the year: No
8. Are inlet and outlet available: No
9. Source of water: a. Rain,
 b. Inlet channel (channel from sompet tank)
 c. Recharging purpose
10. Status of bund? covered with bushes
 - i. Is strengthening required? Yes
 - ii. Are planting trees possible? Yes
11. Do people use the pond a. bathing/washing of cloths,
 b. for cattle,
 c. Recharging
12. Is waste water discharged inside the pond? No.
13. Is it given for lease? No.
14. Whether desilted earlier? No
15. No of trees around the bund: Nil

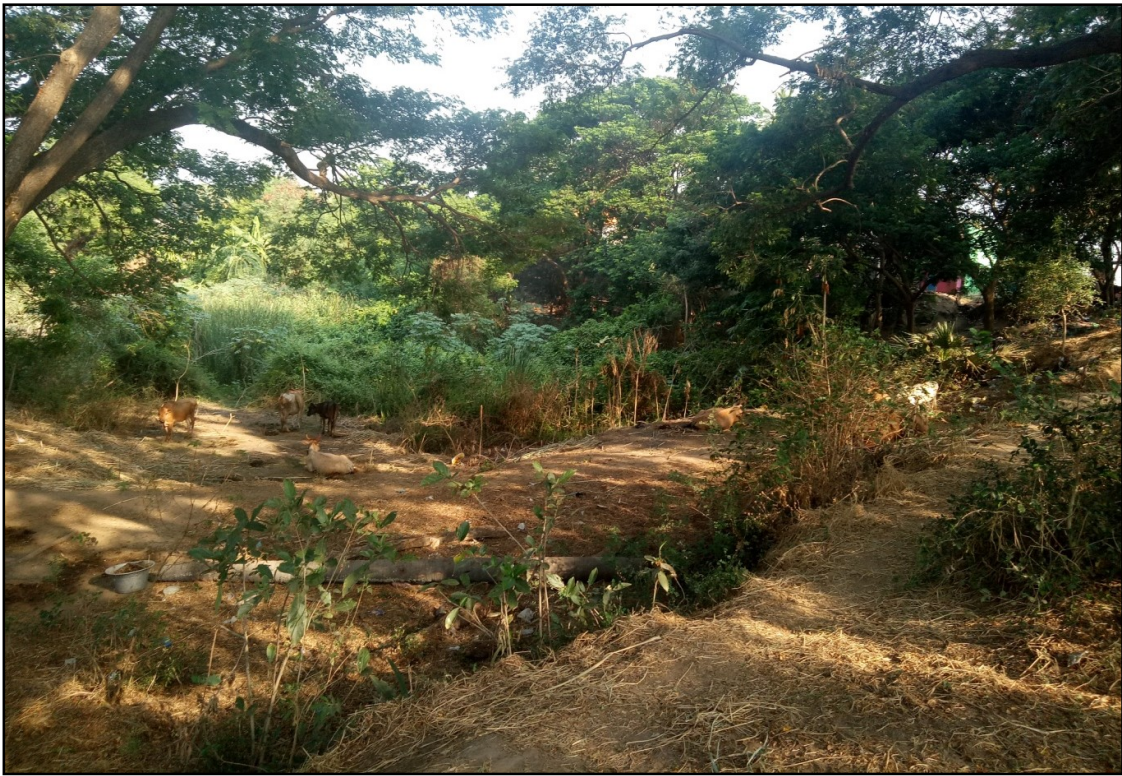
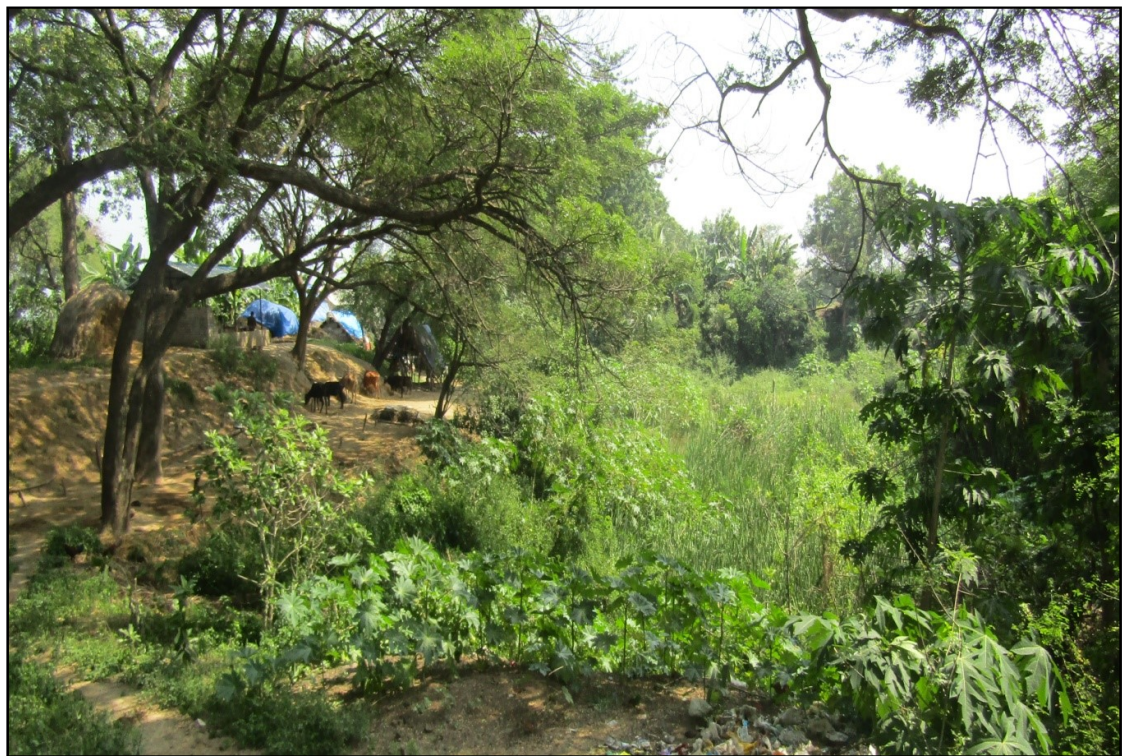
16. Pond photos before execution of the work:

13. Is it given for lease? No.
14. Whether desilted earlier? Nil
15. No of trees around the bund: 8 and its status: Alive

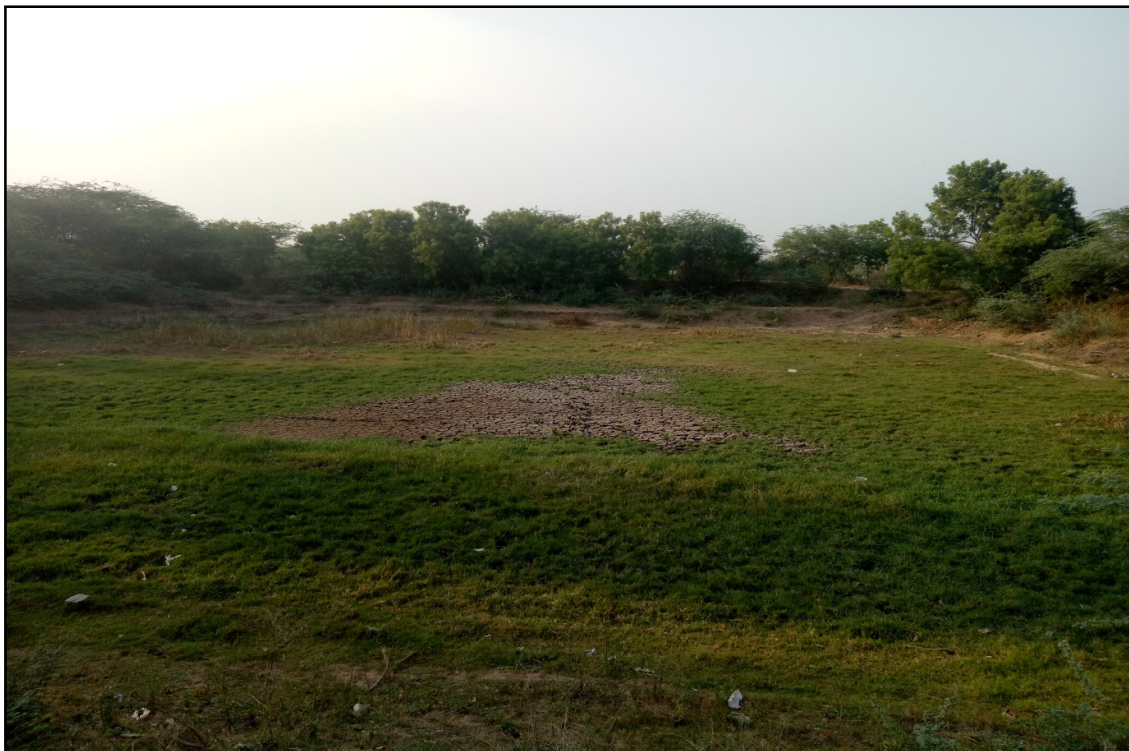
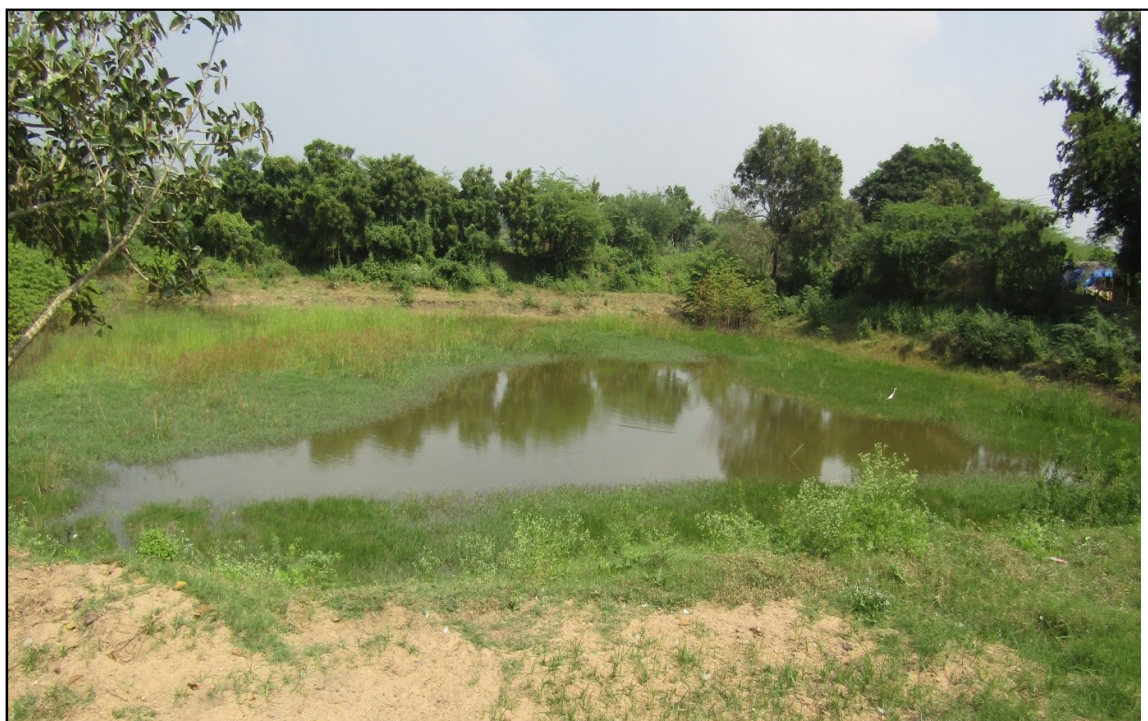
16. Pond photos before execution of the work:

1. Commune: Mannadipet Commune Panchayat
2. GPS coordinates: 12° 01' 41.21" N 79° 37' 37.34" E
3. Dimension: Side 1: 200 ft.
 Side 2: 200 ft.
 Side 3: 200 ft.
 Side 4: 200 ft.
4. Total Area: 40149.39 sq. ft
5. Is water available: No.
6. Status of Eutrophication: Fully present
7. Is water available throughout the year: No
8. Are inlet and outlet available: No
9. Source of water: Rain
10. Status of bund? Good condition
 - i. Is strengthening required? No
 - ii. Are planting trees possible? Yes
11. Do people use the pond
 - a. bathing/washing of cloths,
 - b. for cattle,
 - c. Recharging,
 - d. for religious activities
12. Is waste water discharged inside the pond? No.
13. Is it given for lease? No.
14. Whether desilted earlier? Nil
15. No of trees around the bund: 03 and its status: Alive

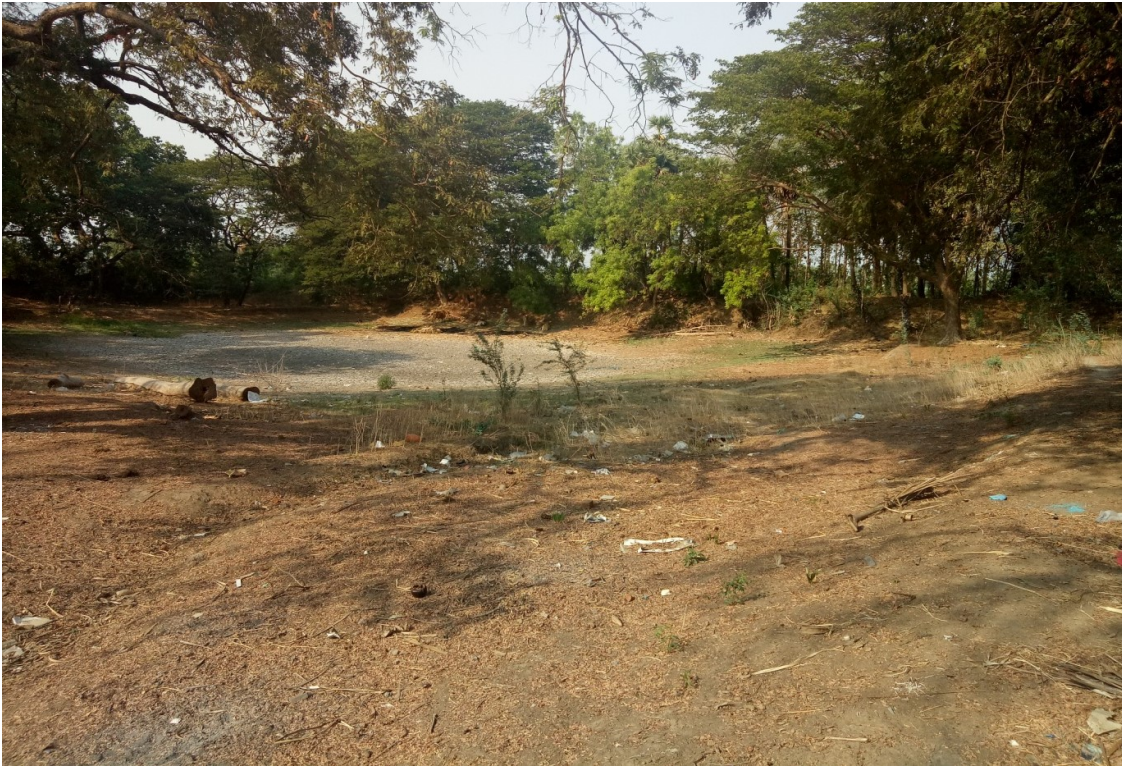
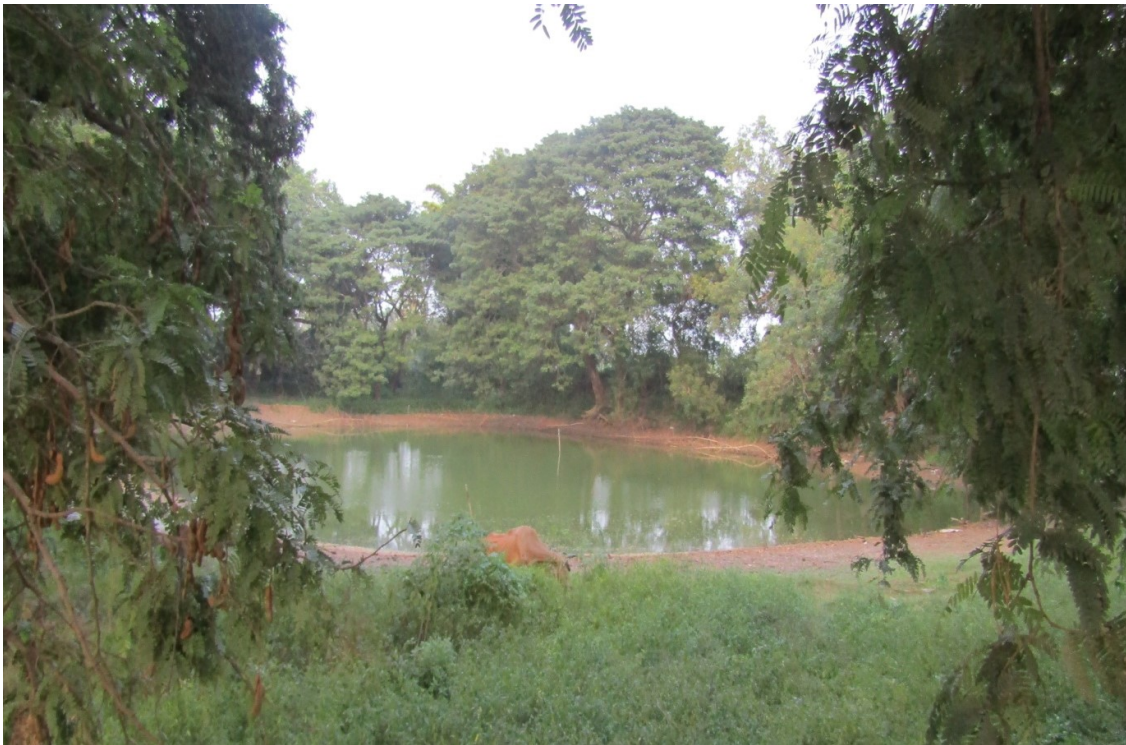
16. Pond photos before execution of the work:

1. Commune: Mannadipet Commune Panchayat
2. GPS coordinates: 11° 55' 42.95" N 79° 37' 15.95" E
3. Dimension: Side 1: 218 ft.
 Side 2: 164 ft.
 Side 3: 218 ft.
 Side 4: 164 ft.
4. Total Area: 35,752 sq.ft
5. Is water available: No
6. Status of Eutrophication: Not present
7. Is water available throughout the year: No
8. Are inlet and outlet available: No
9. Source of water: a. Rain,
 b. Pumping
10. Status of bund: Good condition
 - i. Is strengthening required? No
 - ii. Are planting trees possible? No
11. Do people use the pond
 - a. bathing/washing of cloths,
 - b. for cattle,
 - c. fishing,
 - d. Recharging
12. Is waste water discharged inside the pond? No.
13. Is it given for lease? No.
14. Whether desilted earlier? No
15. No of trees around the bund: 29 and its status: Alive
