BASELINE REPORT

NAFCC PROJECT

INTEGRATED SURFACE WATER MANAGEMENT THROUGH CLIMATE CHANGE ADAPTATION IN U.T. OF PUDUCHERRY

Government of Puducherry

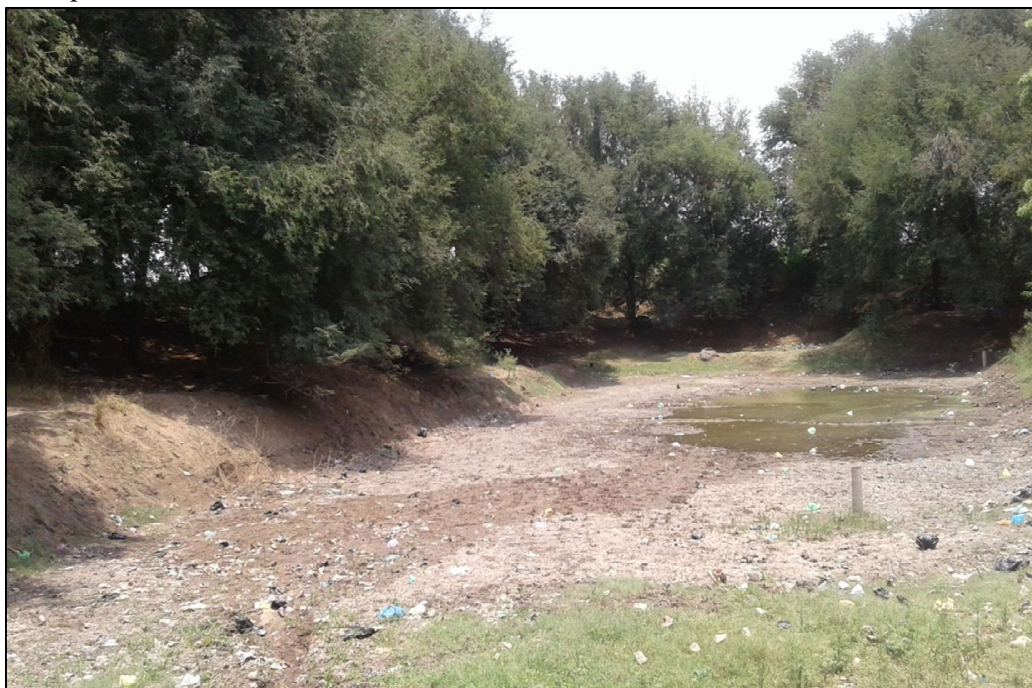
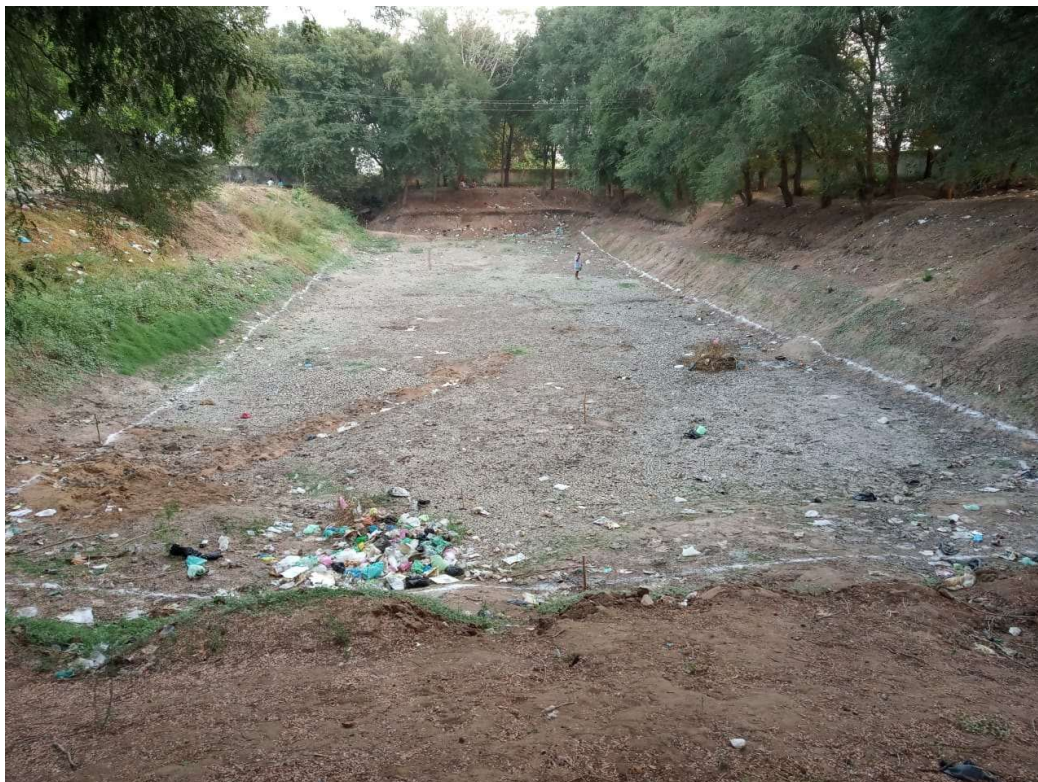
17. Pond photos before execution of the work:

1. Commune: Nettapakkam Commune Panchayat
2. GPS coordinates: 11° 52' 47.52" N 79° 36' 04.61" E
3. Dimension: Side 1: 200 ft.
 Side 2: 56 ft.
 Side 3: 200 ft.
 Side 4: 56 ft.
4. Total Area: 64476 sq. ft.
5. Depth of pond: Depth 1: 13.50 ft,
 Depth 2: 13 ft,
 Depth 3: 14 ft.
6. Is water available: No
7. Status of Eutrophication: Not Present
8. Is water available throughout the year: No
9. Are inlet and outlet available: Yes,
 If yes, are they alive?: Yes, in good condition
10. Source of water: a. Rain,
 b. Pumping
11. Status of bund? Good condition but covered with bushes
 - i. Is strengthening required? No
 - ii. Are planting trees possible? Yes
12. Do people use the pond a. bathing/washing of cloths,
 b. for cattle
13. Is waste water discharged inside the pond? No.
14. Is it given for lease? No.
15. Whether desilted earlier? No
16. No of trees around the bund: 20 and its status : Alive

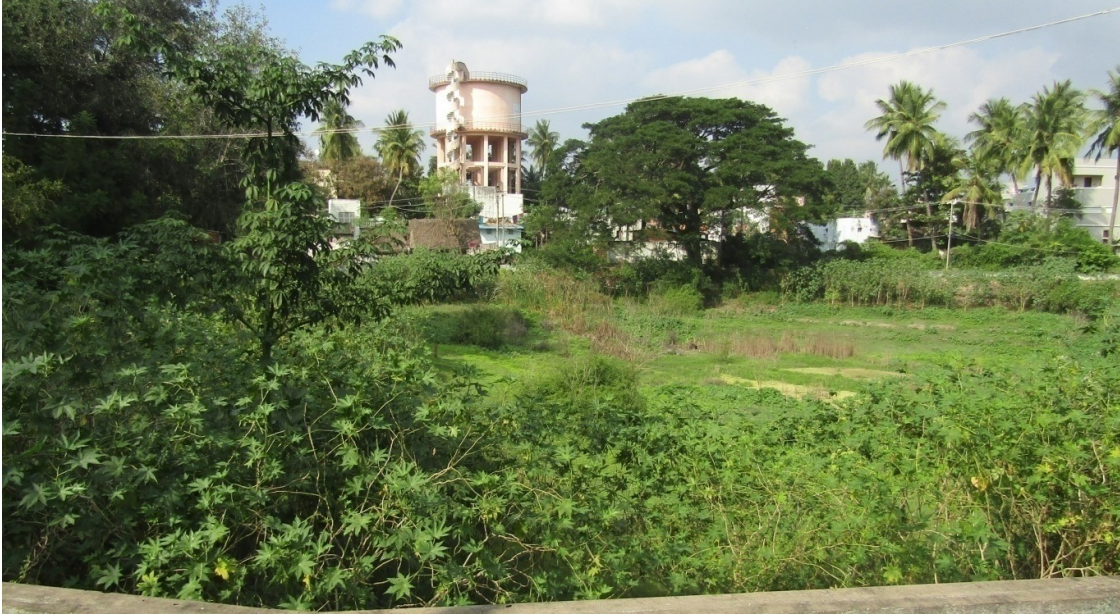
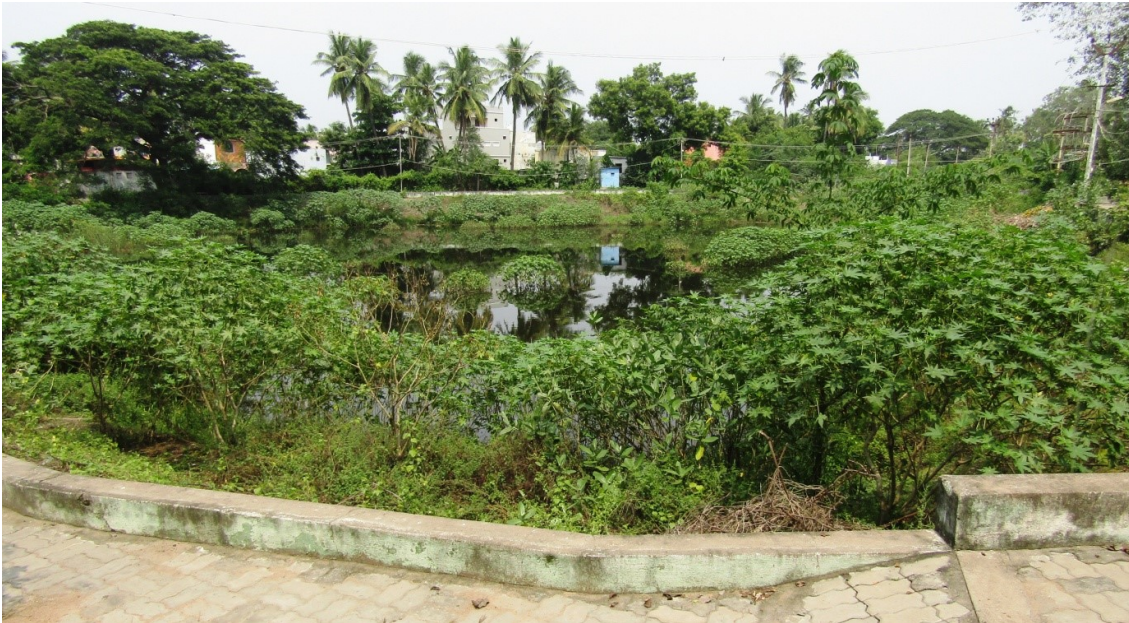
17. Pond photos before execution of the work:

15. Whether desilted earlier? No
16. No of trees around the bund: 2 and its status: Alive

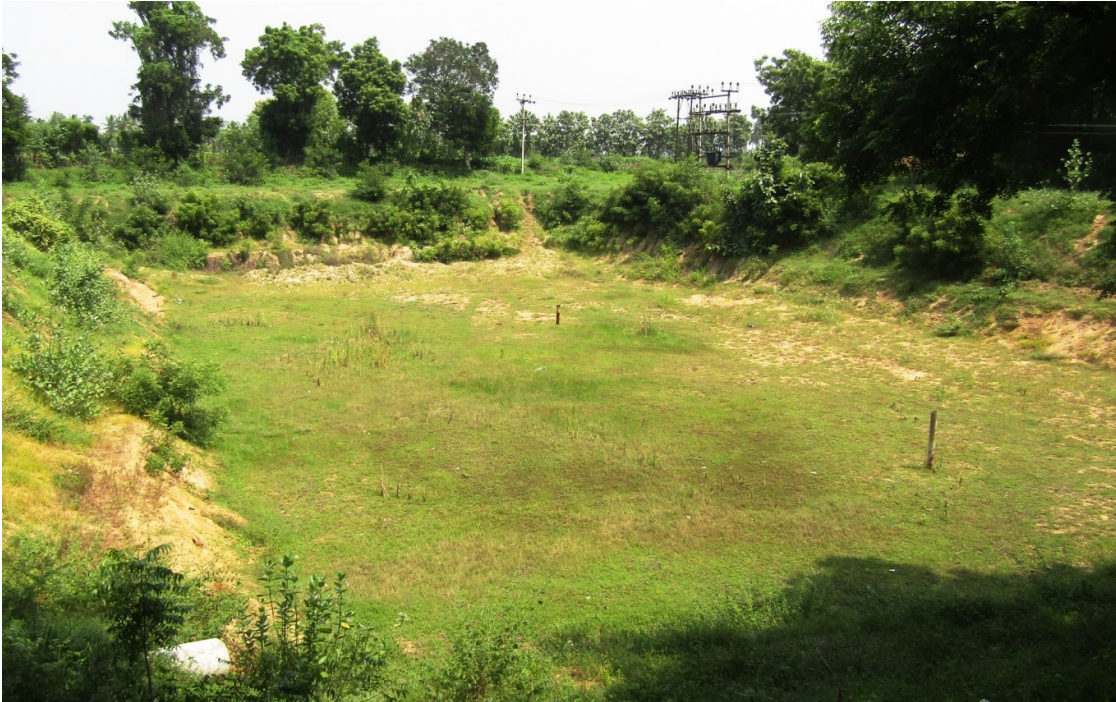
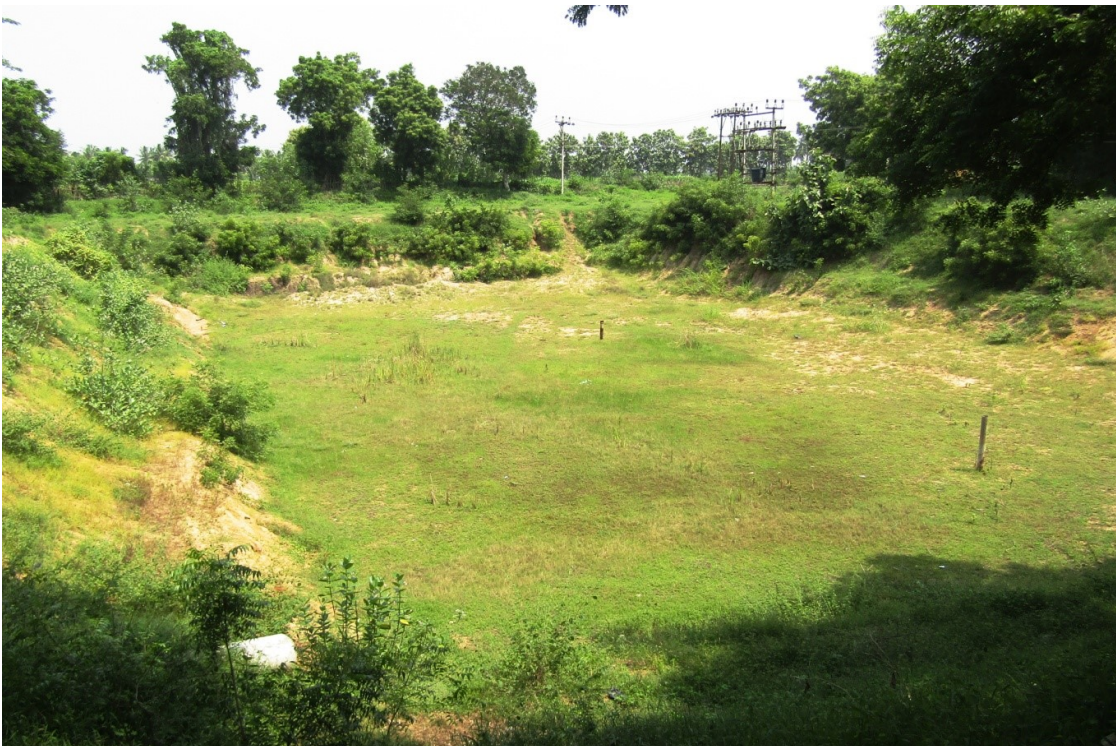
17. Pond photos before execution of the work:

11. Status of bund? Good condition
 - i. Is strengthening required? No
 - ii. Are planting trees possible? Yes
12. Do people use the pond
 - a. bathing/washing of cloths,

16. No of trees around the bund: Nil

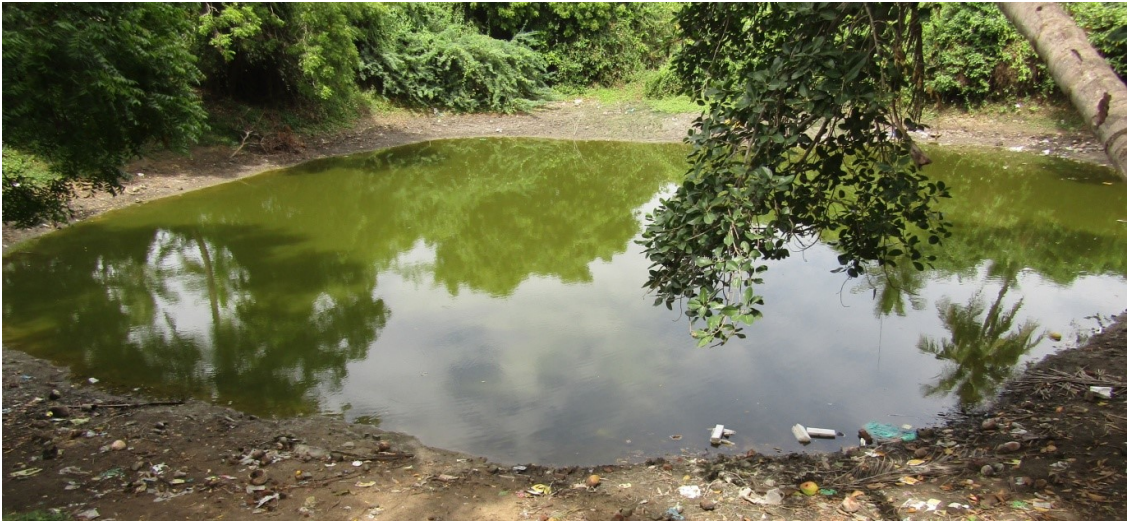
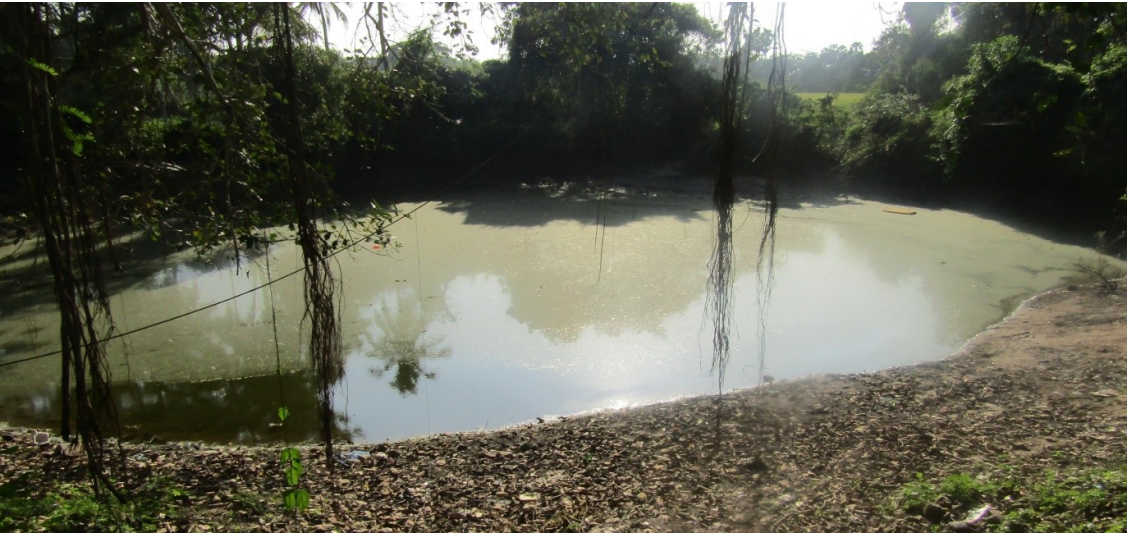
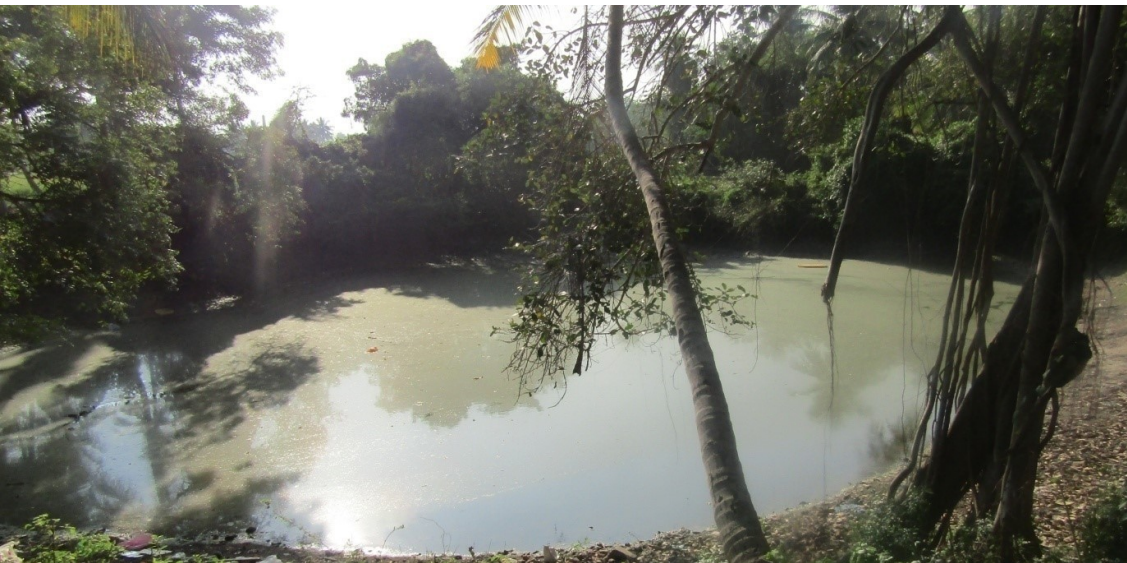
17. Pond photos before execution of the work:

16. No of trees around the bund: 7 and its status: Alive

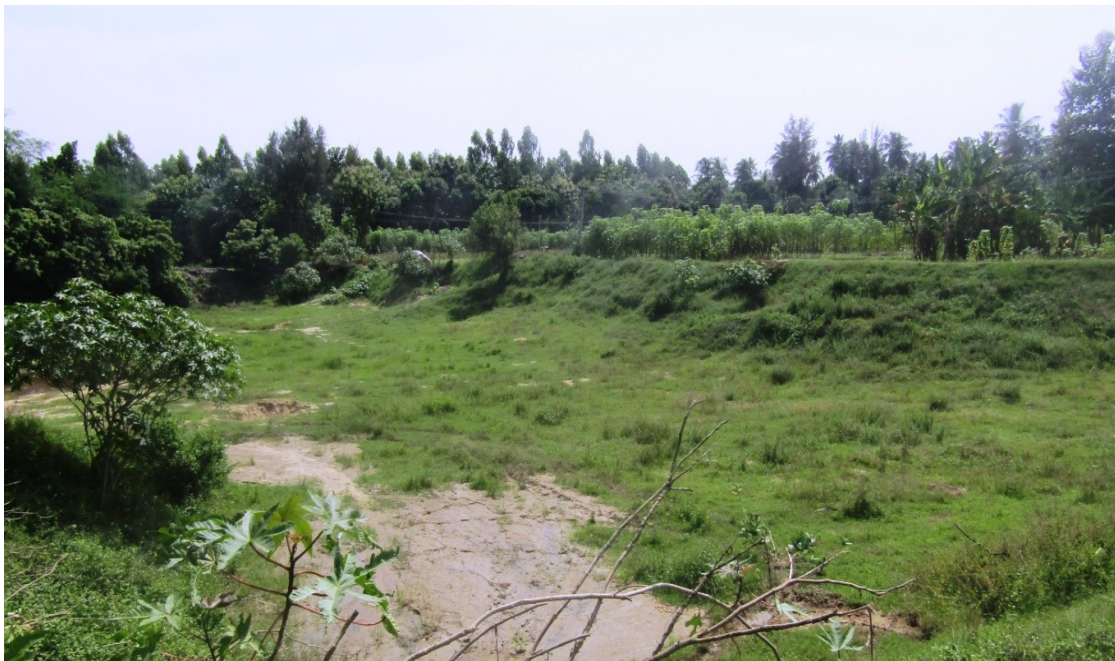
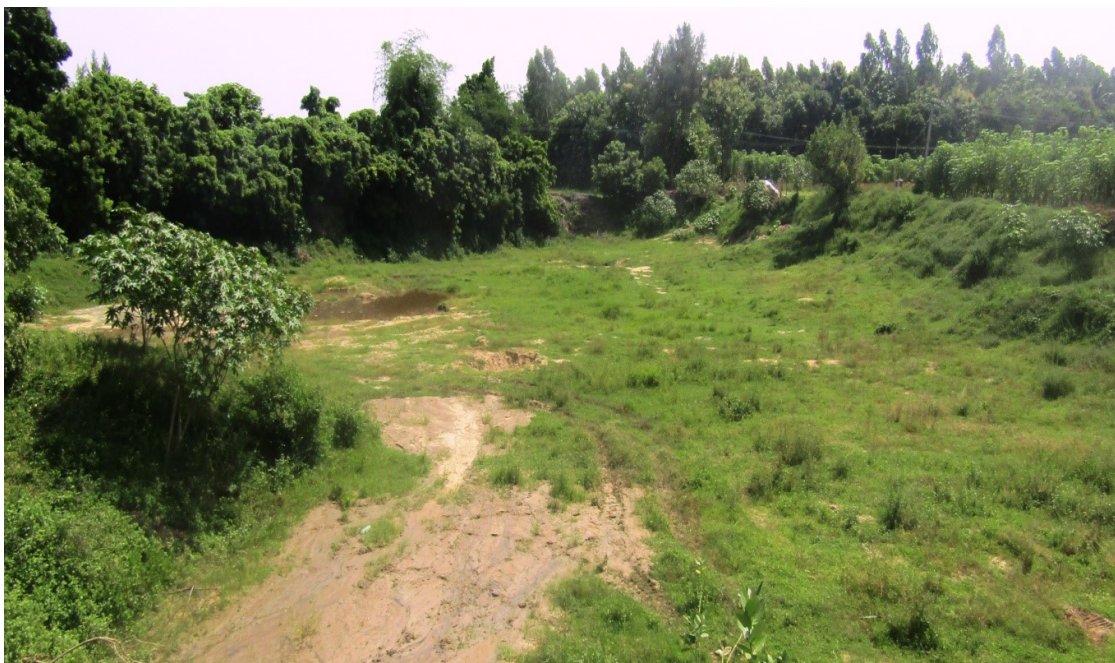
17. Pond photos before execution of the work:

1. Commune: Nettapakkam Commune Panchayat
2. GPS coordinates: 11° 52' 05.74" N 79° 44' 18.30" E
3. Dimension: Side 1: 200 ft.
 Side 2: 42 ft.
 Side 3: 210 ft.
 Side 4: 130 ft.
4. Total Area: 0-83-00
5. Depth of pond: Depth 1: 9 ft.
 Depth 2: 9 ft.
 Depth 3: 9 ft.
 Depth 4: 9 ft.
6. Is water available: No
7. Status of Eutrophication: Not present
8. Is water available throughout the year: No
9. Are inlet and outlet available: No
10. Source of water: a. Rain,
 b. Pumping
11. Status of bund? Partially good, need strengthening
 - i. Is strengthening required? Yes
 - ii. Are planting trees possible? Yes
12. Do people use the pond a. bathing/washing of cloths,
 b. for cattle,
 c. fishing,
 d. for religious activities
13. Is waste water discharged inside the pond? No.
14. Is it given for lease? No.
15. Whether desilted earlier? No
16. No of trees around the bund: 10 trees alive.

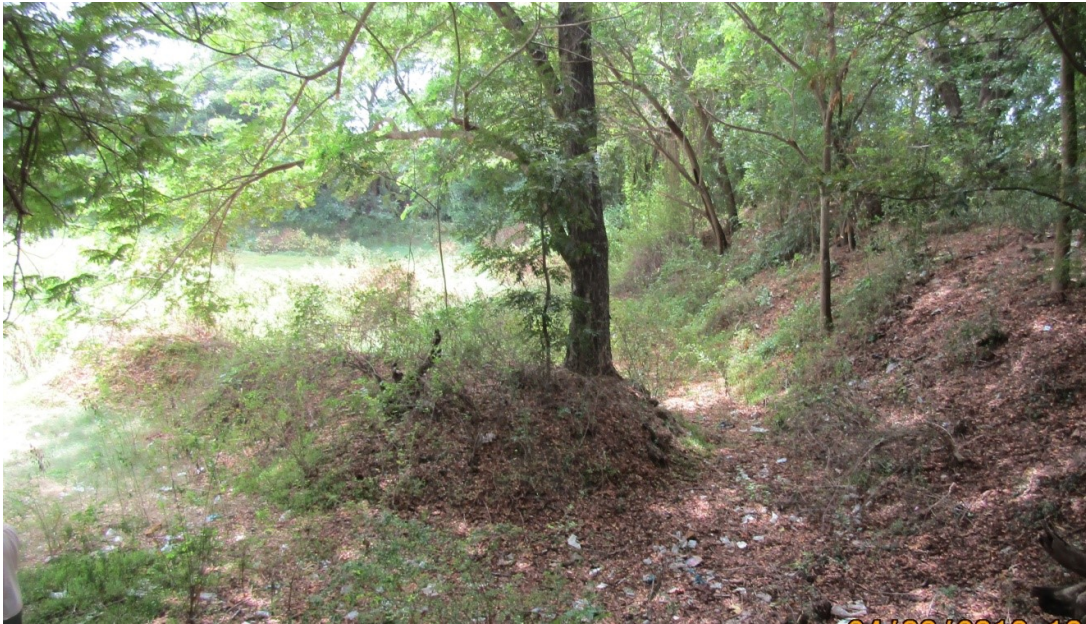
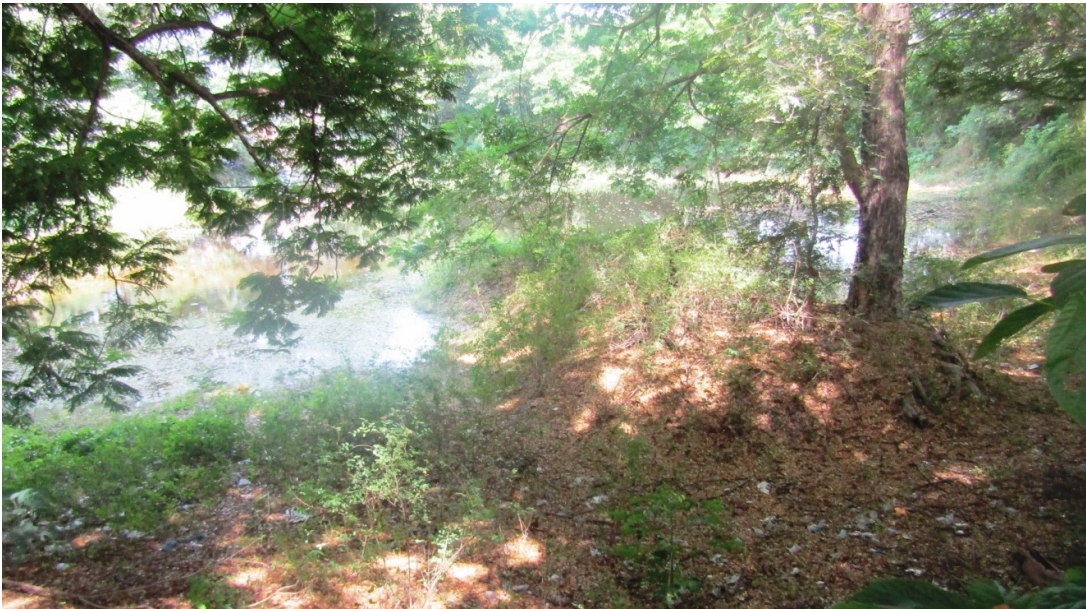
17. Pond photos before execution of the work:

1. Commune: Nettapakkam Commune Panchayat
2. GPS coordinates: 11° 51' 58.05" N 79° 43' 09.30" E
3. Dimension: Side 1: 200 ft.
 Side 2: 200 ft.
 Side 3: 210 ft.
 Side 4: 130 ft.
4. Total Area: 0-81-50
5. Depth of pond: Depth 1: 7 ft.
 Depth 2: 7 ft.
 Depth 3: 7 ft.
6. Is water available: Yes, if yes, water level from top: 4 ft.
7. Status of Eutrophication: Fully present
8. Is water available throughout the year: No
9. Are inlet and outlet available: No
10. Source of water: Rain
11. Status of bund? Fully covered with bushes need strengthening
 - i. Is strengthening required? Yes
 - ii. Are planting trees possible? Yes
12. Do people use the pond: Nil
13. Is waste water discharged inside the pond? No. biomedical wastes were found in the pond during inspection.
14. Is it given for lease? No.
15. Whether desilted earlier? No
16. No of trees around the bund: 10 trees alive.

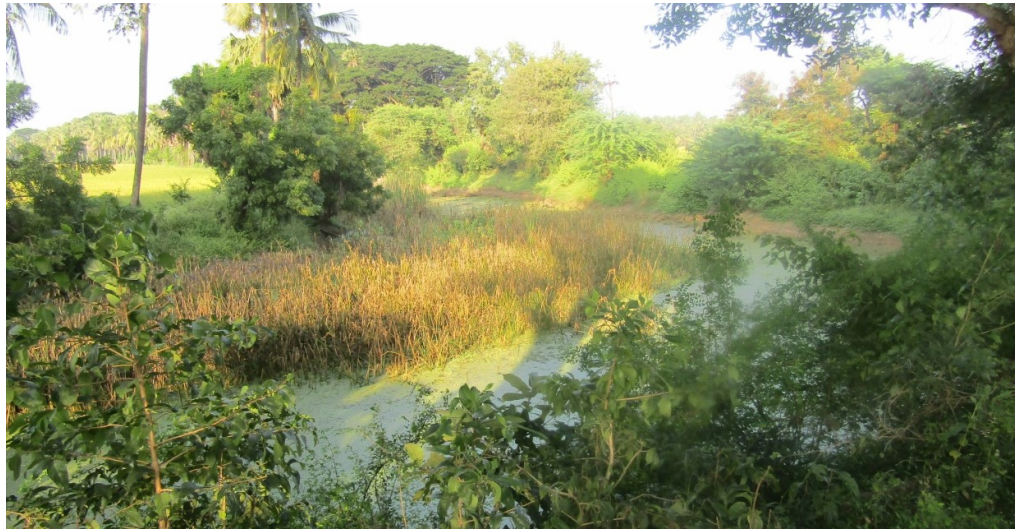
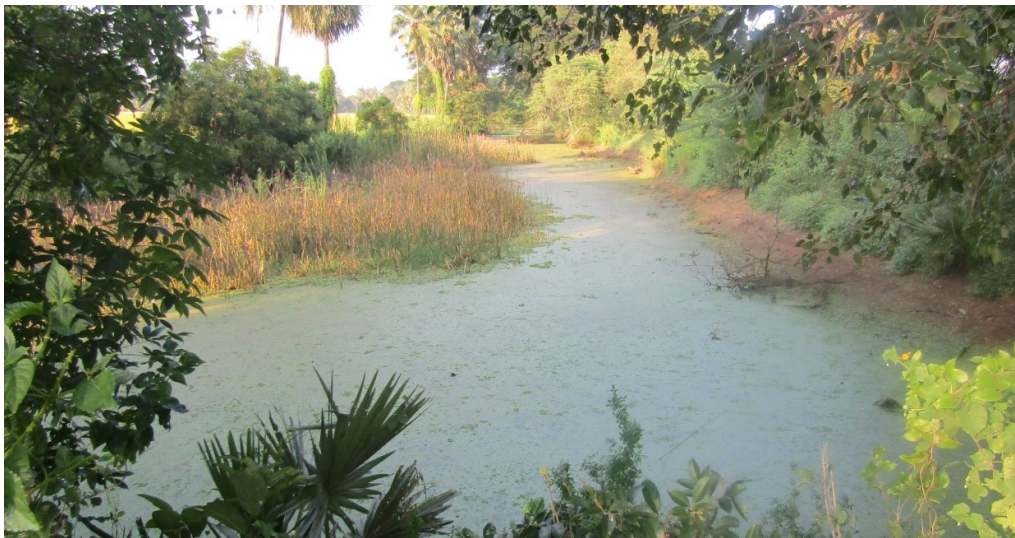
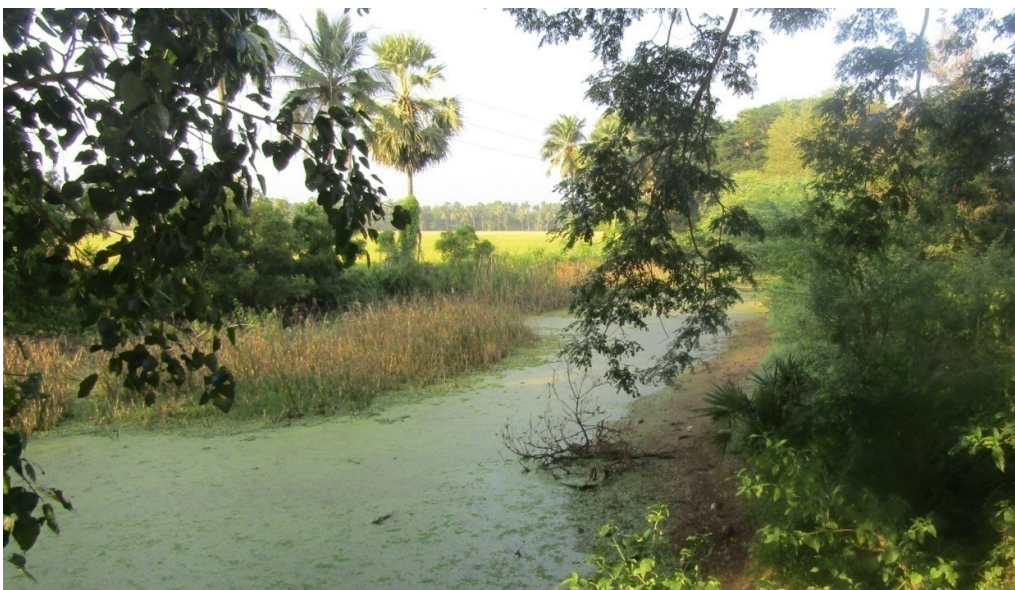
17. Pond photos before execution of the work:

i. When was it desilted? 2017-2018 (partly desilted)
ii. by whom? B.D.O.(MGNERA Scheme)
16. No of trees around the bund: 500 and its status: Alive

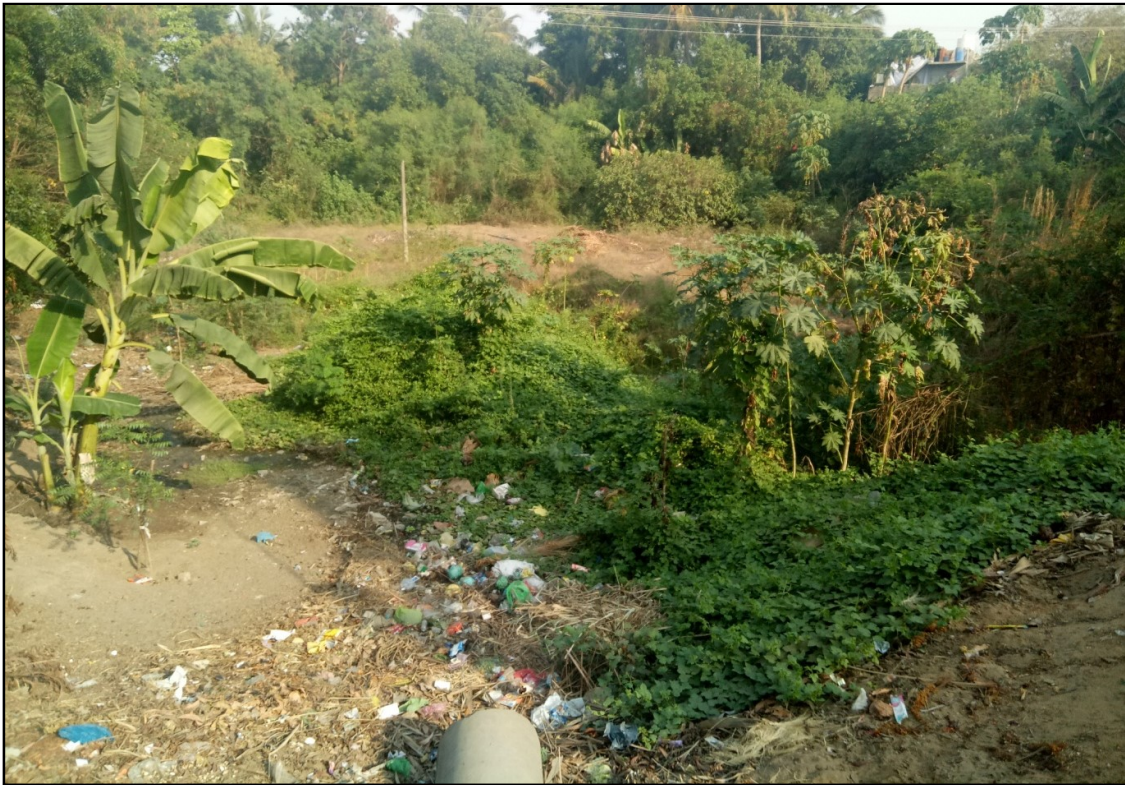
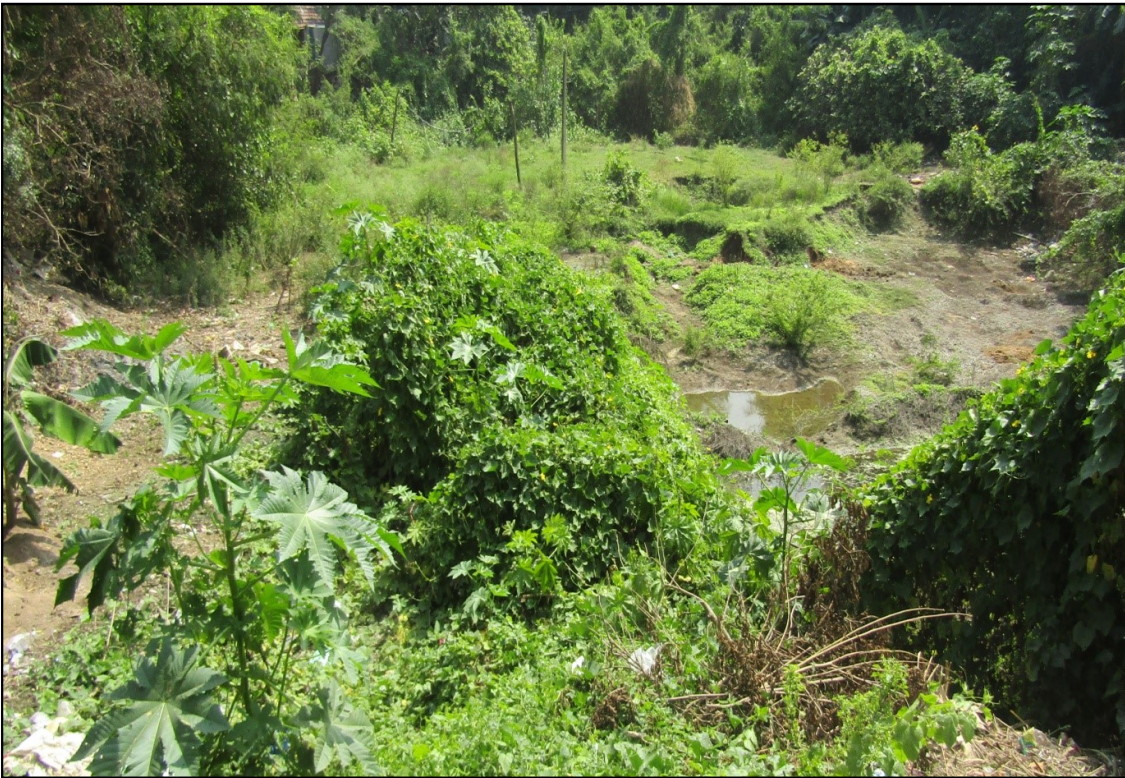
17. Pond photos before execution of the work:

1. Commune: Mannadipet Commune Panchayat
2. GPS coordinates: 11° 57' 10" N 79° 39' 06" E
3. Dimension: Side 1: 220 ft.
 Side 2: 600 ft.
 Side 3: 230 ft.
 Side 4: 620 ft.
4. Total area: 135625.3 Sq. ft.
5. Depth of pond: Depth 1: 10 ft,
 Depth 2: 10 ft,
 Depth 3: 10 ft.
6. Is water available: No
7. Status of Eutrophication: Partially Present
8. Is water available throughout the year: No
9. Are inlet and outlet available: No
10. Source of water: Rain
11. Status of bund? Need strengthening
 - i. Is strengthening required? Yes.
 - ii. Are planting trees possible? Yes.
12. Do people use the pond a. bathing/washing of cloths,
 b. for cattle
13. Is waste water discharged inside the pond? Yes. If Yes, Source: Domestic waste water
14. Is it given for lease? No.
15. Whether desilted earlier? No
16. No of trees around the bund: 10 and its status: Alive
